Technical Report: Power Supply Replacement – South Exit Dispenser

Author: Jose Antonio Acebuche

Date: June 29, 2025

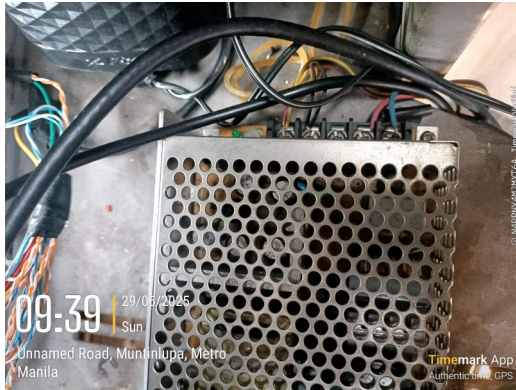
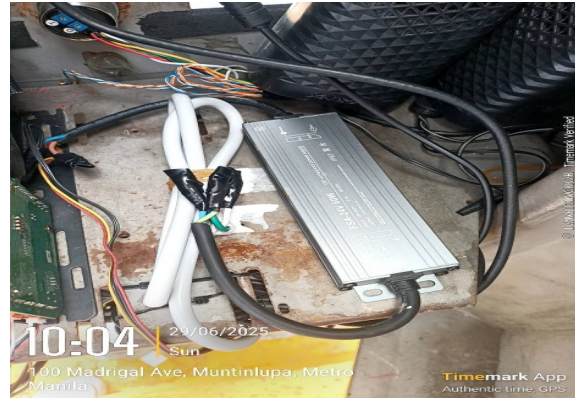
Photo Evidence:

Dispenser unit at South Exit was completely unresponsive, no lights, no sound. No motor or indicator response when powered.

- Power adapter output showed 0V — confirmed power supply failure.

- Replaced defective power supply with a verified working unit of the same voltage/amperage rating.
- Performed system boot and ran basic functions:
 - Card insertion and eject
 - Internal board LED status
 - Network connectivity

Dispenser is fully operational. No error or fault detected during test transactions. System returned to service.
