NASA Reference Publication 1390

Spacecraft System Failures and Anomalies Attributed to the Natural Space Environment

K.L. Bedingfield, R.D. Leach, and M.B. Alexander, Editor

August 1996

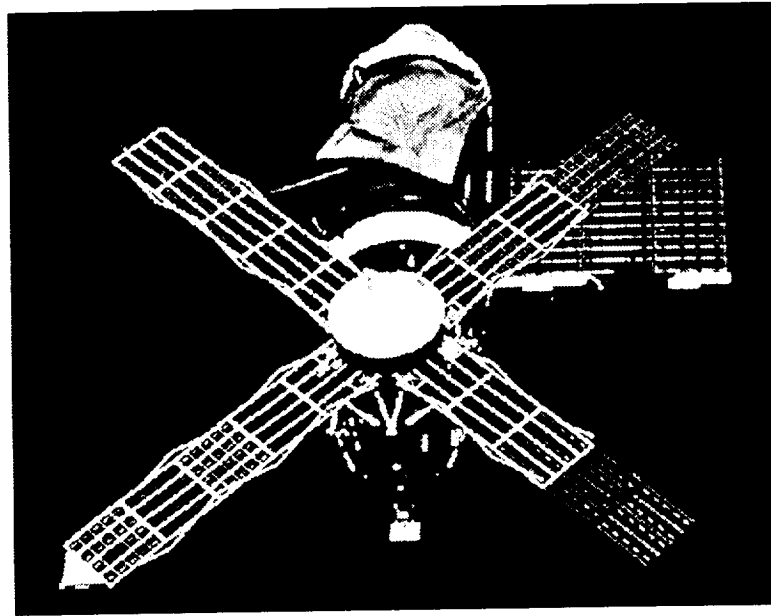
Figure 4. *Skylab*.

On July 11, 1979, *Skylab* (fig. 4) prematurely reentered the Earth's atmosphere. This orbiting laboratory, the first of its kind, experienced the density effects of the neutral thermosphere. As atmospheric drag increased, the spacecraft reached the point at which it could no longer stay in orbit, and before a rescue mission could be launched, it fell to Earth.⁴

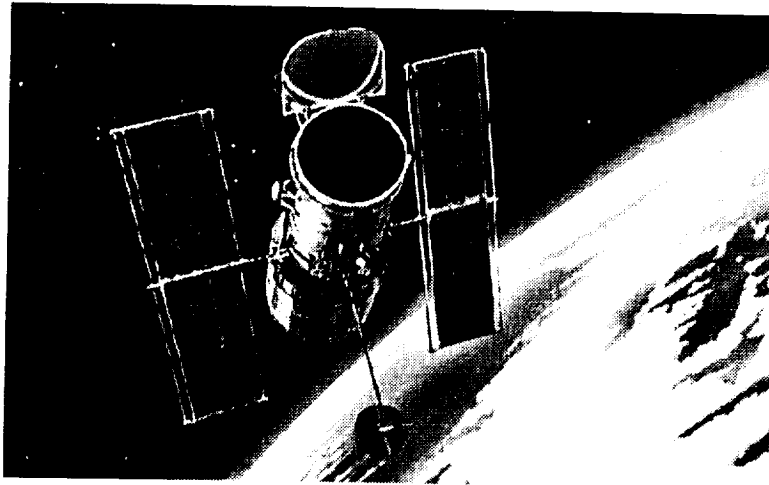
Figure 7. HST.

Before the December 1993 HST service mission, the solar arrays vibrated severely each time the observatory emerged from shade into sunlight. Active vibration cancellation using the onboard gyros was implemented before the service mission to minimize the problem. Thermal expansion of the support poles (also called bistems) was blamed for the vibrations, which interfered with deep-space observations. The new arrays installed during the service mission had sleeves over the bistems to provide jitter-free imagery⁷ (fig. 7).
