VoLTE 优化经验总结及案例分享

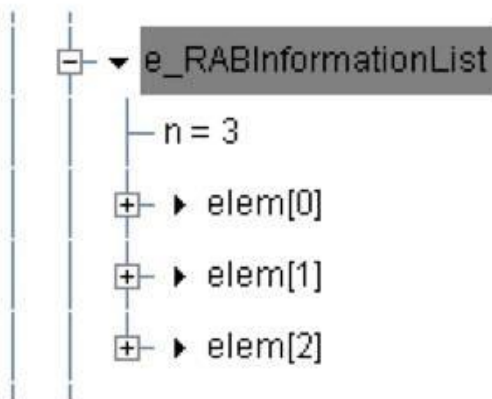
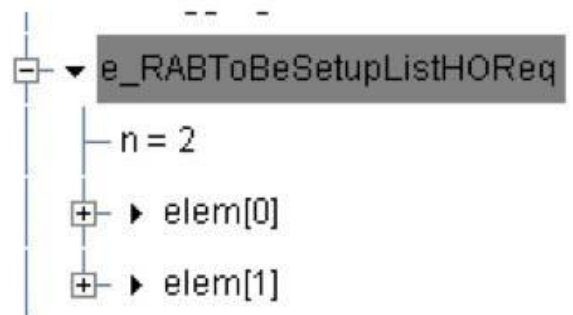
现象：呼叫建立与切换过程冲突，专载被 MME 释放。呼叫建立过程中专载建立与切换几乎同时发生，MME 未收到 NAS 专载完成消息导致释放专载，终端回复 invite580（也有上发 CANCEL 的情况），专载丢失形成未接通事件。

源小区3条DRB

目标小区2条DRB

原因分析: QCI5 设置的 RLC 优先级为 2, 高于 SRB=2(传送 NAS 层消息) 配置为 3. 导致 NAS 的层 3 消息已经比 MR 要早, 但是因为优先级比 MR 和 SIP 低, 未及时发送。

优化措施: 降低 QCI 5 优先级, 确保 SIP 消息及时上传, 修改后此类问题改善明显。

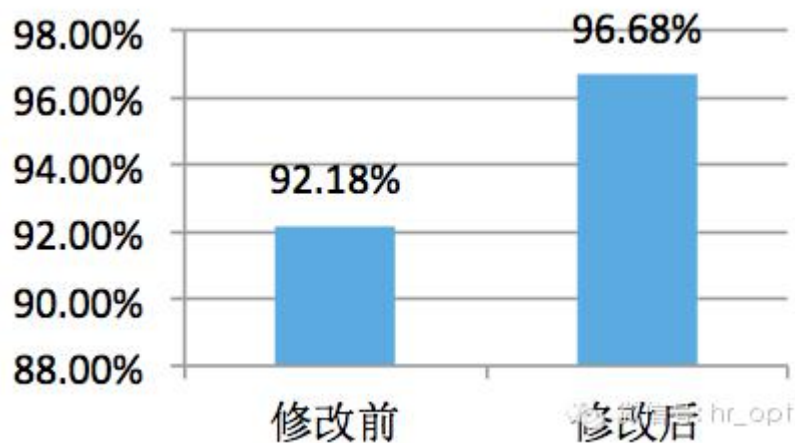
VoLTE 无线接通率提升明显

QC15 PDCP DiscardTimer 由 300ms 修改为无穷大

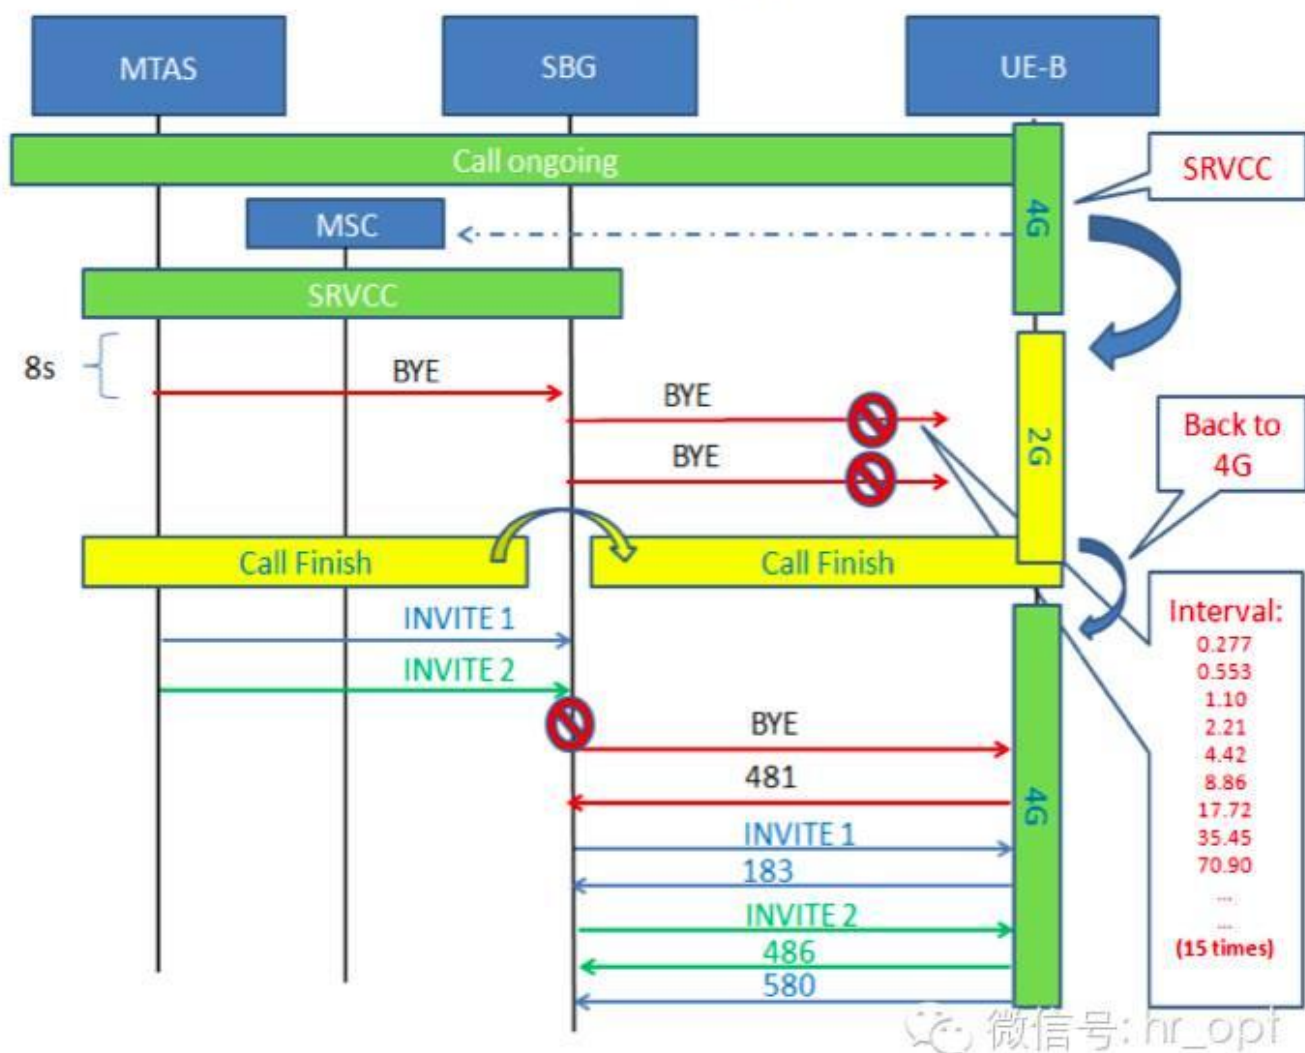
BYE消息重传机制

爱立信IMS传输协议TCP配置默认15次，SIP消息未送达，TCP协议会一直做重传尝试，且每次重传不成功，下次等待重传时间会double，重传时间一直增加，最多会到十几分钟。

优化措施：爱立信 SBC 对 TCP 配置进行了修改：最大重传次数从 15 次改为 5 次，最大重传隔间从十几分钟改为 15s，此类问题已解决。

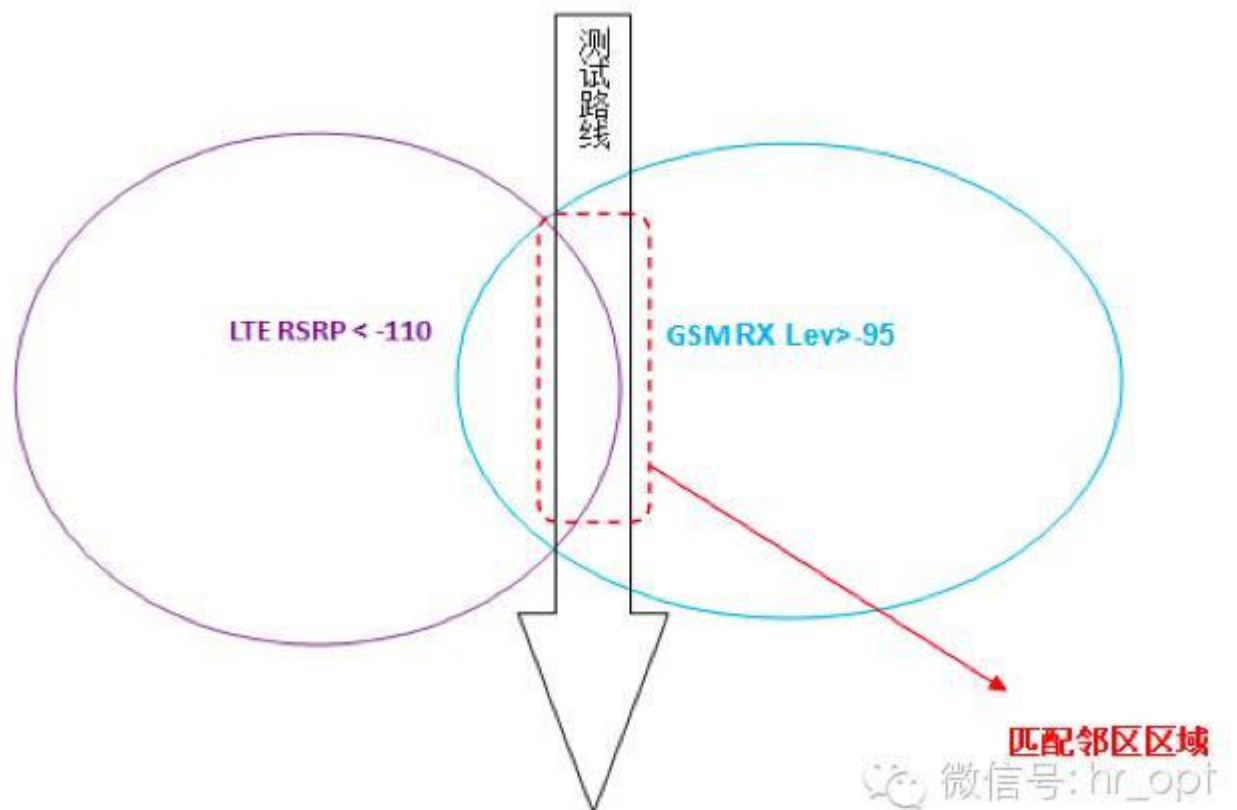
4G 弱信号路段与 2G 拉网服务小区匹配：利用第三方拉网测试数据，将 4G 和 2G 拉网信号强度、经纬度、服务小区等信息导出。通过经纬将 4G

弱信号(RSRP<-110dbm)与 2G 强信号 (RXLOV>-95dbm) 在 50 米范围内拟合，根据拟合度对 2G 邻区进行补漏工作。

剔除现网已配置的邻区关系，补漏邻区关系对后，eSRVCC 切换提升明显，且由于 2G 邻区不准确导致的异系统重定向大大减少。

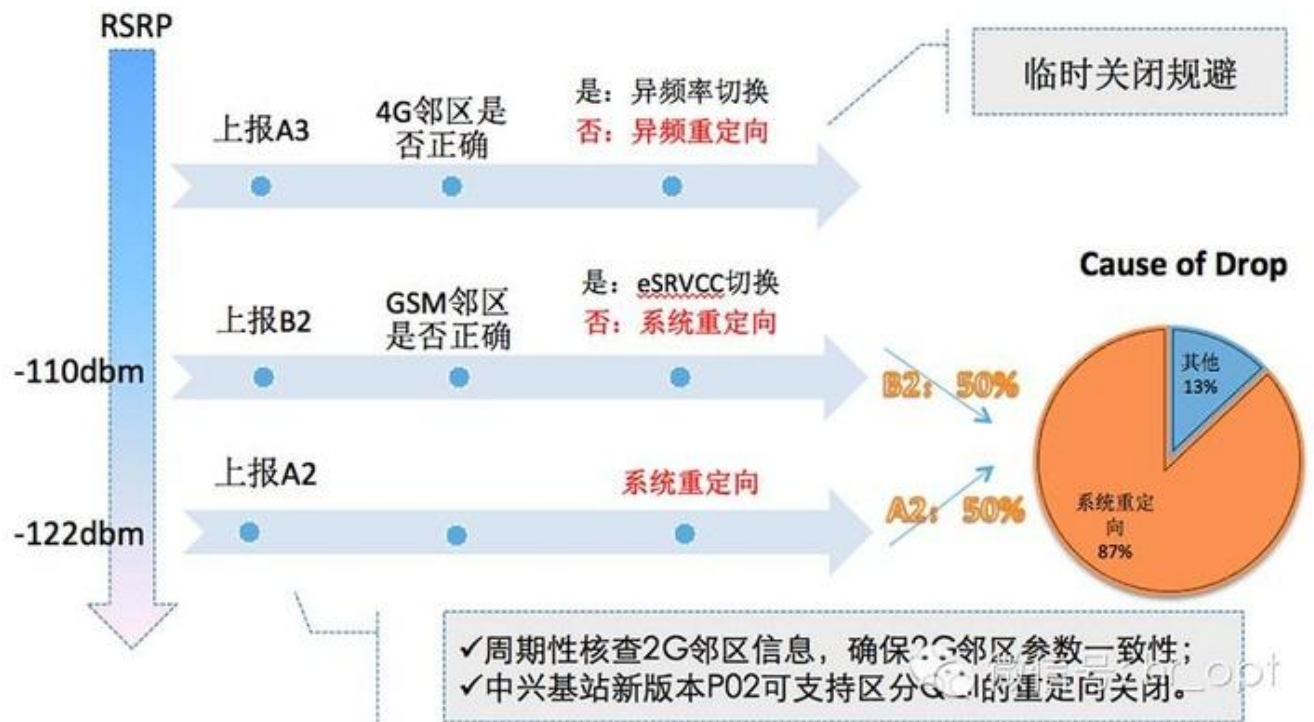
XX 区域掉话最严重属于重定向掉话，在 XX 基站算法中，以下三种可能发生重定向，重定向释放 RRC 后，专载同时被拆除，VoLTE 业务产生掉话。

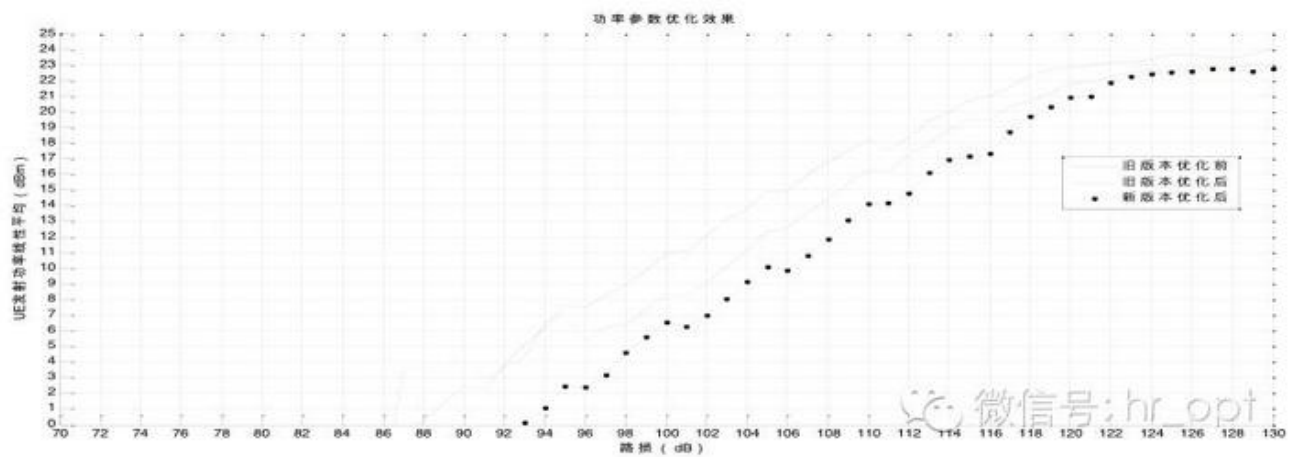
背景：xx 区域拉网测试发现上行 PUSCH 发射功率偏高，对现网参数检查发现，xx 区域上行期望功率值设置过高。

- 同等路损情况下，参数修改后，ue 发射功率大约下降 2~3dB。
- 目前终端平均上行发射功率仍高于 10db，仍需完善现有功控方式。

现网配置： p0NominalPUSCH = -75 ； puschPCAdjType=0

优化值： p0NominalPUSCH = -87 ； puschPCAdjType=2

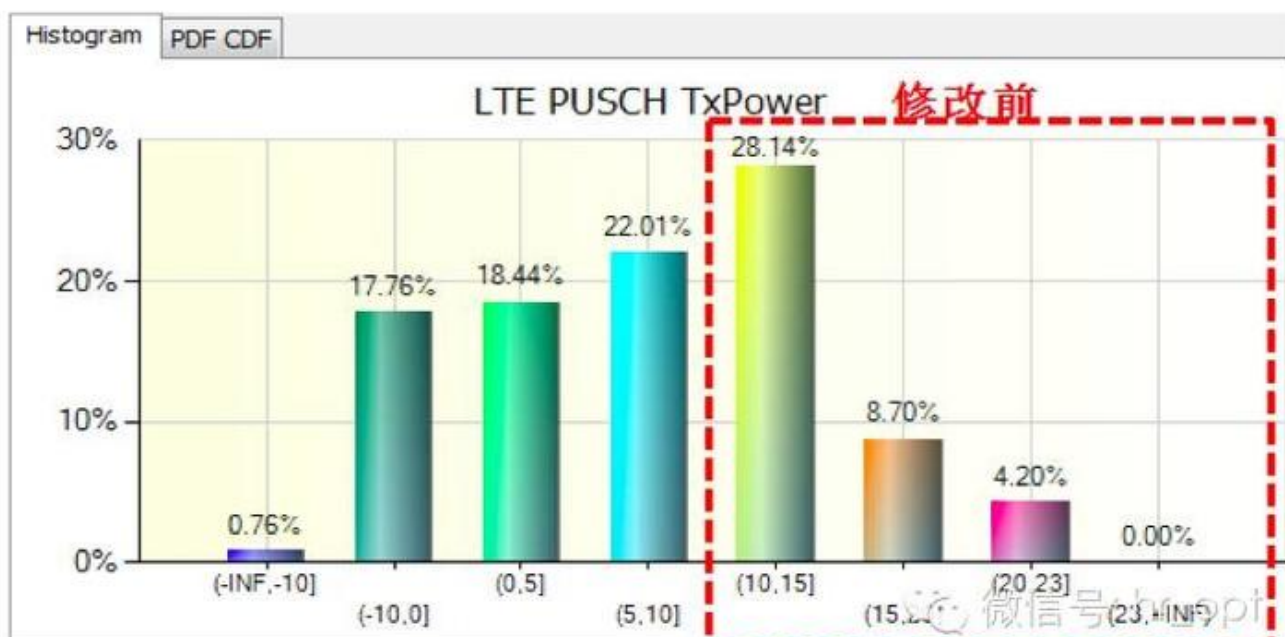
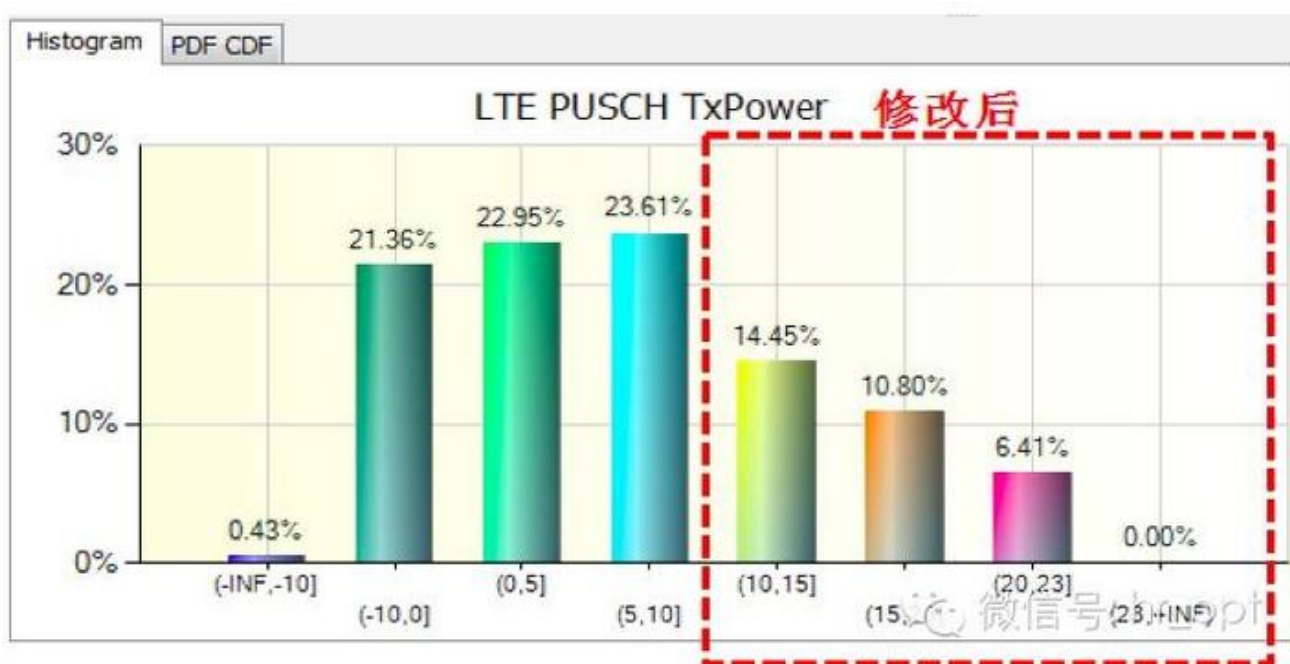
修改后，PUSCH TxPower（10dbm 以上）占比由 40%下降到 30%左右。

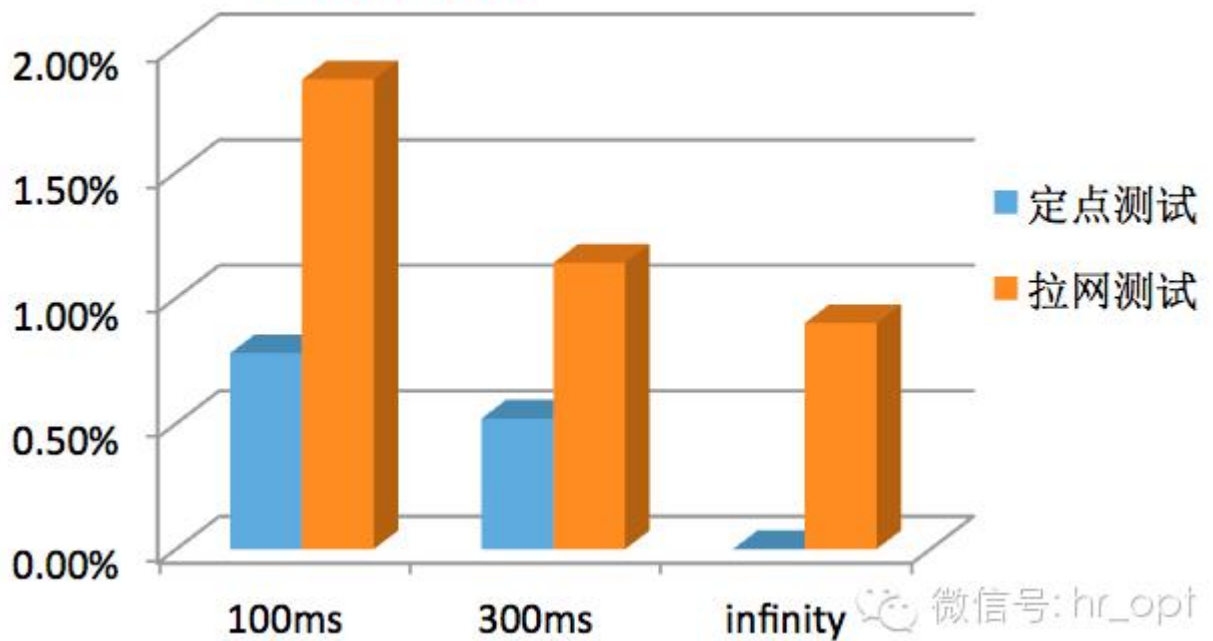
Discardtimer配置与RTP丢包率关系图

外场测试表明 QCI 1 PDCP Discardtimer 配置与 RTP 丢包率及 Jitter 有密切关系，QCI 1 PDCP Discardtimer 配置越大，RTP 丢包率越低，但 Jitter 也随之变大。

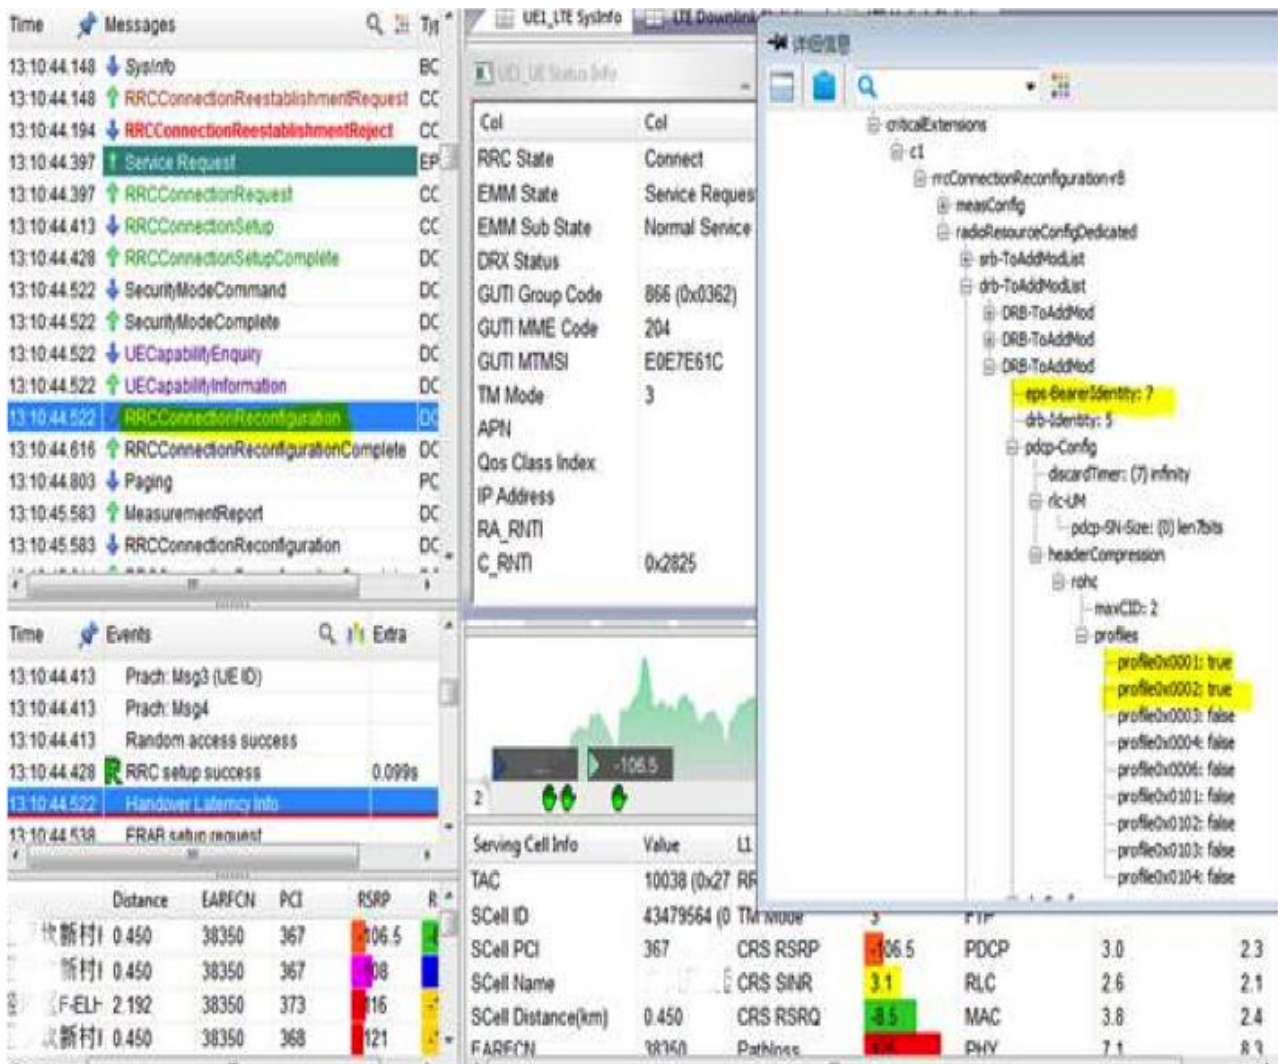
验证情况：已在某 MME 下成功验证了该功能。当时无线环境较差，UE 发起 RRC 重建失败，通过 MME 专载 QCI1 保持功能使得在新发起的业务过程中，RRC 重配中建立包括专载 QCI1 的 3 条 DRB，不会发生掉话。
（本次测试中专载保持时长约 1.358s）

- 1) 当无线环境较差时, UE 发生 RRC 重建, 若 RRC 重建成功, 手机将不会掉话。
- 2) MME 侧也可以在 RRC 重建失败后, 通过 MME 专载 QCI1 保持功能使得在新发起的业务过程中, 专载 QCI1 继续保持, 也可使得手机不掉话。
- 3) 此功能为爱立信 MME 非必选功能, 建议打开。但是该功能不在集采目录, 暂时无法采购。

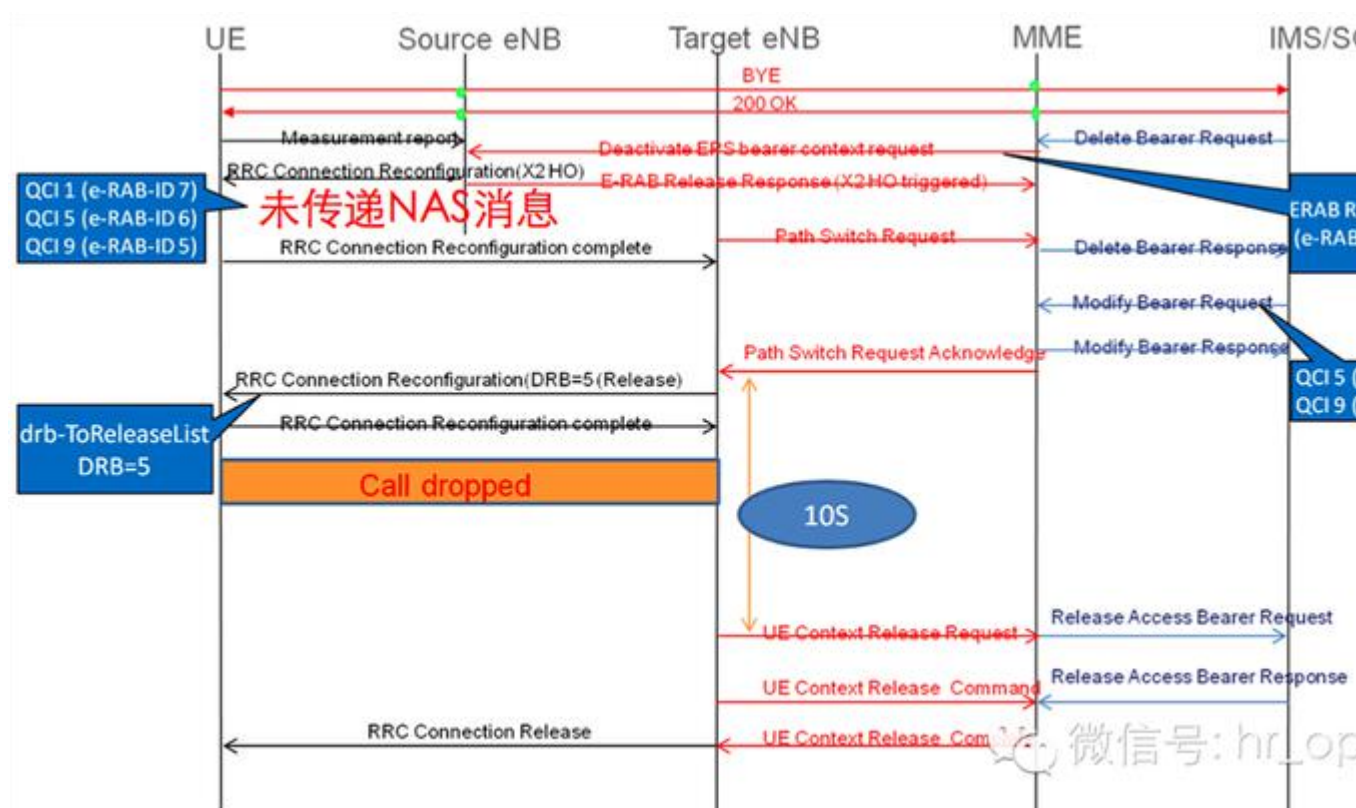
[问题描述]: 通话挂机后，主叫上报 BYE 消息，IMS 回 BYE200 消息前后，同时手机发生切换，EPS 专载没有释放，1s 后软件统计掉话。

[问题分析]: 主叫挂机后，MME 收到 del bearer req，下发 Deactivate EPS bearer context Request 给源 eNB 携带 NAS 释放专载，但同时源 eNB 触发 X2 切换，向 MME 响应 ERAB release response

(X2-Handover-Triggered)，NAS 消息未下发到手机。根据协议 36.413 中 8.6.2.4 有描述当 eNB 在触发 X2 切换时，eNB 将不传递 NAS 消息。

[优化措施]: 属测试软件统计问题，建议软件加以剔除该问题。

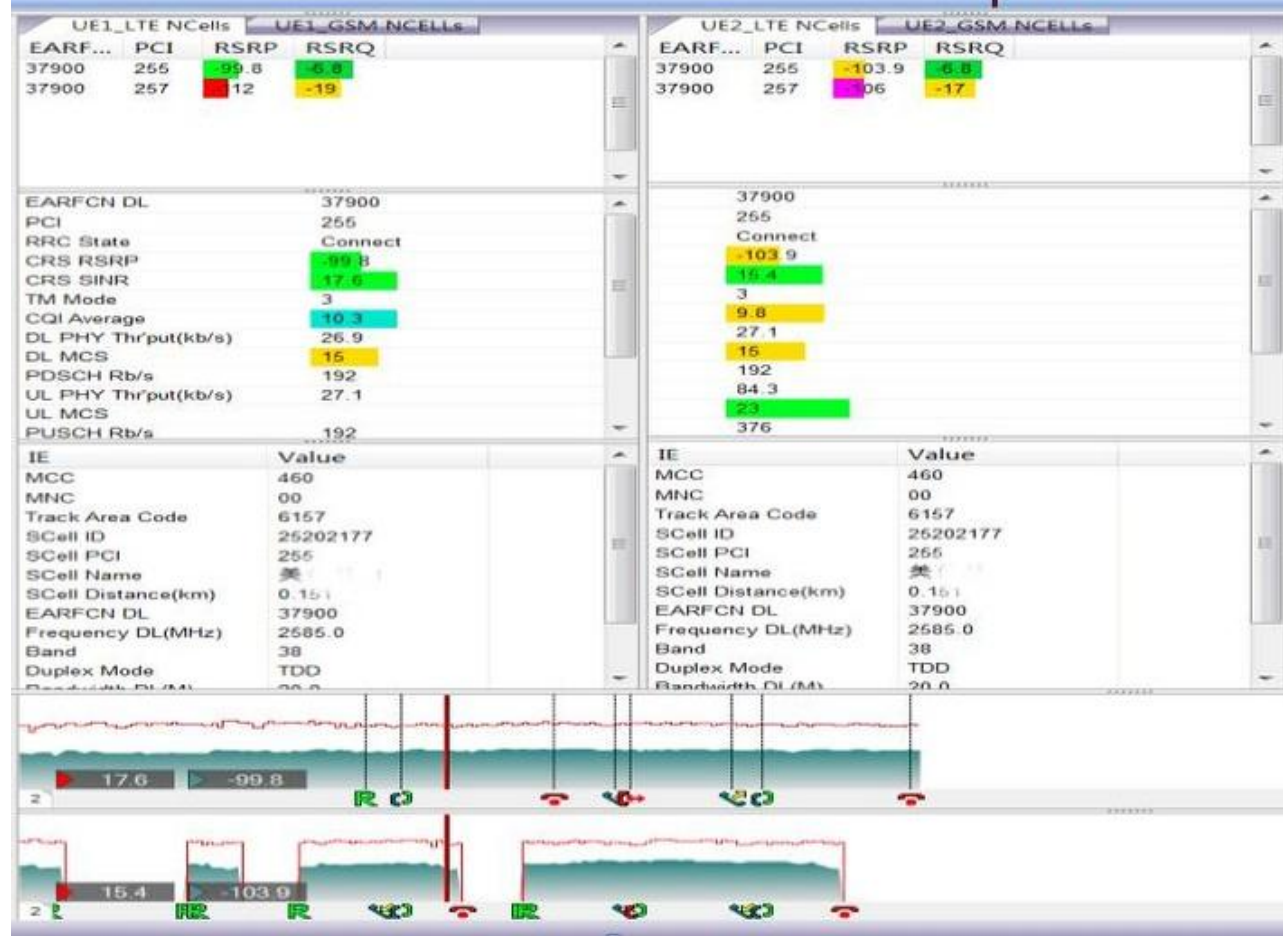
终端发生 eSRVCC 时，在 LTE 向 GSM 切换过程中产生掉话。

终端可以正常收到测控消息，并上报测量报告，且掉话发生在向 GSM 切换过程中，是 GSM 或者和基站侧参数设置问题。

基站 BsCAccess-ID 项中的管理状态为 Locked，设置有误。将该状态修改为 Unlock 后，对该站点进行重启后发现 eSRVCC 功能正常。

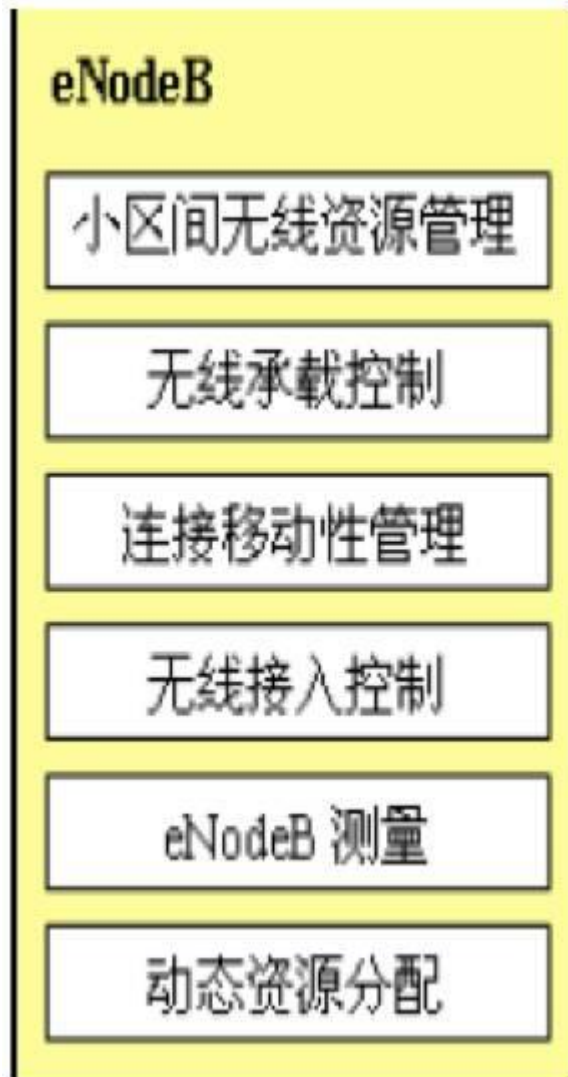
现象：切换失败导致 RRC 释放，重建 RRC 未成功，重新进行 RRC 申请，QCI=1 的承载未建立成功，导致掉话

分析：呼叫重建失败后，新小区重新申请 RRC，未能建立 VOLTE 专载，导致掉话。该流程均由 ENODEB 控制执行。而切换失败的原因往往是无线环境问题、参数配置不合理、邻区漏配、非竞争随机接入异常等，均为无线网问题。

VOLTE接通中发生1次切换失败

1次切换失败后发生呼叫重建且未成功，重新申请RRC，QCI=1的承载未重建

结论：切换失败与 RRC 重申请流程均与 EUTRAN 相关，因此认定为无线网问题。

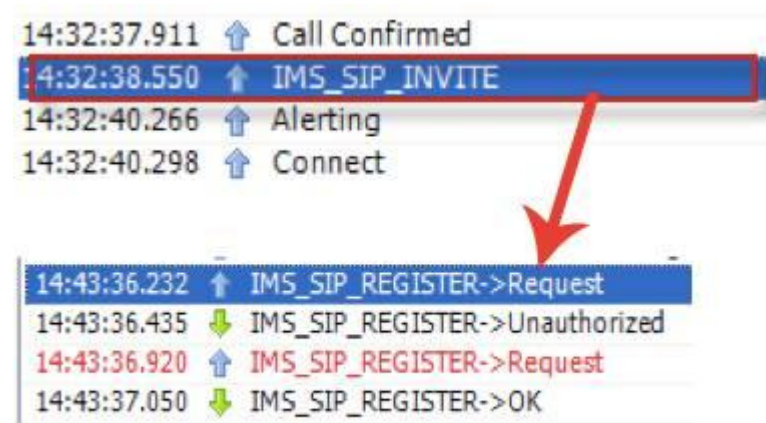
但通过进一步确认，终端实际于 600 秒前已上发了注册消息（UDP），但此时恰好在 G 网下，未收到回复：

注：同样类型的掉话也有 600 秒前处于 LTE 网（TCP），而未收到 OK 或未鉴权回复的情况

结论：前 10 分钟的注册失败，导致了后续的 IMS 通话中释放，虽然终端前一次的失败处理机制可能存在问题，但仍然体现出 IMS 对通话中发生注册时直接释放会话的措施欠妥。

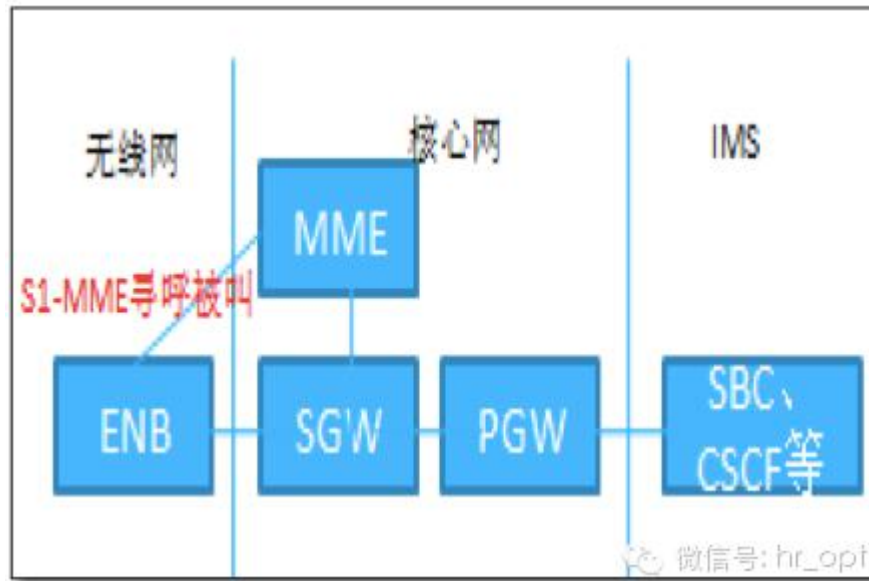
①Sip invite 消息由 IMS 网元 SBC 下发到被叫核心网网元 PGW

②PGW 转发给 SGW，SGW 通过 S11 触发 MME 进行寻呼被叫

③被叫被寻呼到，并完成 RRC 连接与建立默认承载所需 RAB，接收数据

结论：收到寻呼消息表示 sip invite 数据包已经到达了 LTE 核心网，未能继续下发当前怀疑是 sip 数据在 S/PGW 异常丢失。

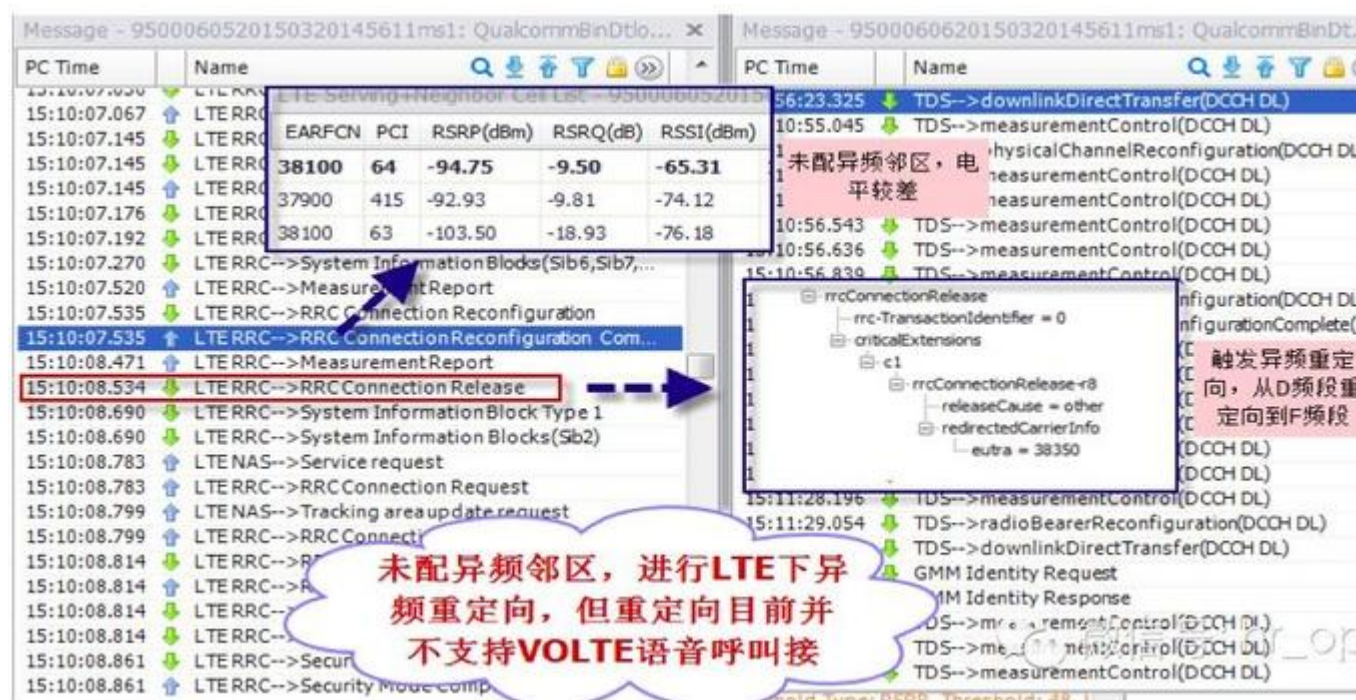
现象：主被叫 VOLTE 接通后，服务小区信号较差，但未配置异频邻区；
通过重定向消息 RRC connection release 携带频点，由 D 频段重定向到 F
频段，但 VOLTE 呼叫不支持重定向方式的 RTP 包接续，导致掉话。

分析：中兴设备为了防止邻区漏配情况下，影响用户在 LTE 数据业务下的
感知质量，默认具备异频重定向功能，但未曾考虑对 VOLTE 呼叫的接续
保持。

结论：完善邻区配置，在 VOLTE 呼叫区域考虑关闭中兴设备的异频重定向功能。

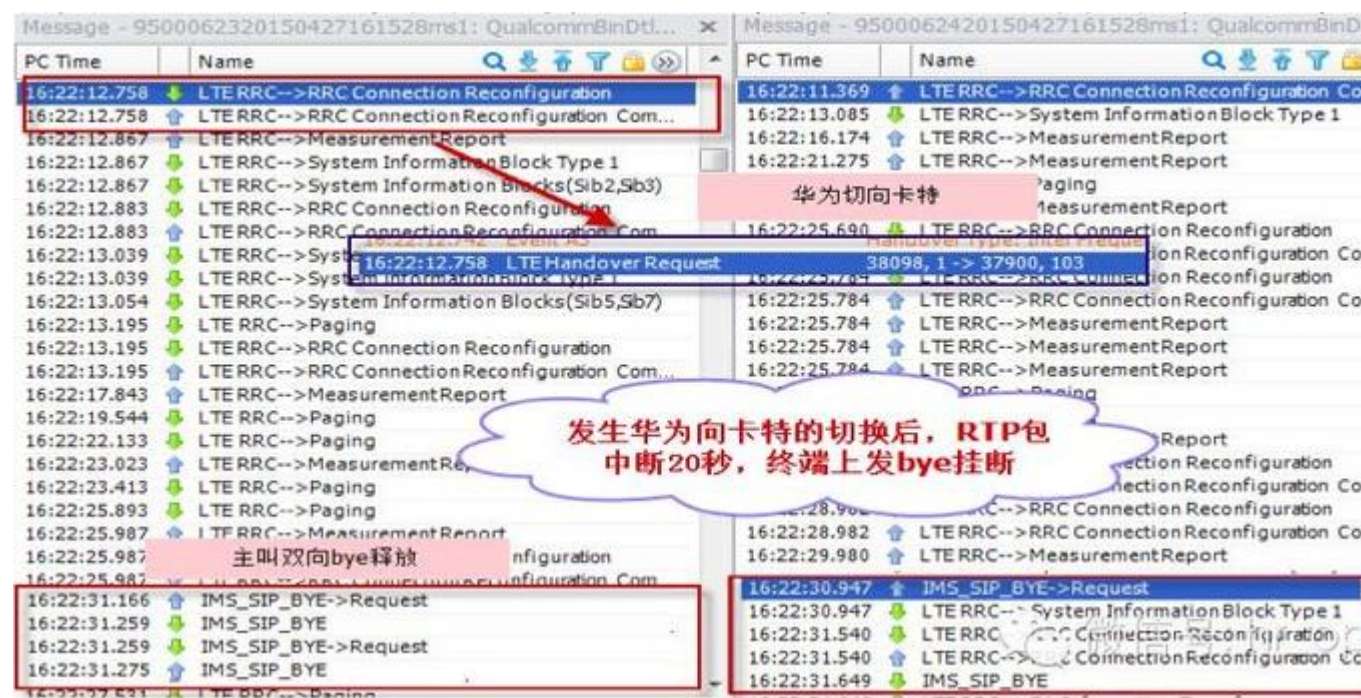
现象：主被叫接通状态下，在发生一次由华为设备到卡特设备的切换后，20 秒后主被叫终端同时上发了 **bye request** 消息，网络侧回复 **bye(487 Request Terminated)**，后网络去激活了 **EPS** 承载，掉话。

分析：PDCP SN SIZE 长度有 12bit 和 7bit，目前华为基站配置为 12bit，贝尔配置为 7bit，两个厂家配置数据不统一。华为 **enodeb** 设备具有自适应功能。

①在华为小区起呼时，切换到卡特小区时，卡特无自适应功能，PDCP SN 不一致导致组包混乱。

②当在贝尔小区起呼时,切换到华为小区时,华为PDCP SN自适应为7bit,通话正常。

结论：临时解决方案：华为 PDCP SN Size 修改为 7bit，进行拉网测试主叫呼叫 56 次，未出现终端主动上发 bye 的掉话。异常掉话及切换后单通问题基本解决
