4/7/24 Dyno

Critical Issues:

- Ignition coils would not fire
 - PDU had bad soldering on the output of the ignition current sensor IC
- No power to entire car
 - PDU 12V+ ring terminal crimp failed and pulled out
- Fuel pressure regulator started dumping fuel out of the vac/boost reference hole/fitting location
 - Assumed the internal seal failed
- Starter would not crank, and dash had no power
 - PDU output connector wasn't fully seated lol
- Fuel pump stopped working
 - PDU 0602 0 ohm jumper on the fuel pump circuit burnt up

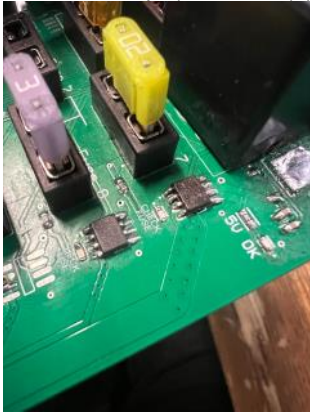
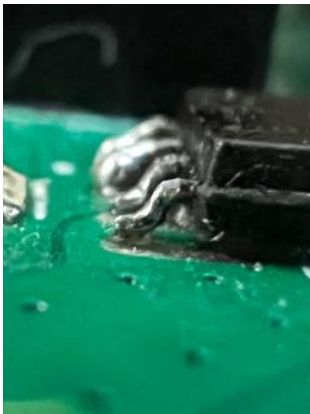
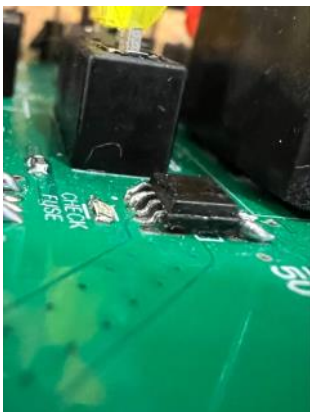
Car was strapped down to dyno and prepared to run. ECU turns on, cooling works, everything cranks, but would not fire. Test procedure was run for coils/injectors, and coils were determined to not be firing. PDU was checked, with 12V+ being received at fuse #7. While unplugging PDU to check for continuity on the output pin/wire harness, the main 12V+ crimp failed and pulled out. During fixing that crimp, it was suspected that there were poor soldering joints on the current sensor's output pins. Solder was added to the pairs of IN+ and IN-, but was advised to remove entire current sensor and instead jump/short the empty pads which was then done.

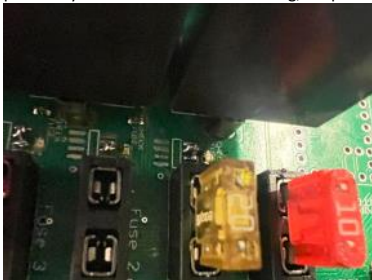
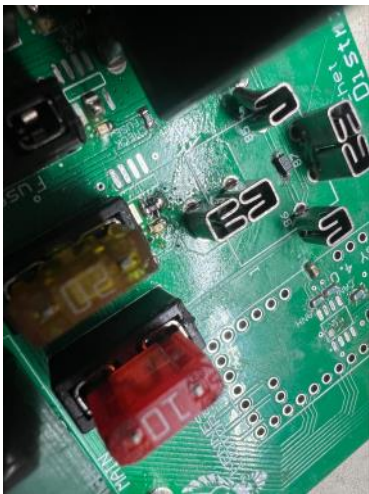
Next, the fuel pump began to lose pressure while idling, until it fully shut off and would not turn on at all. Probing revealed power at the fuse, but none at the output. Visual inspection showed charring on the board, and a burnt up 0 ohm 0602 jumper. With a 15A load, this makes sense. The high amperage jumpers then had adequate solder added to carry the current. The low amperage jumpers also had additional solder added mostly to prevent the small possibility of the same failure occurring, despite the lower amperage.

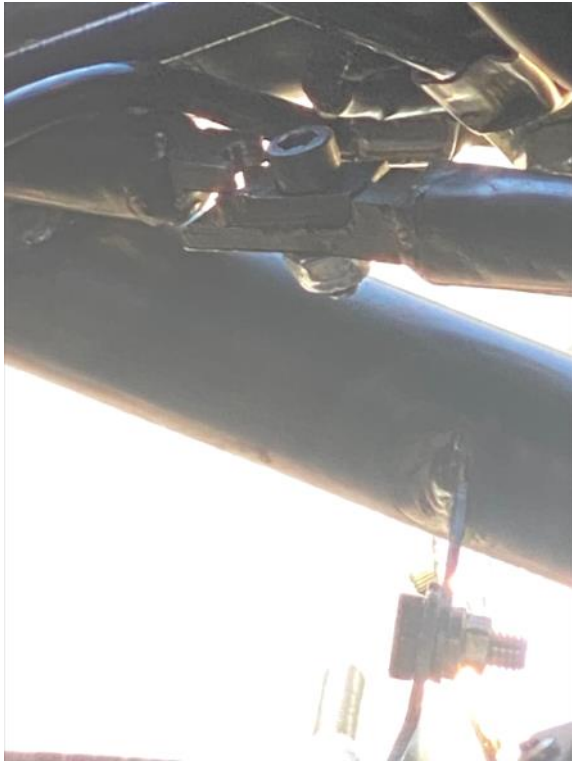
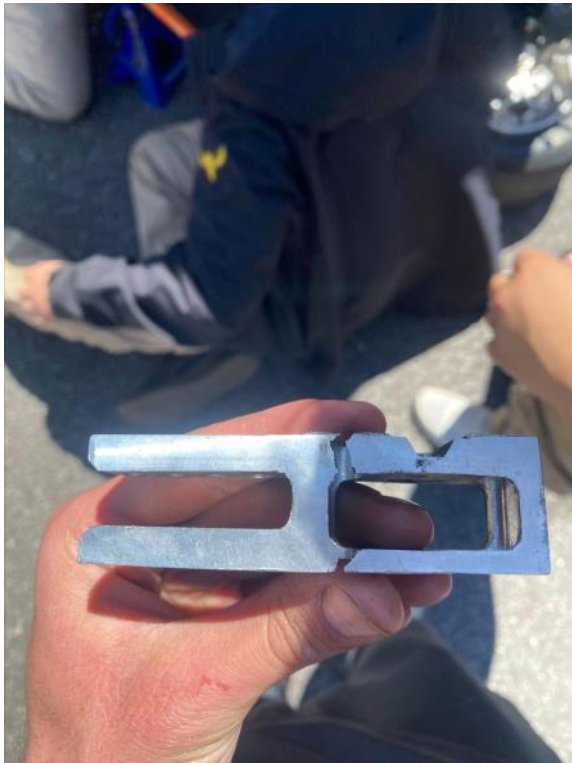
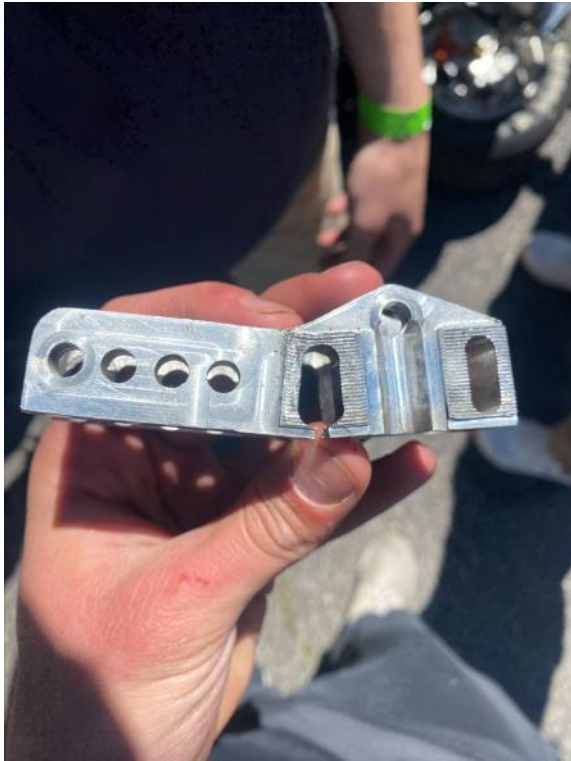
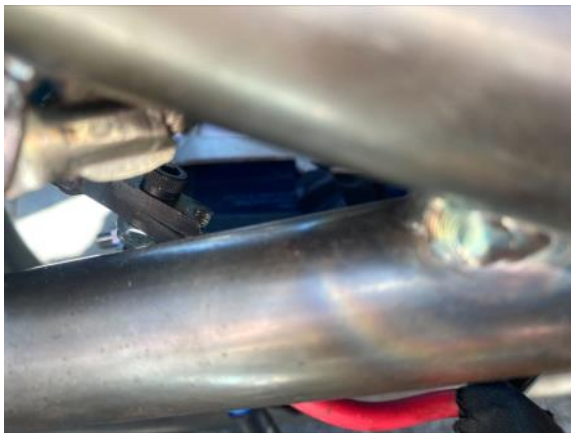
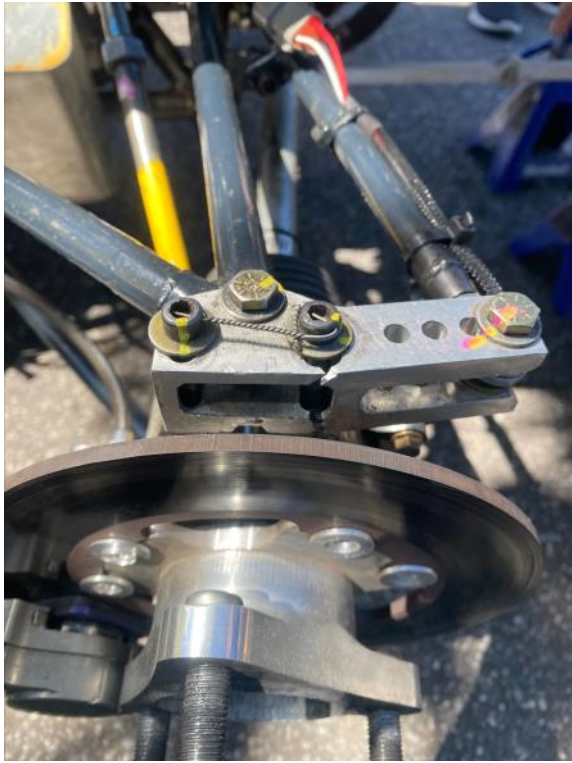
loose chain,
exhaust leaking from headers,
no launch control,
clicking coming from car when moving,
struggles to put power to ground,
wheel bearing about to give out on the left,
rear axle locking,
leaking fuel(may have miss heard) @ the neck
motor mount bolts loose,
no clevis pin in clutch pneumatic shifter on right side,
master link on chain gave out,
right left pickup had broke

Master link broke
Leaking coolant

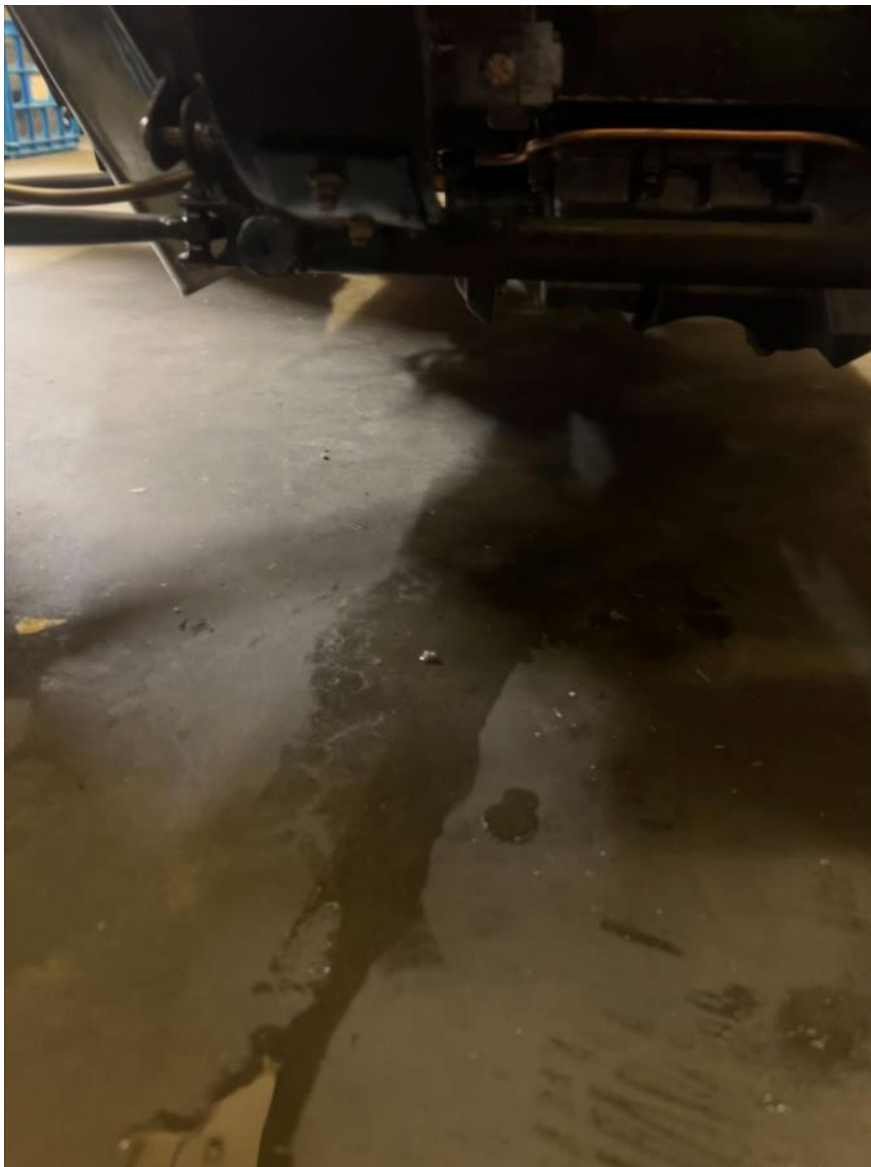
Leaky rear brakes

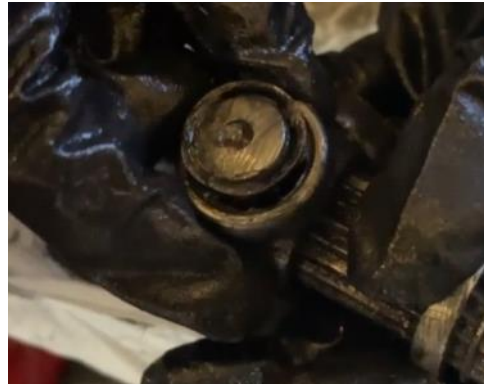
IMG_3404

Video of tripod barring of left rear, It lost its rollers/ exploded

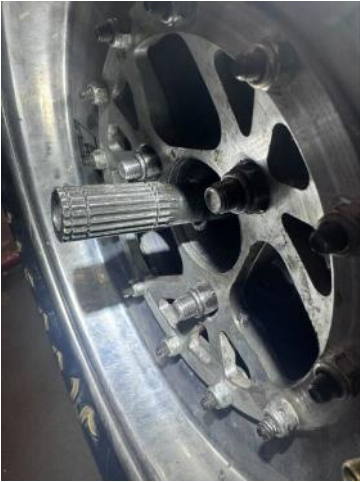
Drexler side the tripod fit nice and had move to room

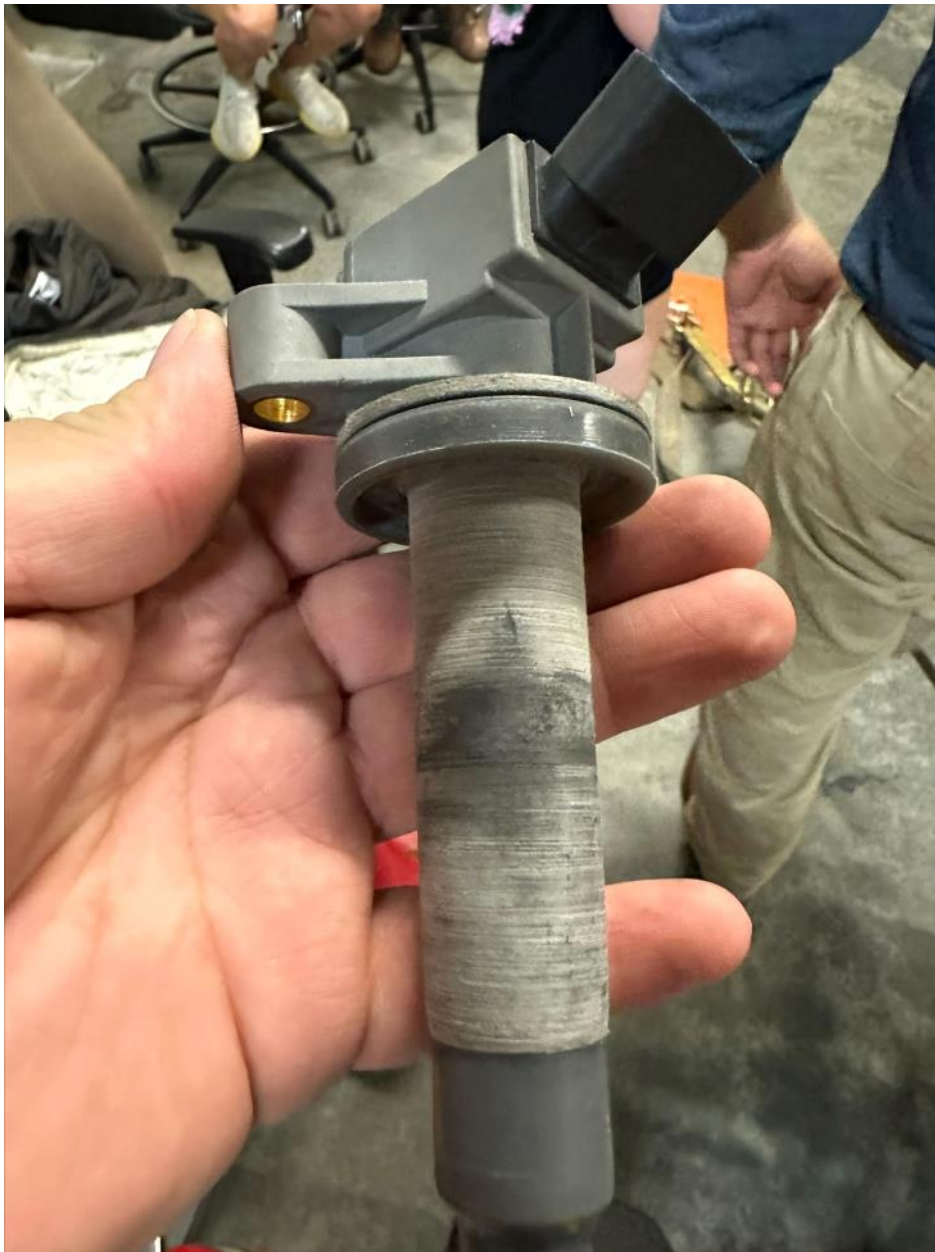
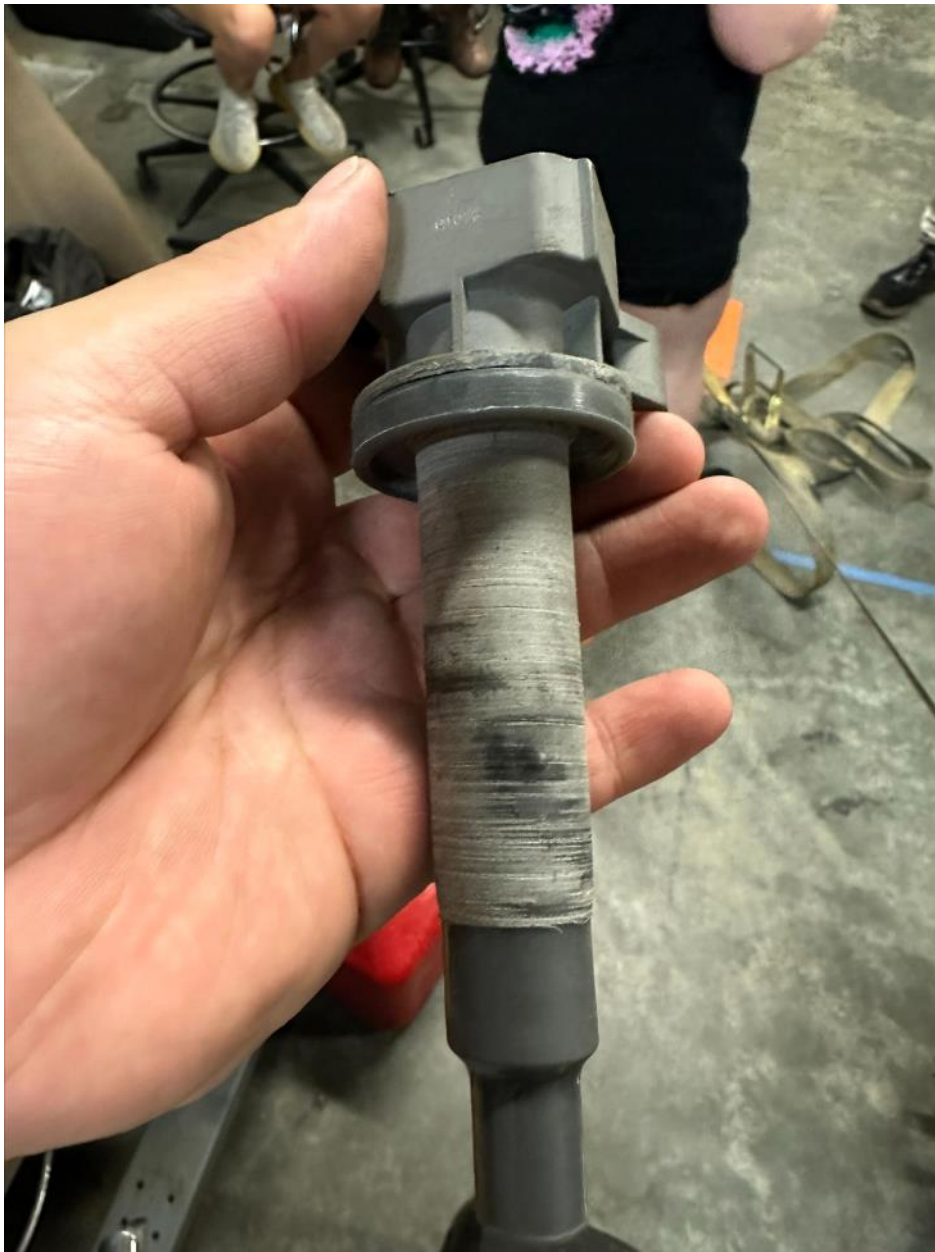
Compression fine; Cyl 3 Sparkplug shot out

Cylinder 3 Coil contacting wall, Fuck cylinder 3

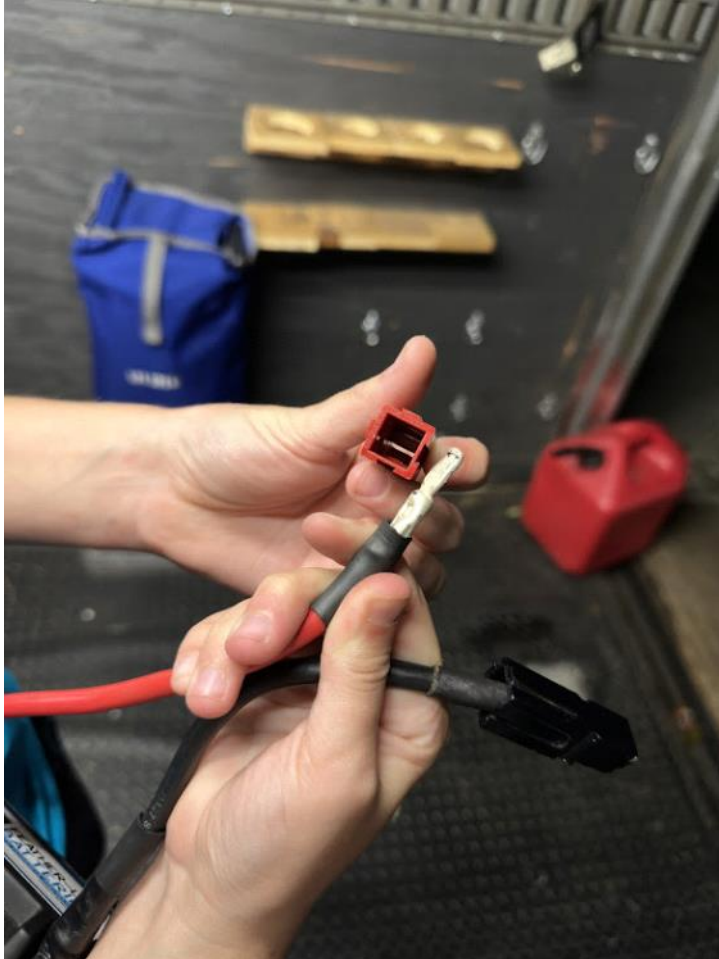
Anderson connector on IC battery broke
Battery was not secured properly before drive
Positive anderson connector missing metal locking feature

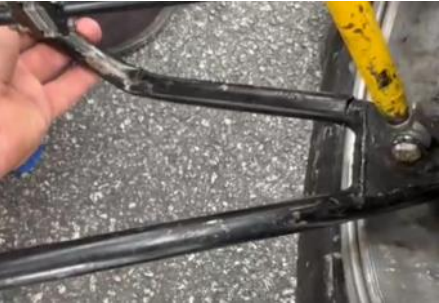
Image 1

Lower control arm:
Driver hit curb at approx. 12:45 PM
Front left wheel hit curb, it was the only one to make contact and rise up on the curb.
Lower control arm broke in 3 places.
The rear arm was bent down about halfway down the length of the pipe with a crack in the inner elbow of the bend. See image 1
The front and rear pipes cracked about 70% of the way through both left with a small tab of metal holding them still on. Front looked to have a little more remaining than the rear but not 100% sure. They were broken near the upright just past the welded plate. See image 2
The rear pipe that was also bent, broke on the top side with a small tab holding it on underneath. The front pipe was broken on the top side directly opposite the way the rear broke. See image 3
Someone noted that the bushing on the upright seemed loose, unsure of who it was and did not confirm myself yet.

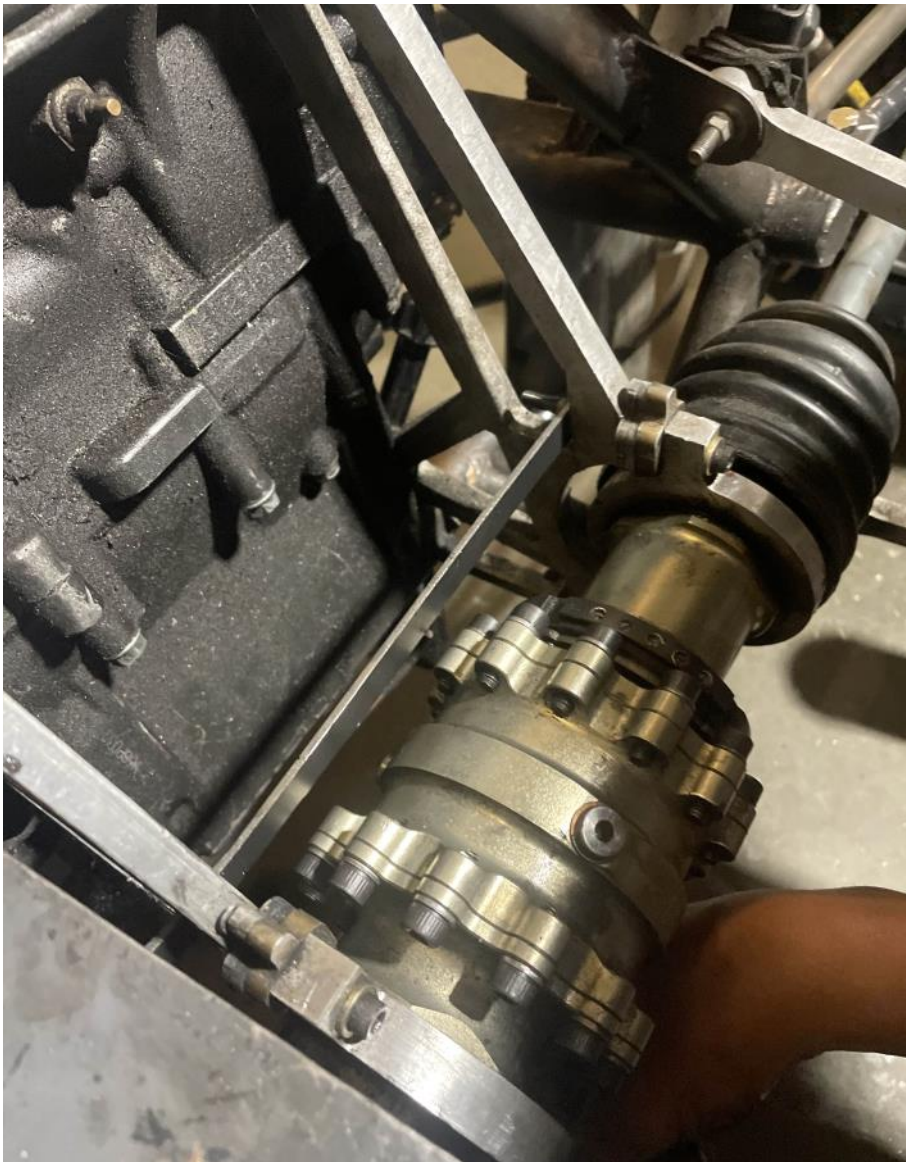
- When we got down to the lot the car driver noted down shifting was not working. Issue was that the pneumatic tank was not screwed all the way onto the regulator.
- Driver did a few laps for shakedown
Chain flew off the rear end. When car was analyzed the sprocket was loose.
Car was towed up to shop
- When analyzed the motor mounts had once again become loose (Last time this happened was 11-02 at Barnesville)
- Bearing carriers also appeared to have shifted. Bearings were tapped back into correct location
- We added 2 steel bars connecting left and right carriers to prevent above
- Sprocket bolts were loctited and will be allowed to set for 24 hours
- New Master link installed

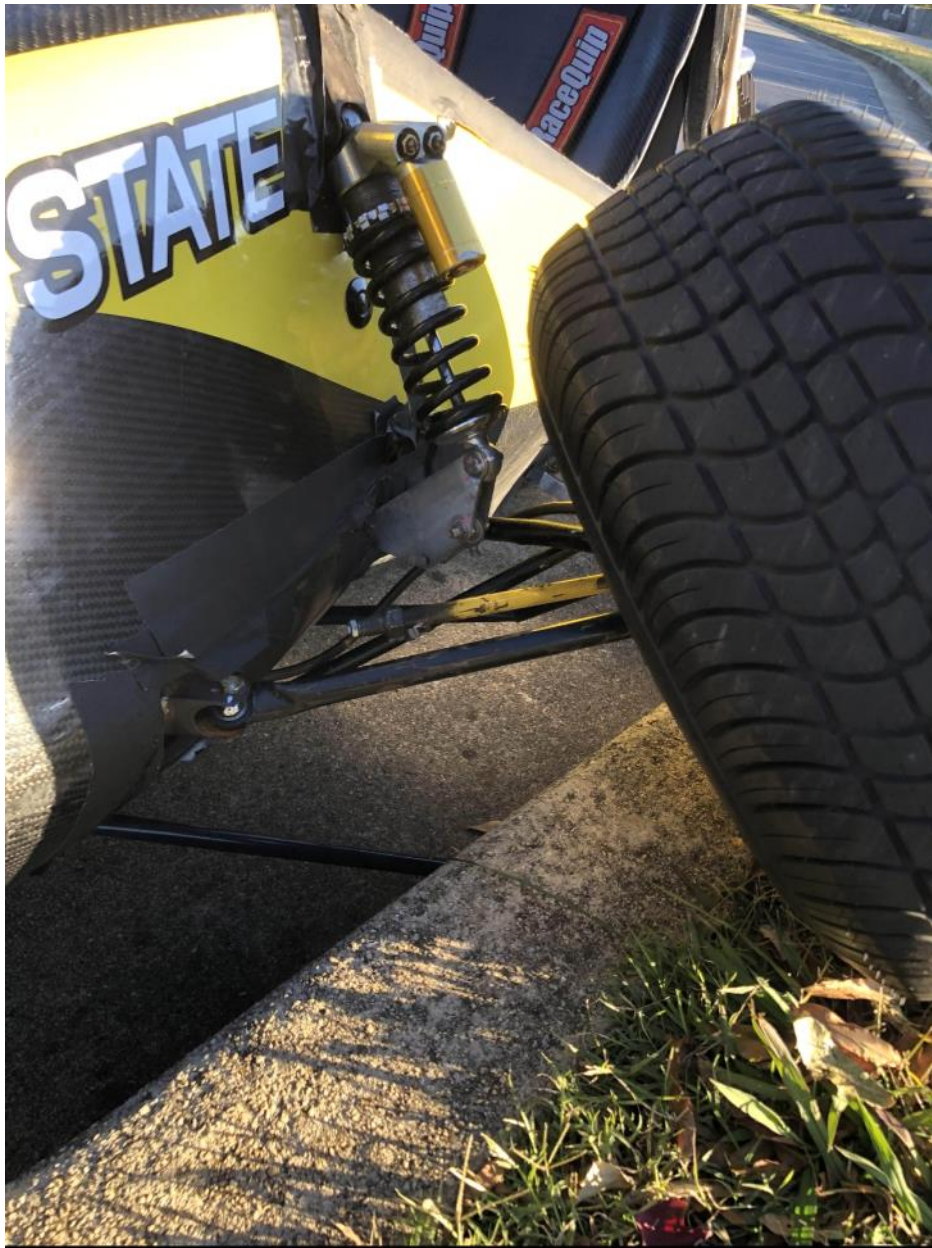
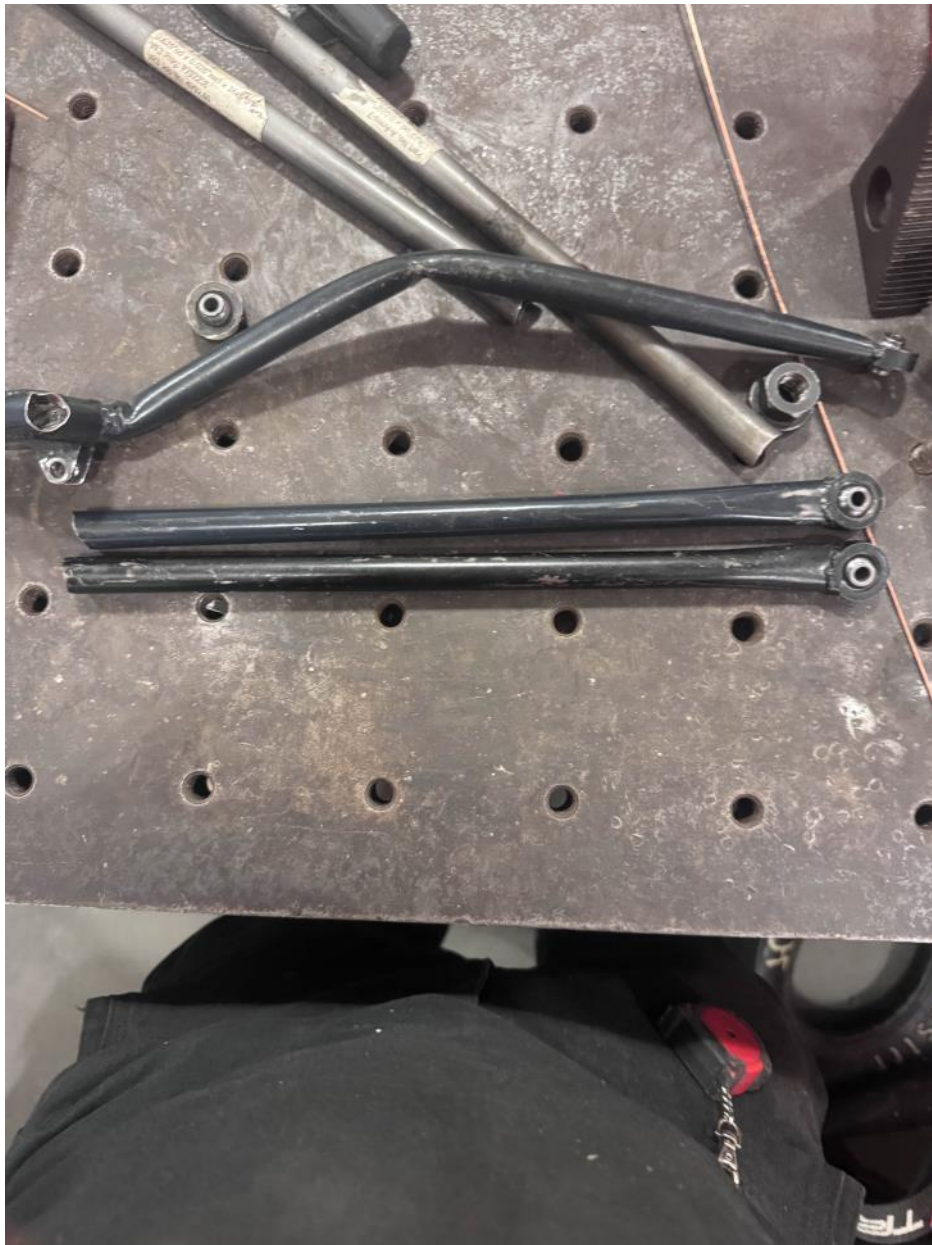
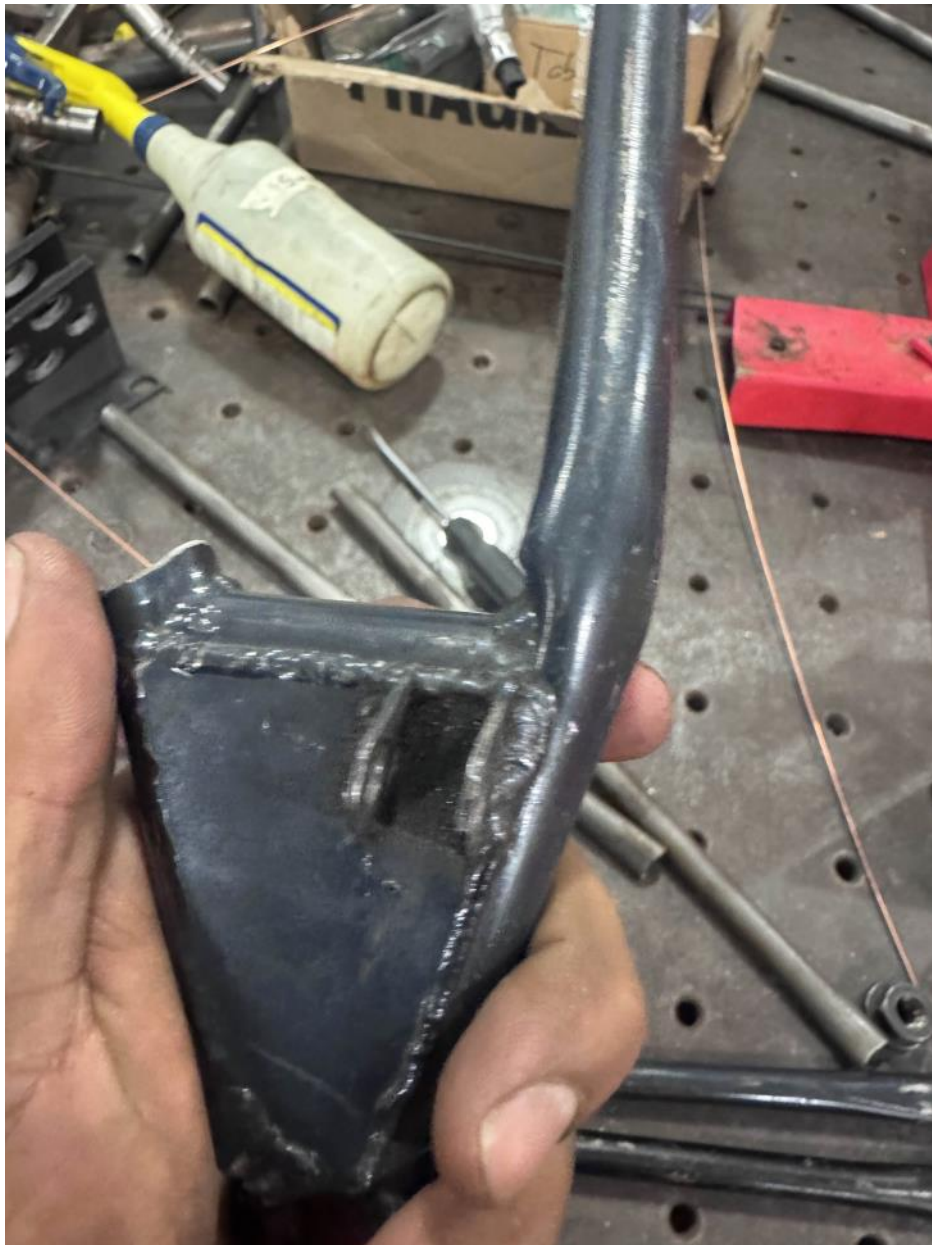
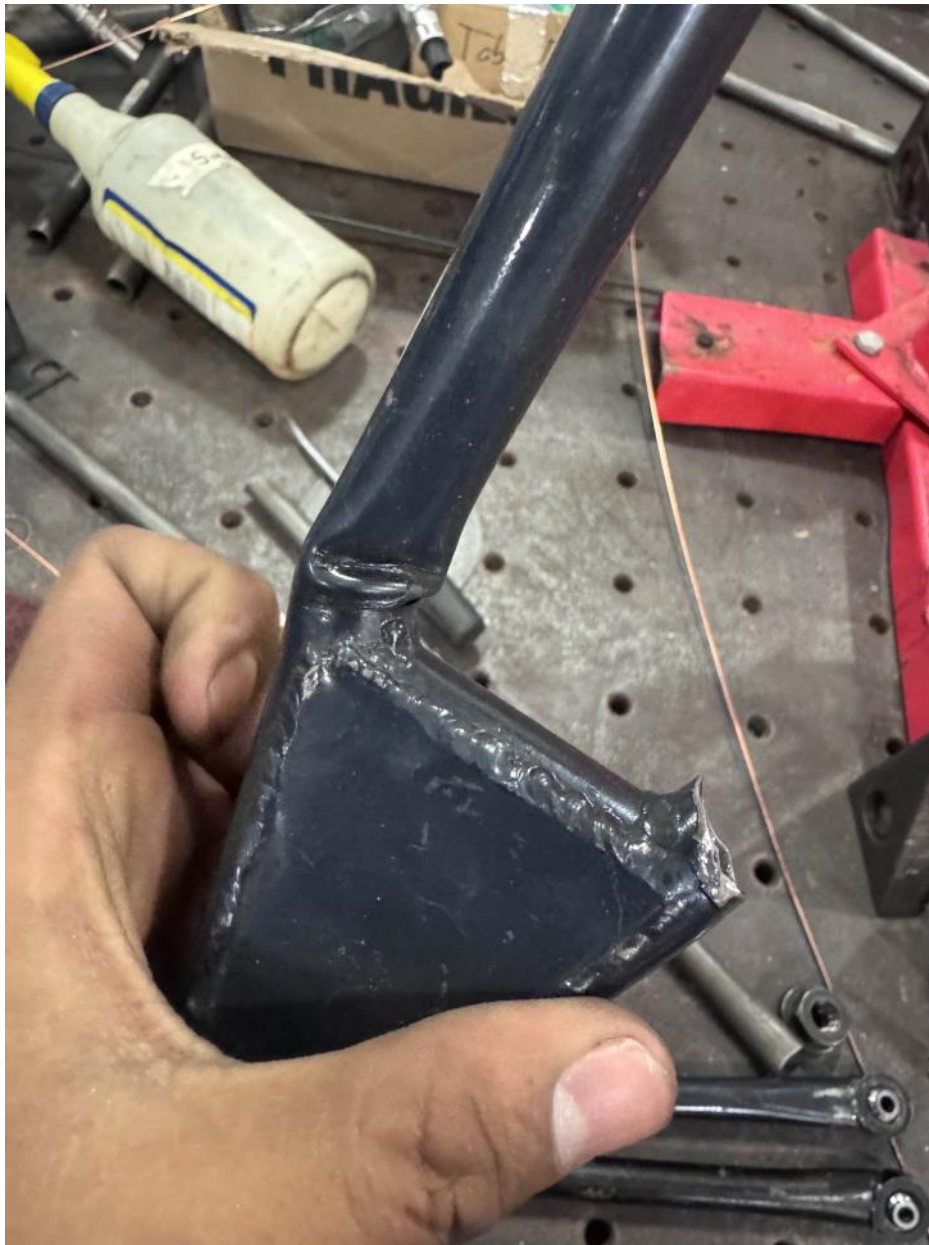
-Car Hit Curb

Driver states foot fell off brake pedal and knee got caught up, was unable to find brakes and ended up hitting the curb with front right tire

When front right suspension was removed the Rod Ends on push rods and toe rods were bent.

Top and Bottom control arms were damaged as seen above

Top Control Arm Replaced & New Bottom Control Arm

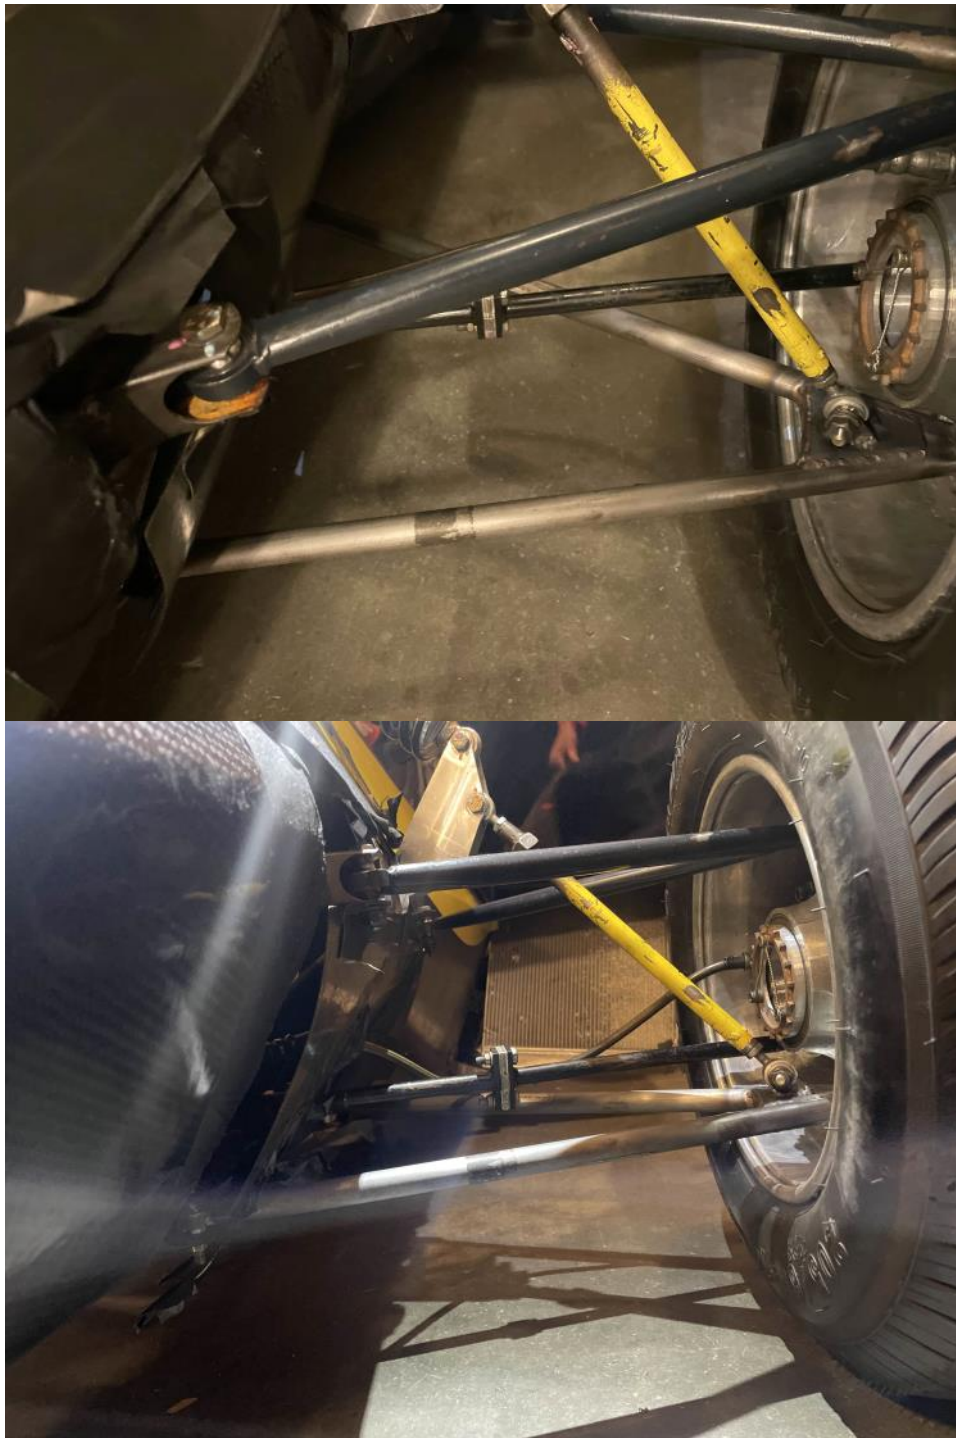
Bottom control arm was replaced with a new made control arm. The stock was from the 22' car and cups and sphericals were from the previously damaged control arm
