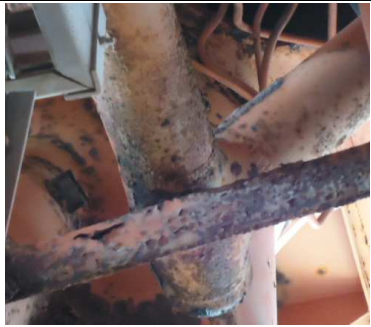
Item	Process Flow		Anomaly Description	Recommendations	Priority	PHOTO
1	QAY-7 WELL HEADS FLOW LINES	OIL PRODUCTION HEADERS	1. Severe crevice corrosion evident between piping and u bolt clamp. 2. Severe corrosion and coating failure was evident on the piping , welds and associated fittings downstream of SSV 7A	Section replacement recommended (approx 24').	P3

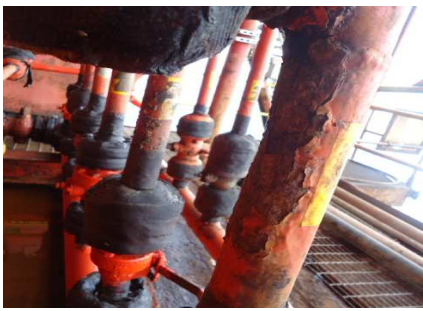
3	QAY 7 WELL HEAD	400 GAS LIFT HEADER	1. Severe corrosion and coating failure evident on the piping, welds and associated fittings. 2. Severe localized corrosion evident on the U clamp and associated piping support.	Section replacement recommended (approx 10').	P3

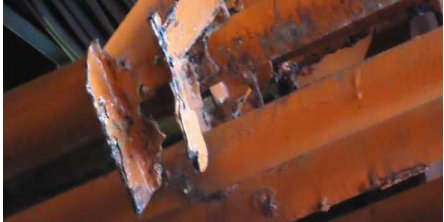
4	QAY 13 WELL HEAD	400 GAS LIFT HEADER	Moderate corrosion and coating failure was evident on the piping,weld and associated fittings.	Consider composite wrap (approx 10').	P2

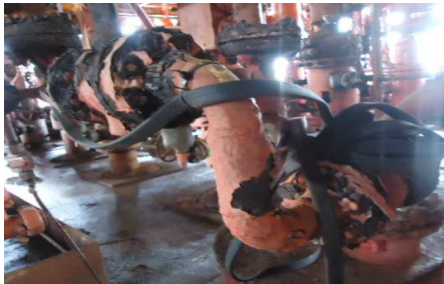
5	PBH-9640 DISCHARGE	ATMOS	Severe corrosion and coating failure on valves,fittings and valve handle associated nuts and bolts.	Replace valves,fittings and valve handle associated nuts and bolts	P2

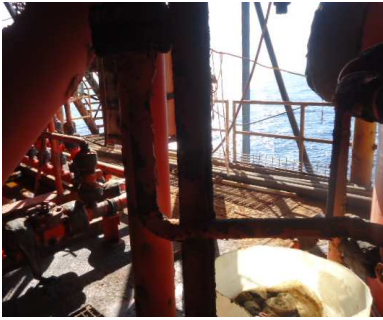
6	LIQUID TO 16"X8" HEADER	V-300 GAS SCRUBBER	Severe corrosion and coating failure on valves,fittings and valve handle associated nuts and bolts.	Replace valves,fittings and valve handle associated nuts and bolts	P2
