Report of the mechanical evaluation of LT428

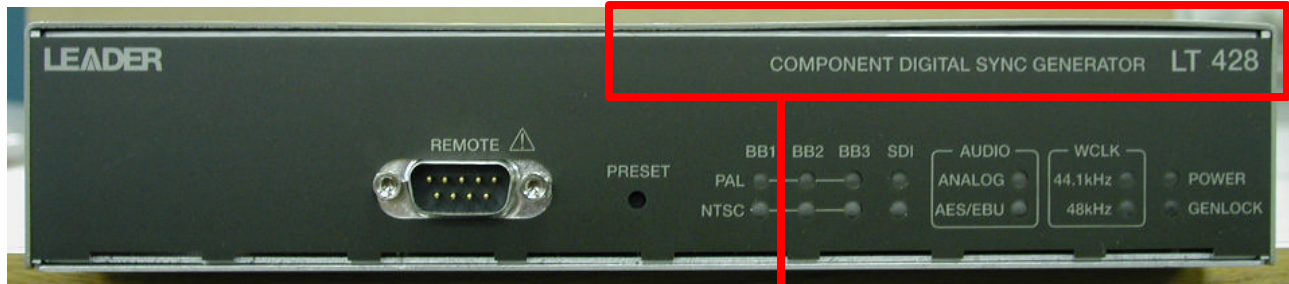
Photo 1: Front panel

1. A gap between front panel and upper cover

As shown on the attached photos, there is a gap between upper portion of the front panel and Upper cover of the case.

As it is the face of the LT428, do not you think it looks cheaper?

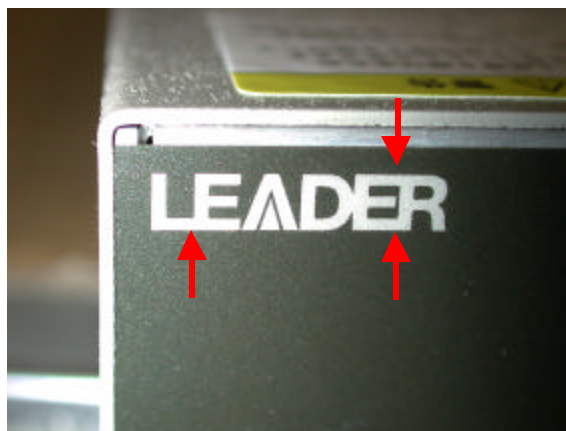
Photo 3: Leader logo

The Leader logo on the front panel is not proper.

As shown on the attached photo, between L and E also E and R are touched. This should be separated and please see that our original logo is separated and the logo on an application SW from you is fine.
