**MARUTI  
SUZUKI**

SL No	CH-ALK413D-25/2016
Date	8.11.2016
Page	1 / 2

**CASE STUDY: All or any one gear shifting hard**

<b>MODEL:</b>	Vitara Brezza (D)	<b>MILEAGE</b>	4753 kms	<b>SYSTEM:</b>	Transmission
<b>Other Models</b>	Ciaz (D & P), Baleno (D), S Cross 1.3, Ertiga (P&D), New Swift (P & D).

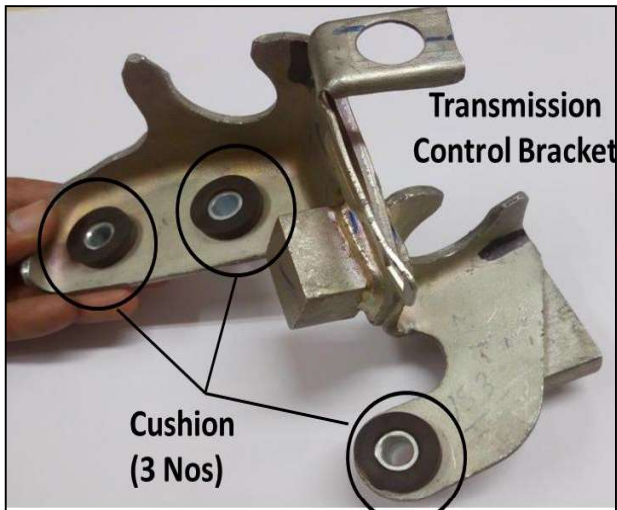
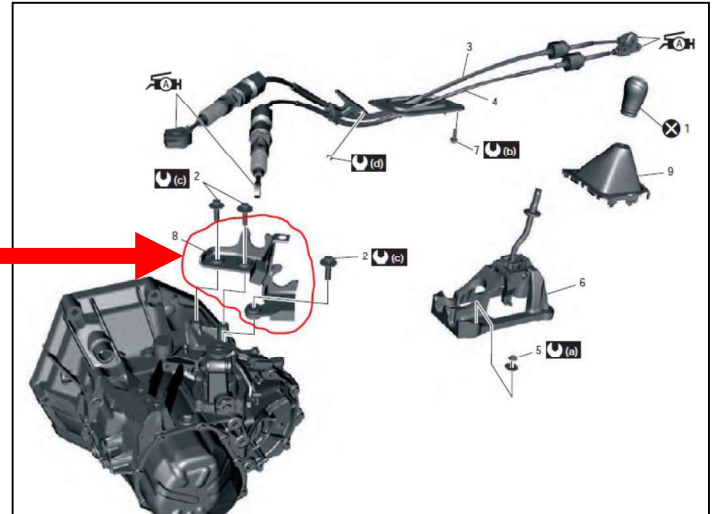
**Cushion. control cable bracket**

Gear shift and select cables are mounted on control cable bracket from transmission side. For control cable bracket mounting, there are 3 holes. Cushion rubber bushes are provided in these 3 holes to keep the bracket fixed in its place and to dampen the movement. Cushion rubber bush once worn out leads to excessive play in control cable bracket which can result to any of the following problems:

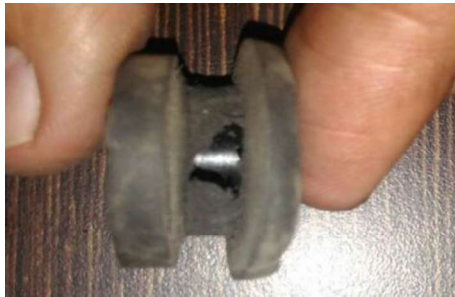
**NG Cushion**

PROBLEM	ROOT CAUSE	ACTION FOR RESOLUTION
Customer reported for 3 <sup>rd</sup> gear shifting hard.	Rubber cushion of control cable bracket found cut causing excessive play in control bracket, this lead to hard gear shifting problem.	Rubber cushion of control cable bracket replaced and problem was resolved.

Check Point	Observation/ Condition	Conclusion
Check gear cable for any damage / wear	No damage or abnormality observed	Problem may relate to cable mounting / Brackets
Check transmission control cable bracket for bend / distortion / Looseness	T/M control cable bracket found loose, which was leading to the gear shifting hard problem.	Check condition of T/M control cable bracket.
Check transmission control cable bracket cushion rubber for wear	One cushion rubber of transmission control cable bracket found cut due to which cable was loose.	Rubber cushion of control cable bracket replaced and issue was resolved

- Rubber Cushion (28393M79M00) of control cable bracket replaced and issue was resolved.
- Road test taken and all gears were engaging normally.
