## CASE STUDY: MIL glowing while driving the vehicle (DTC P0115)

<b>MODEL:</b>	S Cross 1.6	<b>MILEAGE:</b>	129883	<b>SYSTEM:</b>	Engine
---------------	-------------	-----------------	--------	----------------	--------

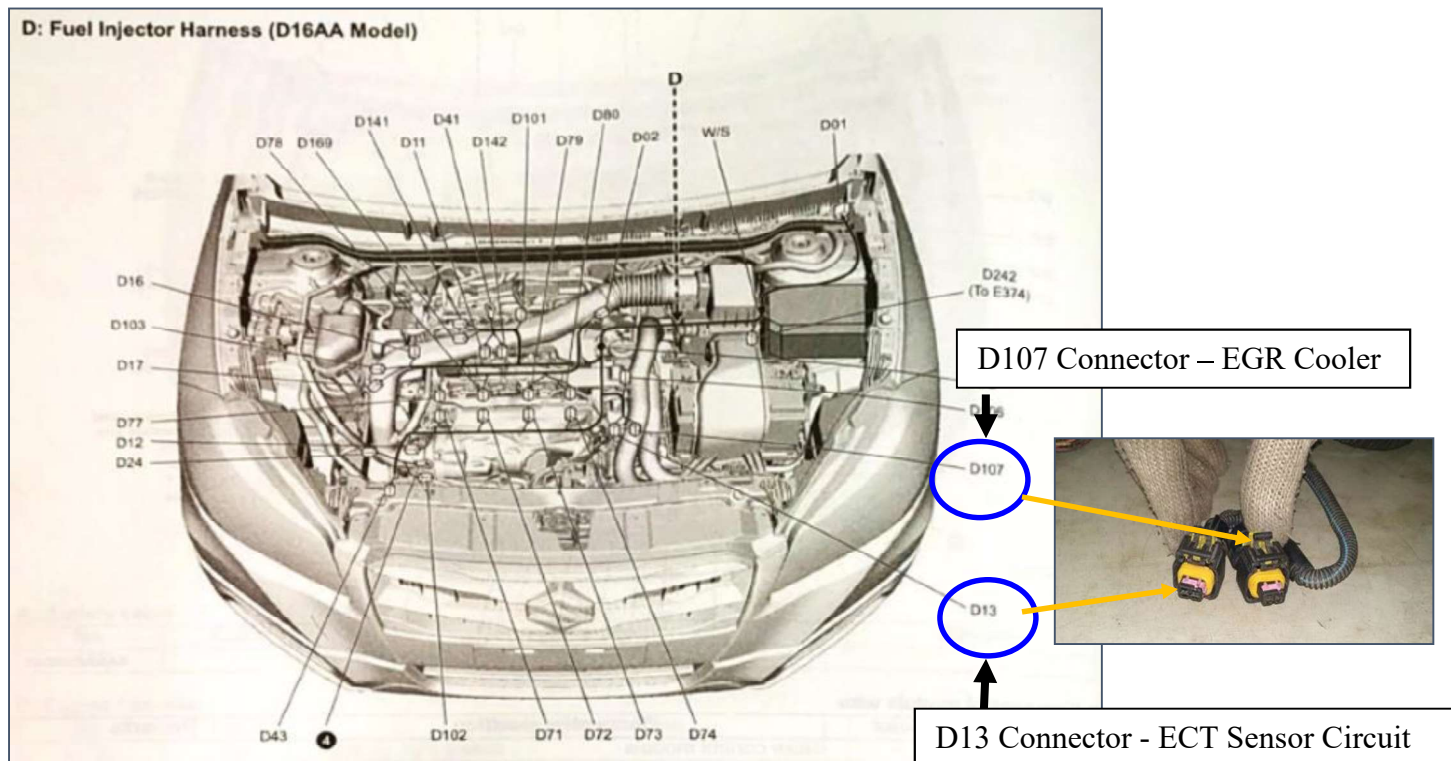
- DTC P0015 (Engine Coolant Temperature Sensor 1 Circuit) was checked as per service manual.
- During inspection, it was observed that the connectors of ECT sensor and EGR Cooler circuit were interchanged during replacement of Fuel injector harness.
- Both these connectors were similar in size and appearance ( Refer photograph below)

Due to similar appearance of connectors, the wiring connections of ECT sensor and EGR Cooler were incorrectly fitted during replacement of fuel injector harness at workshop. Due to this, the MIL was glowing during road test by workshop.

Service manual was referred for checking the correct wire connections, connector's position was restored and vehicle was road tested for 30 Kms and problem was found to be resolved.
