Implementation – Post-Trip Report

Community:	Ait Bayoud, Bizdad
Country:	Morocco
Chapter:	Columbia University
Submittal Date:	
Dates Traveled:	December 30, 2016 - January 14, 2017
Scope of Implementation (100 words):	The following items were accomplished during this trip: <ol style="list-style-type: none">1. Pumped the well continuously for 5 hours to develop it and take water samples2. Tested portions of the pipeline for leaks3. Collected data on geological formations and water quality

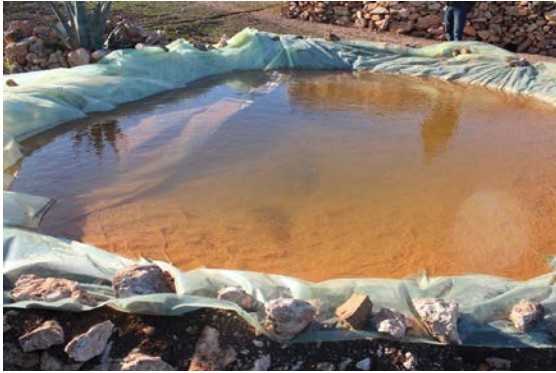
One of the ponds set up to collect water pumped from the well. Plastic tarps were put down in basins and secured by rocks.
2

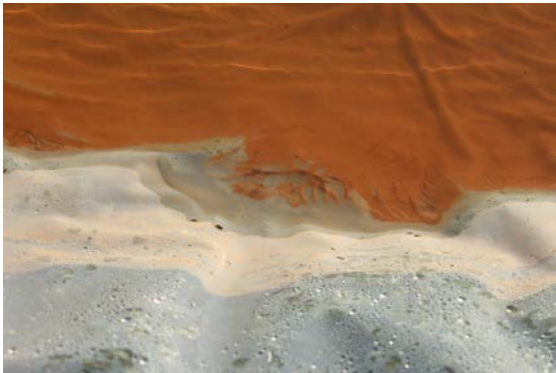
The fine sediment in the pools after a few hours of settlement.

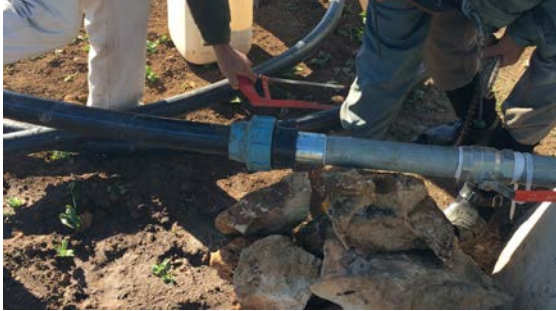
<p>Connection between pipe extending from the well to the tubing used to transport water to the ponds</p>
5

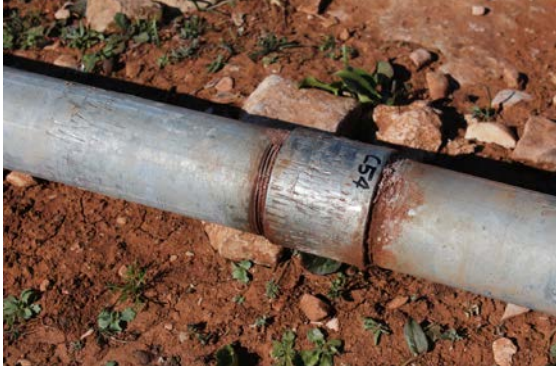
<p>Pipe connection with minor leaking</p>

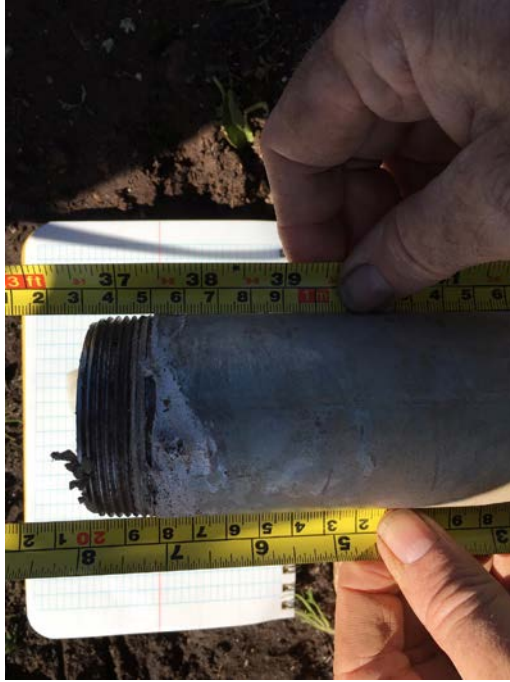
Tapered pipe end.

After detaching the water truck hose the threading on the pipes were inspected. Inspection revealed that the threads were tapered. As the couples were not, a significant portion of the threading did not contact the couple and was thus ineffective for seal creation. Furthermore, it was observed that the pipe walls were particularly thin, so much so that the grooves created by the threading were visible on the interior surface of the pipes.

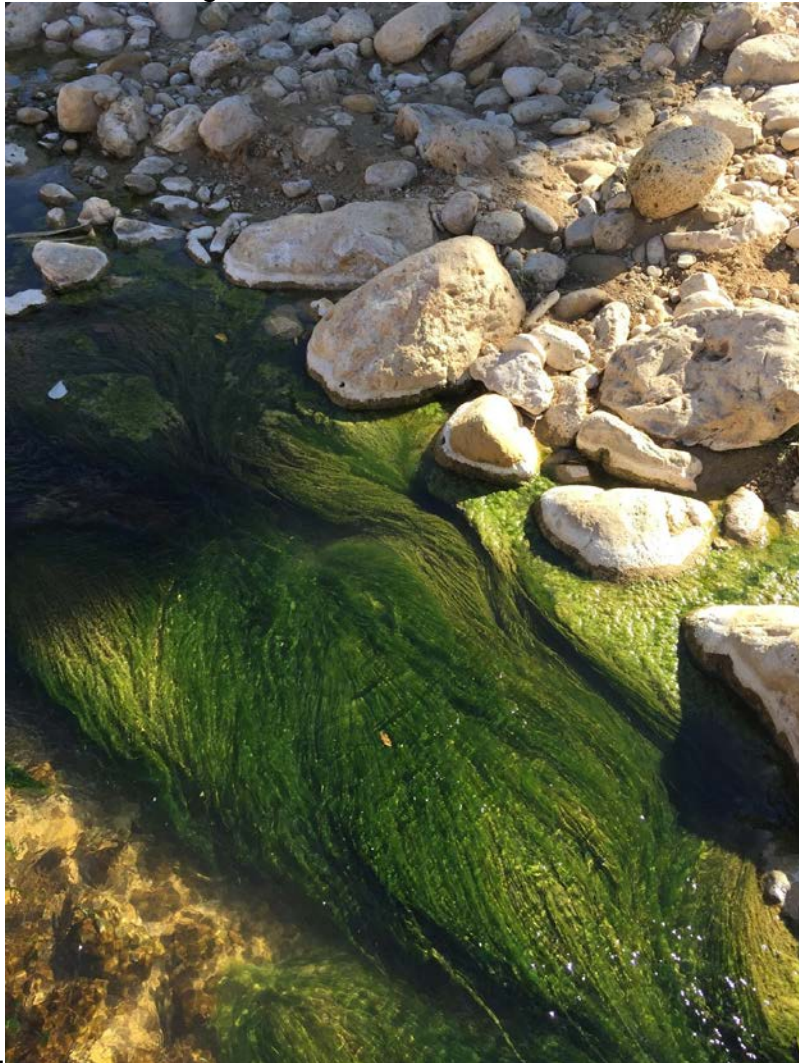
A significantly greater amount of algae was found in the river downstream of the spring

than near the bridge.

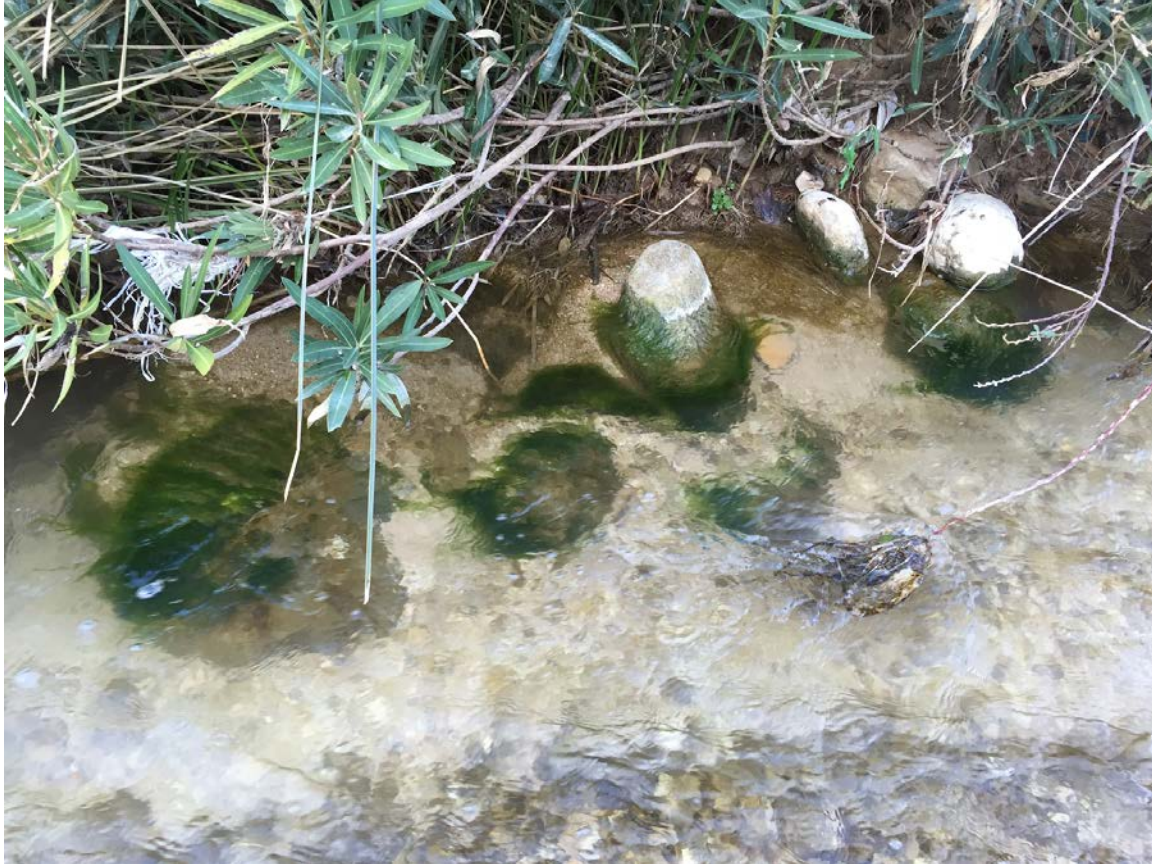
Algae a few feet downstream of the washing point at location R4.

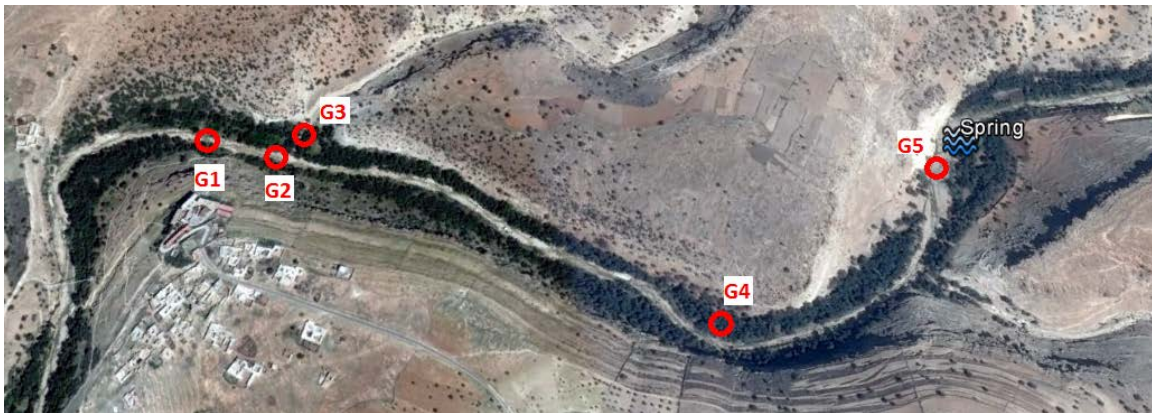
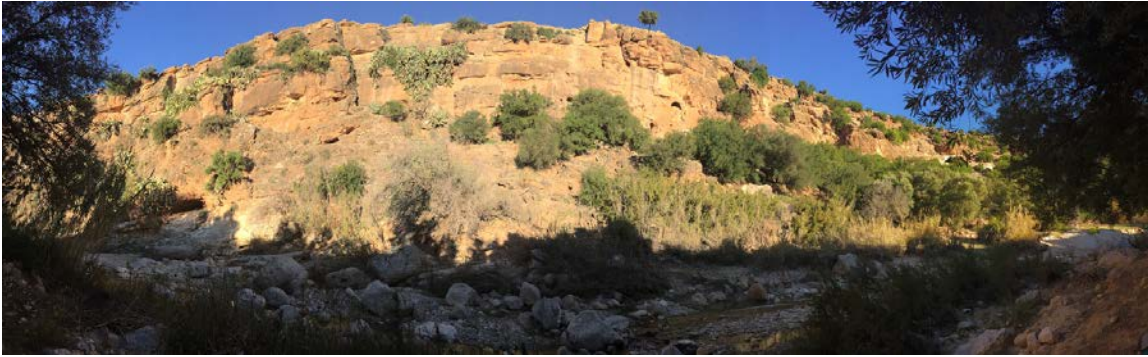
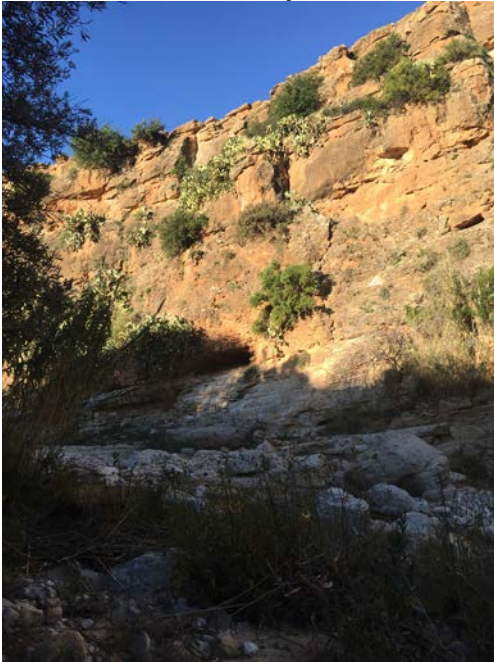
Location G1:

Note: The panoramic image shown above distorts the height of the bank. The top of the formation was mostly level as shown more clearly below.

- Right bank descending
- Thinly bedded white rock sloped about 30 degrees NE
- Layer of 23-30 ft thick weathered, highly-jointed (vertical) dark grey rock
- 50 ft layer of redder rock, bedding 2-6 ft, jointing 2-5 ft, some solutioning (little holes) in lower half
- Strong vegetation change between the grey and red rock layers
- Left bank much lower than right bank

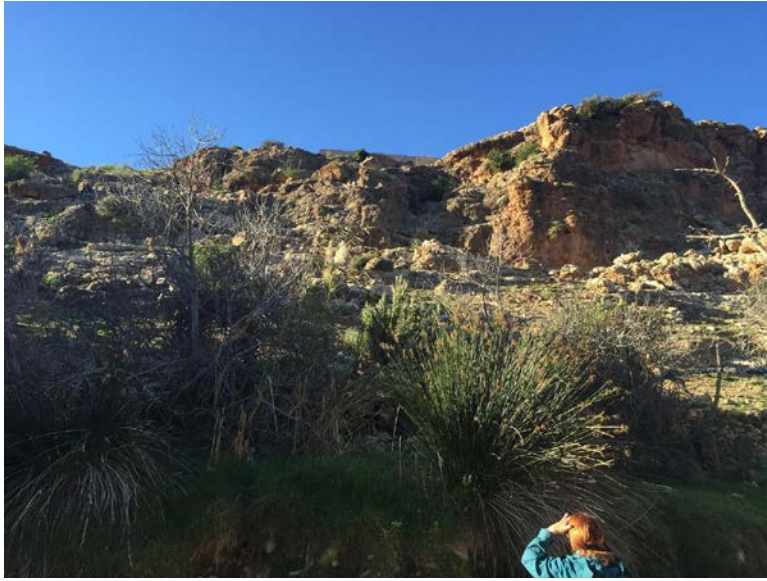
Location G2:

- Left bank descending
- heavily weathered, flocky bank

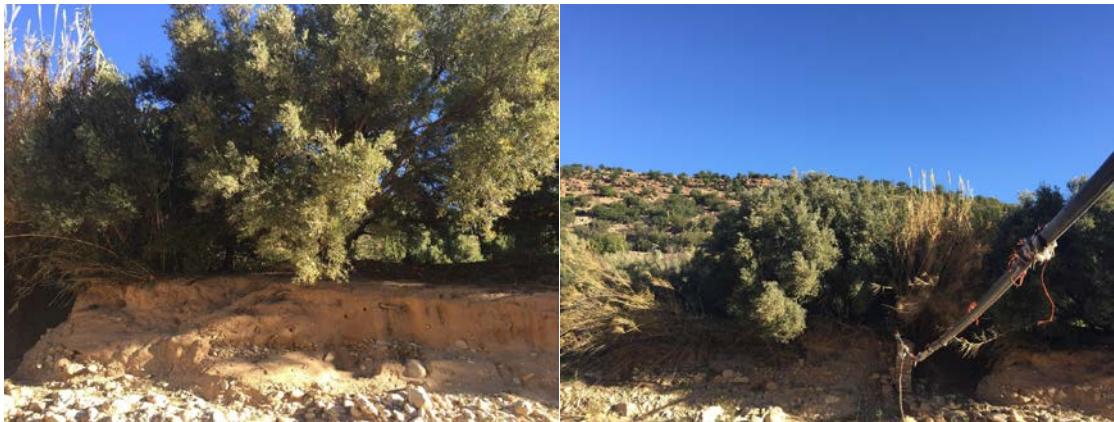
- Right bank ascending (opposite last photo)
- Very low bank with a height around 8 ft
- Silty clay interbedded with cobbles at 3 ft intervals

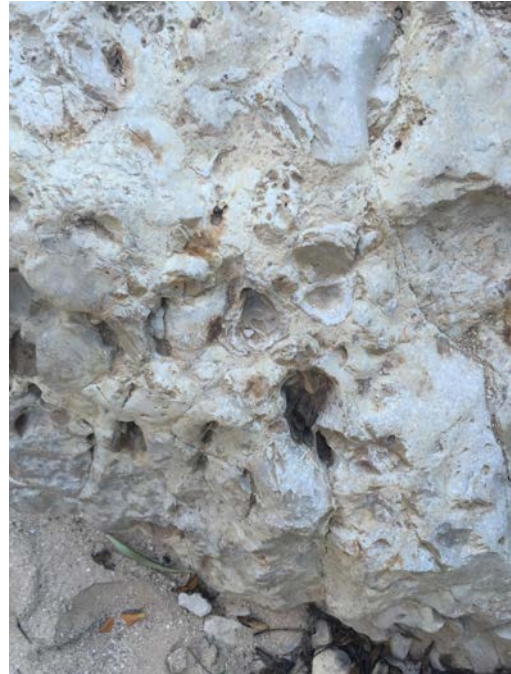
Fossilization of tube worms.

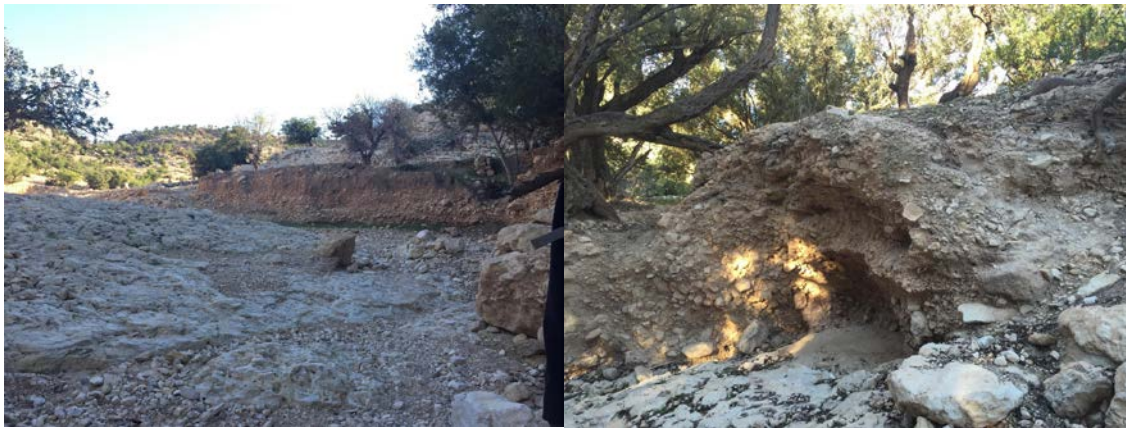
The white rock seen along the river and near the well was also visible on this path up from the river.

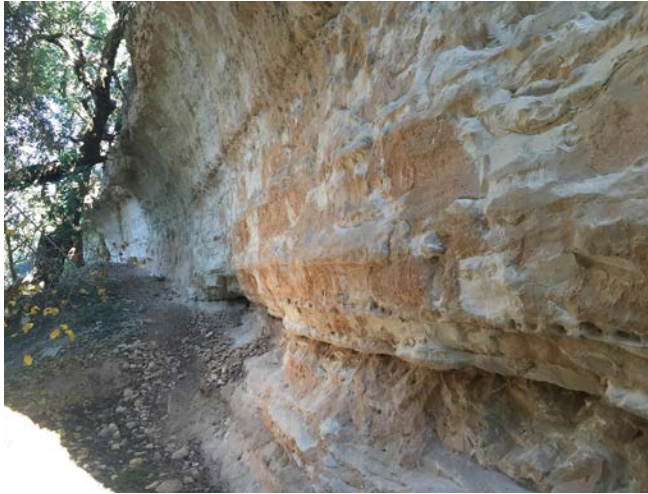
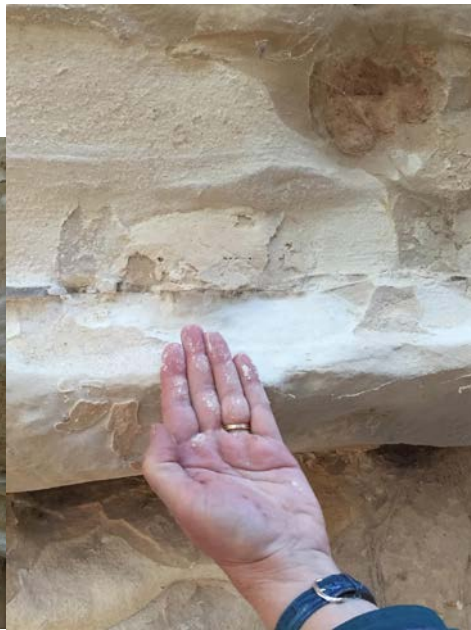
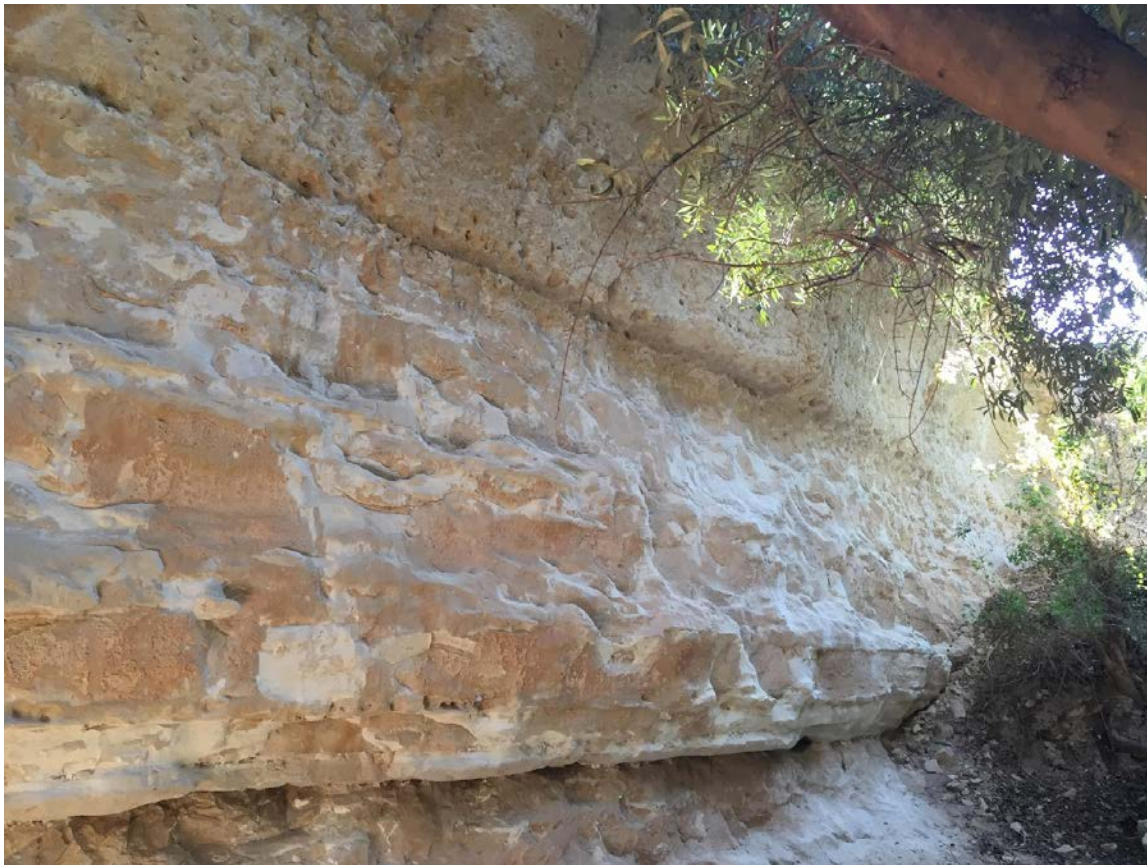
Location G4:

- Solution layer around 10 ft above bank full flood plain
- Bank full flood plain about 12 ft above riverbed
- Elevation at chalk layer 614m

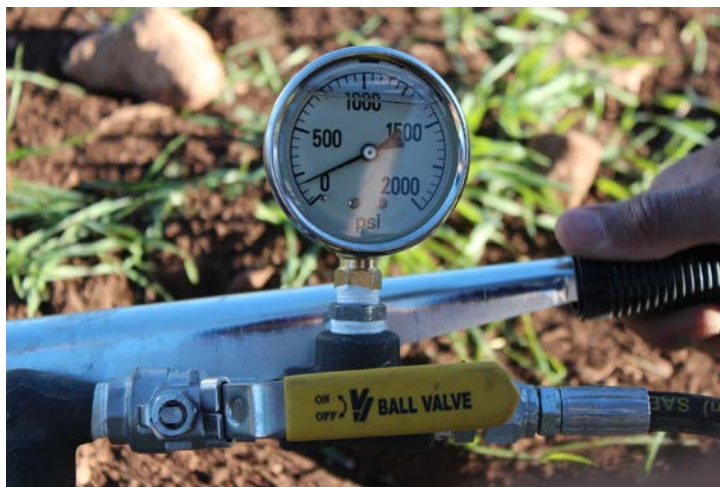
Two pipes connected with a couple that had been put together in the summer were detached as a group from the pipeline. This was capped at one end, filled with water, and pressurized. The system quickly reached ~150psi, but leaks developed at the two ends where the additional parts had been installed. In order to hold at this pressure the pump was continually pumped for 10 seconds. Following this the pressure was increased to 200psi and released. No leaks were detected at the couple connection.

Pressure gauge reading of 200psi at the conclusion of the small scale pressure test.

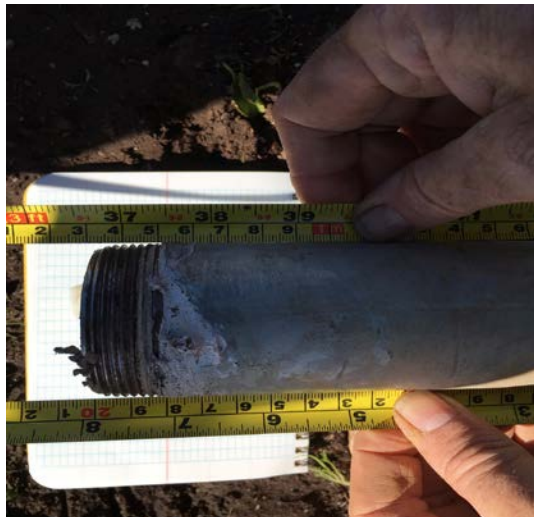
Visible tapering of threads.

The current pipe connection method makes maintenance or replacement of a pipe in the middle of the pipeline extremely difficult. Because all of the pipes are connected by threaded couplings, removing a pipe requires twisting the pipes connected with it. The current plan is to install unions every five pipes when fixing the leaking connections in order to facilitate twisting and enable the community to independently make repairs. Additionally, the program is reconsidering the possibility of converting to High Density Polyethylene piping (HDPE), which is readily used in the area for water transport. Initially HDPE was ruled out due to the requirement of the use of specific machinery to fuse pipes together. During the Winter 2017 trip, the team observed that HDPE tubing was used as water transport and even incorporated a 30ft length tube in the well test to fill pools for community use. The benefits of switching to HDPE are reductions in material cost, installation cost, water lost due to leakages, and installation times. At present, the team is pursuing one method of joining the pipes using plastic fittings. If the program and community decide to follow through with the switch from 2" galvanized steel to 2" HDPE the two existing pipelines would be bridged with the HDPE.
