STM32F412xE and STM32F412xG device errata

This document applies to the part numbers of STM32F412xE and STM32F412xG devices and the device variants as stated in this page.

It gives a summary and a description of the device errata, with respect to the device datasheet and reference manual RM0402.

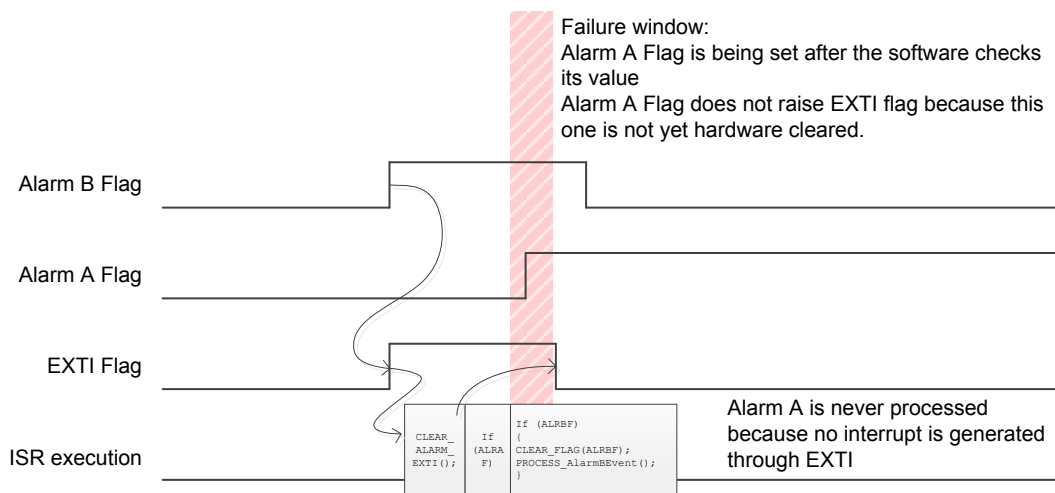
Figure 1. Masked RTC interrupt

The following code example and figure illustrate the failure mechanism: The Alarm A event is lost (fails to generate interrupt) as it occurs in the failure window, that is, after checking the Alarm A event flag but before the effective clear of the EXTI interrupt flag by hardware. The effective clear of the EXTI interrupt flag is delayed with respect to the software instruction to clear it.
