MPC8245/MPC8241

Integrated Processor

Device Errata

This document details all known silicon errata for the MPC8245/MPC8241 and its derivatives. The MPC8245 and MPC8241 are PowerPC™ integrated microprocessors. [Table 1](#) provides a revision history for this chip errata document.

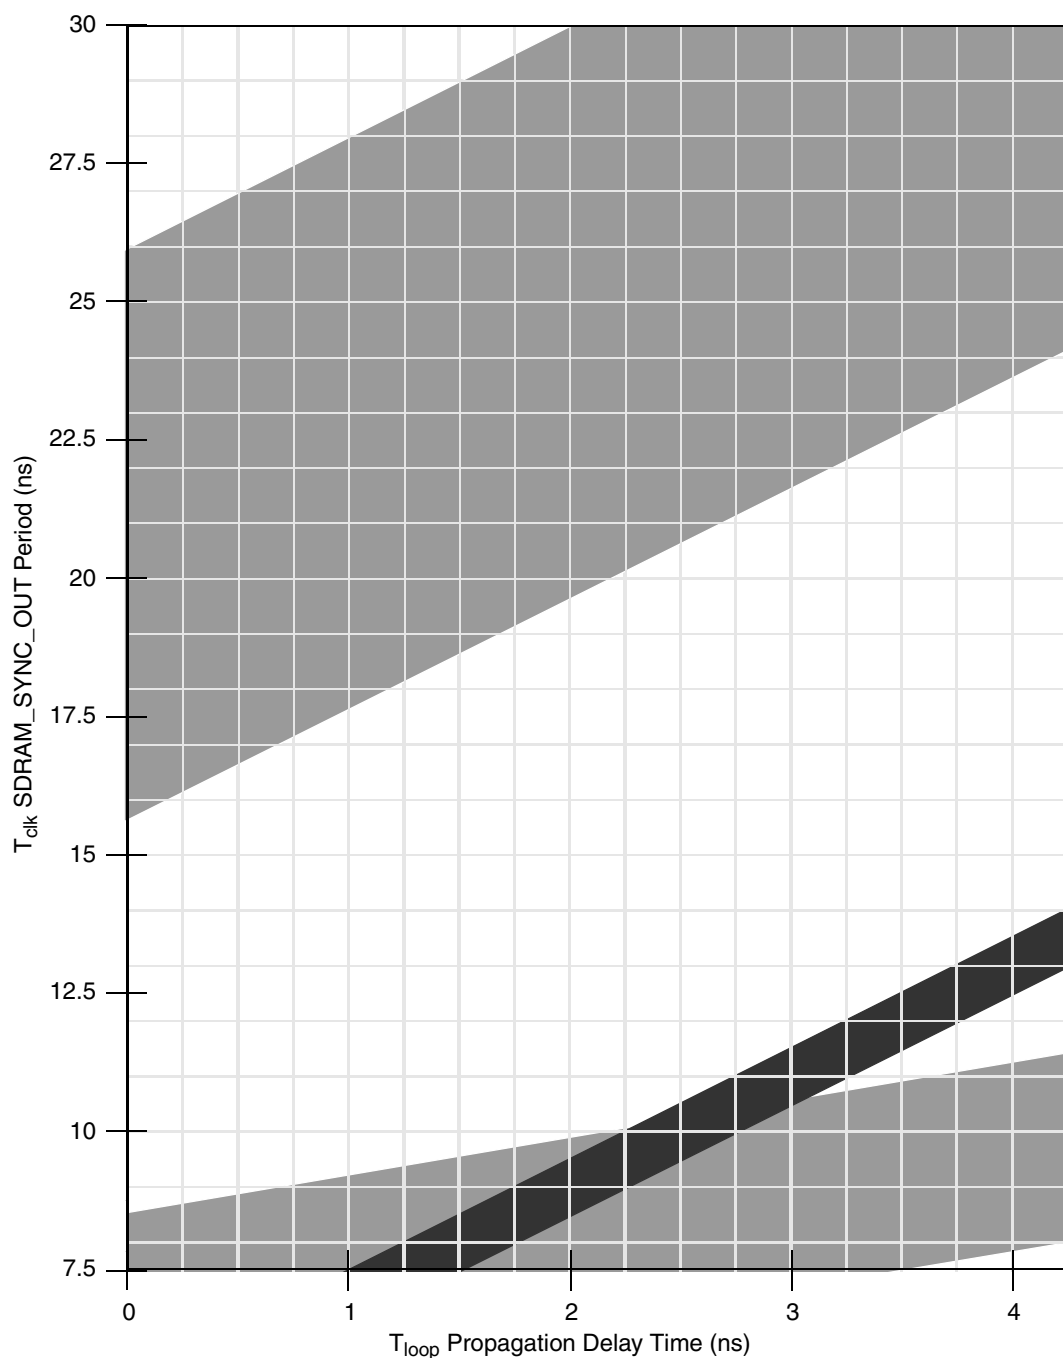
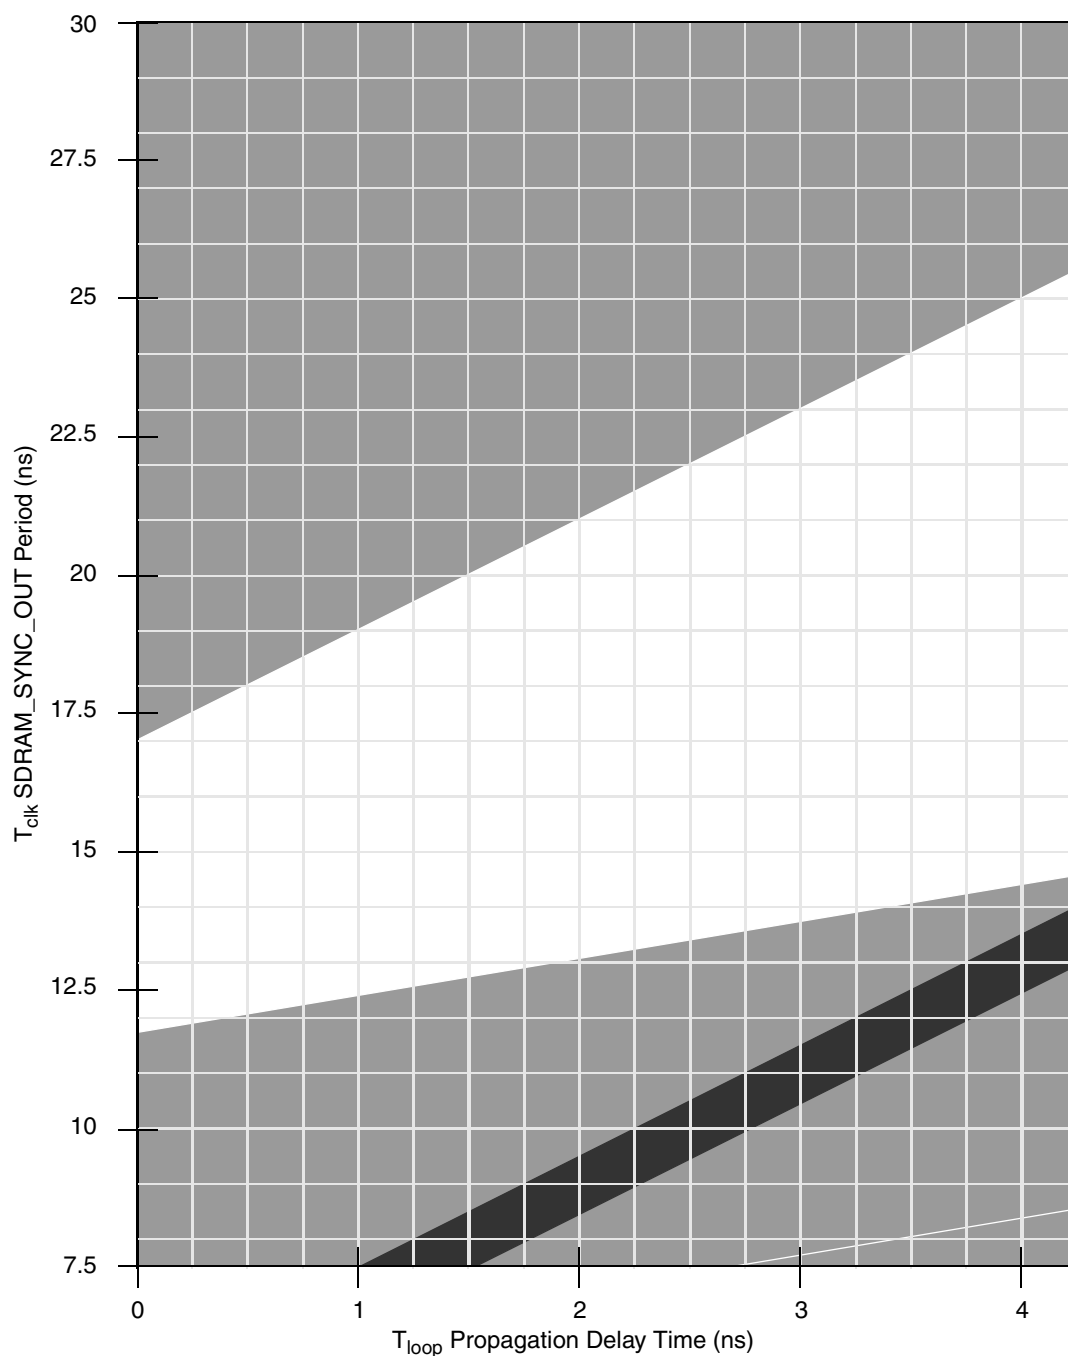
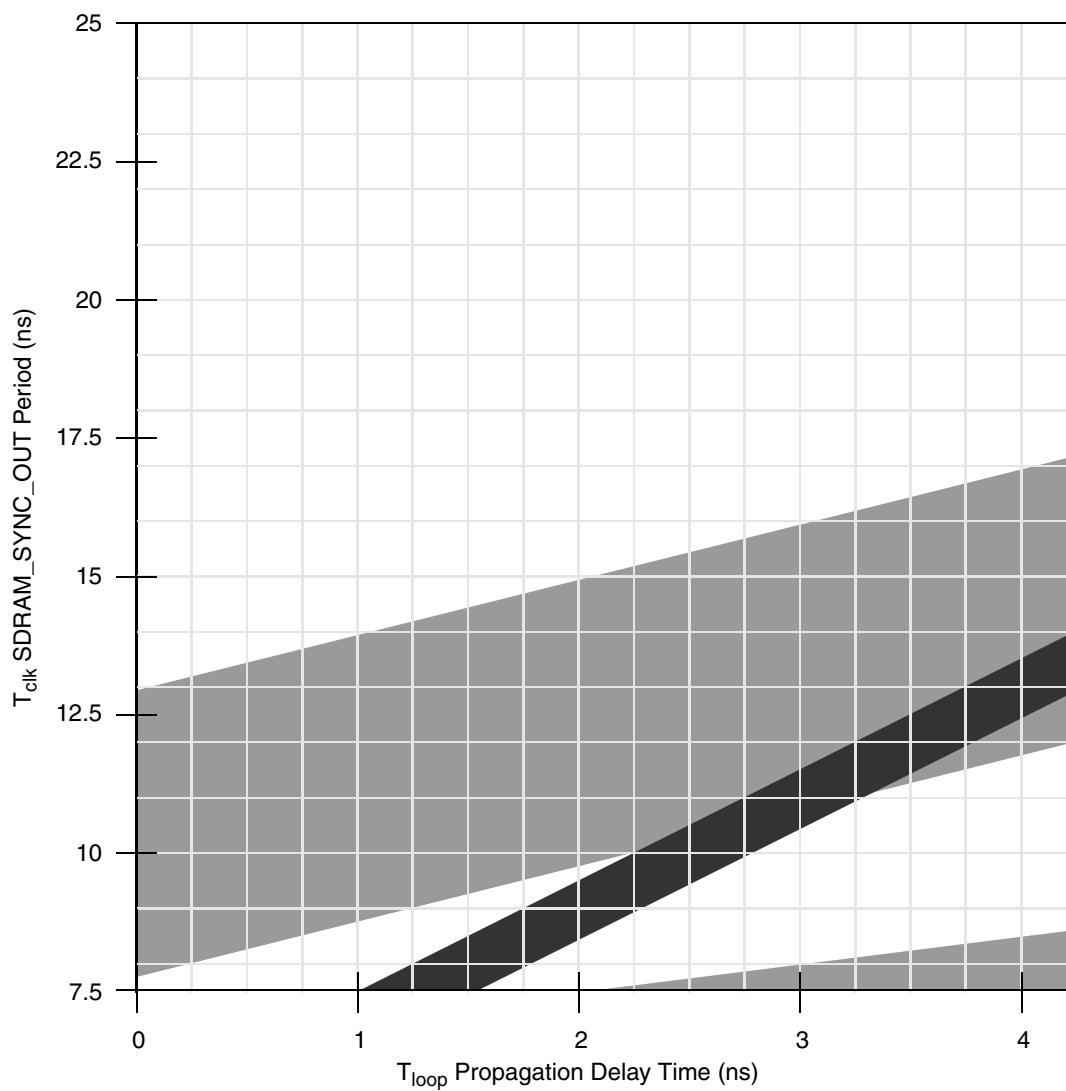
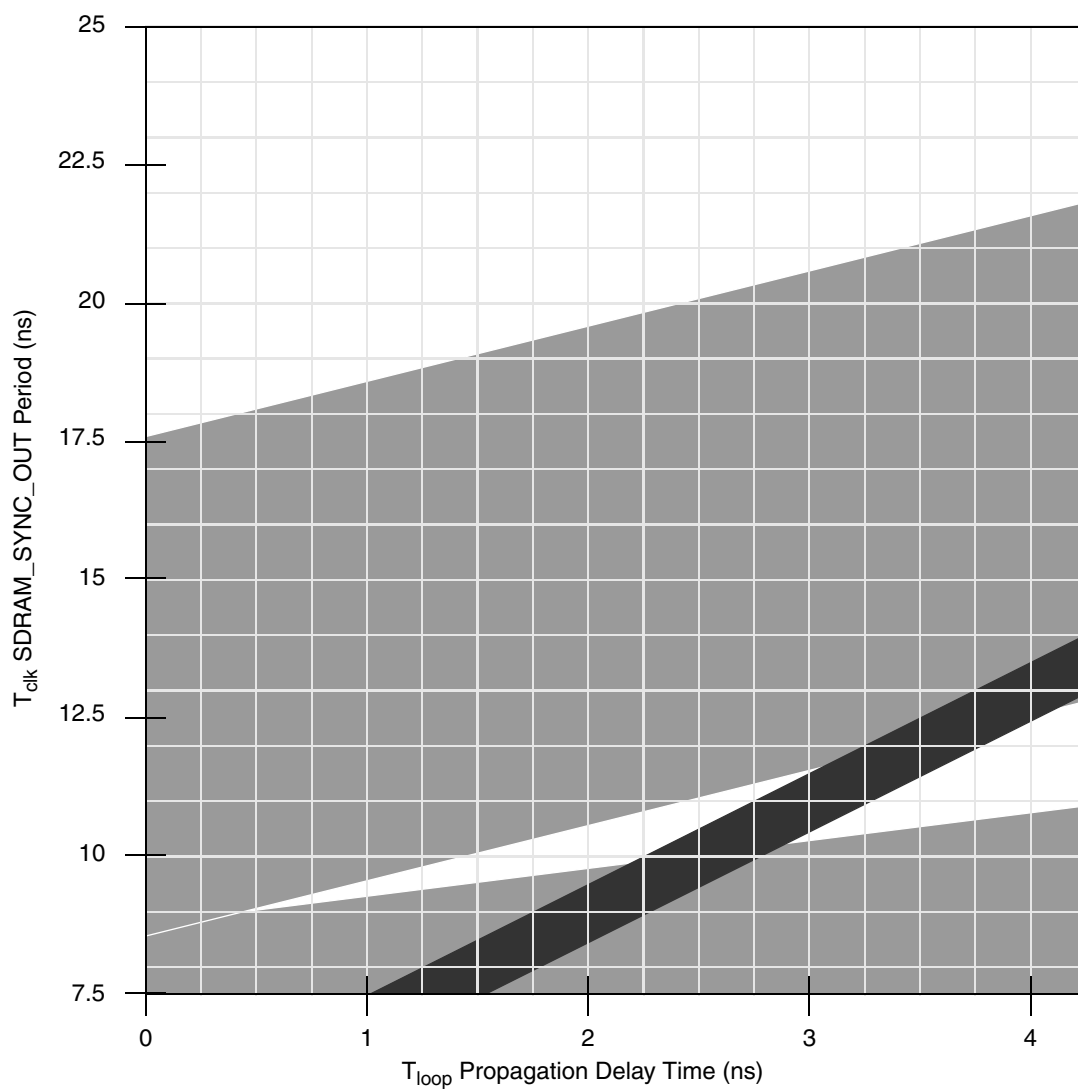
The memory interface DLL is sensitive to operating variables that consist of voltage, frequency, temperature, and processing. For a given frequency, an associated feedback loop length range does not function reliably because the DLL intermittently loses lock.

Board designs must avoid certain SDRAM_SYNC_OUT to SDRAM_SYNC_IN feedback loop lengths to prevent intermittent loss of DLL lock.

Using the charts shown in [Figure 1](#) through [Figure 4](#), find the clock speed of the memory interface for the design in question by finding the associated clock period in nanoseconds (ns) on the Y axis. Then use the black band associated with that frequency to index delay times in ns (X axis) that must be avoided when designing the feedback loop for the design. The grey bands indicate valid operating points for different DLL mode settings and represent where the DLL locks. (Do not use white spaces: the DLL does not lock in any non-grey areas.) The black band represents regions; if the DLL is locked in these regions it will be unstable. The width of the black and grey bands take into account temperature, voltage, and processing variations. For any given part, the actual failure region is more narrow than what is shown in [Figure 1](#) through [Figure 4](#). Consult the *MPC8245 Integrated Processor Hardware Specifications* or the *MPC8241 Integrated Processor Hardware Specifications* for more information on DLL locking and the settings. In addition, see Application Note AN2164, *MPC8245/MPC8241 Memory Clock Design Guidelines*.
