This errata sheet provides updated information on Stratix® devices. This document addresses known issues and includes methods to work around the issues.

Stratix Family Issues

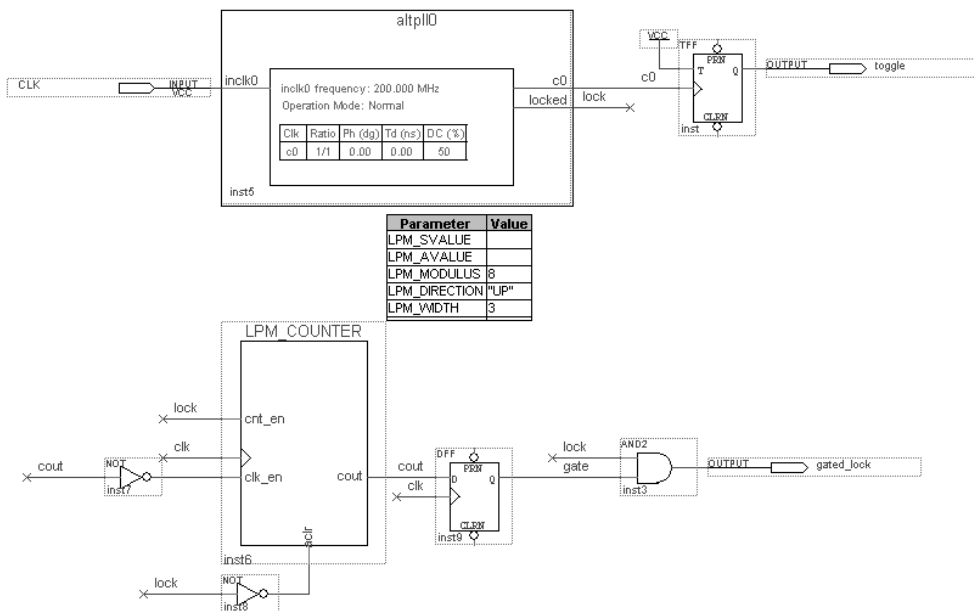
Figure 2. Gated Lock in Internal Logic Circuit

There is a run-through problem in the GLOCK counter that causes the counter to operate incorrectly. Support for the gated_lock circuitry was disabled in the Quartus II software version 2.1. Therefore, the gated_lock feature is unavailable in Stratix devices.

The work around for this problem is to gate the lock signal in internal logic. Altera recommends using a two-input AND gate to gate the lock signal with a counter. The number of bits in the counter (LPM_WIDTH) can be adjusted to control how many clock cycles before the gated_lock signal is released. The counter width in the reference design is currently 3. See [Figure 2](#).

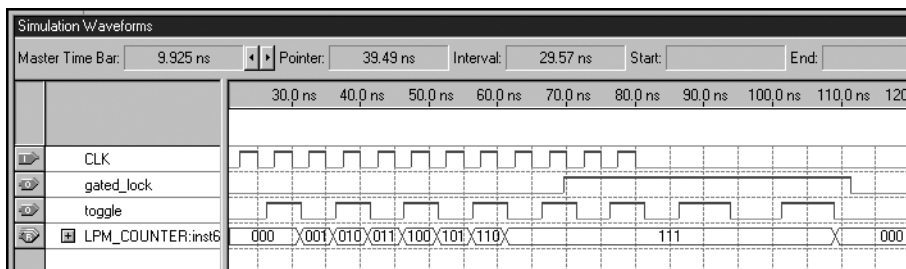
Figure 3. Gated Lock Signal Simulation Waveform

Figure 3 shows the simulation waveform of the gated lock signal. The gated_lock signal transitions high on the 10th clock cycle and is driven low after the PLL loses lock. The toggle signal frequency decreases as the V_{CO} frequency of the PLL begins to drift.
