# **TMS320DM816x DaVinci Digital Media Processors Revisions 2.0, 1.1, 1.0**

## **Silicon Errata**

Literature Number: SPRZ329B  
March 2011–Revised February 2012

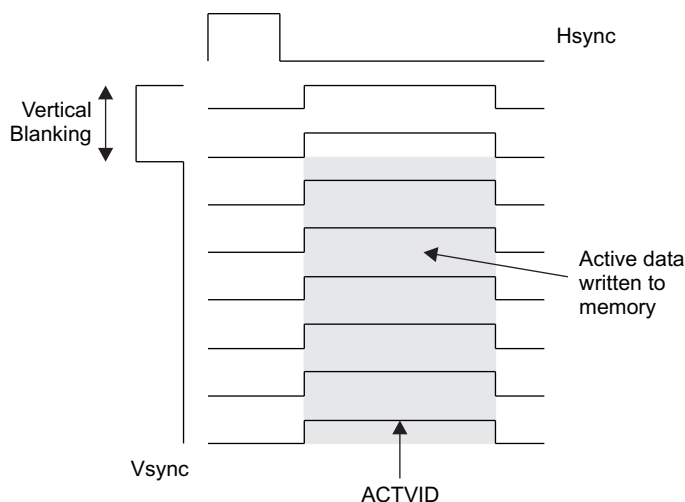
**Figure 3. ACTVID Signal Active for All Lines of Incoming Data**

**Details:** The VIP port supports a discrete sync capture mode where the ACTVID signal is used to determine the active region of the video and then the VPDMA writes this active video frame to memory. However, with some external video decoders, this mode does not work by default.

**Workaround:** The VIP parser requires that the ACTVID signal is active for all lines of the incoming data, including the vertical blanking region. The vertical blanking region, itself, is not written to memory by the VPDMA. [Figure 3](#) illustrates this.
