Revisions and Testing

The Board Is All Over the Place

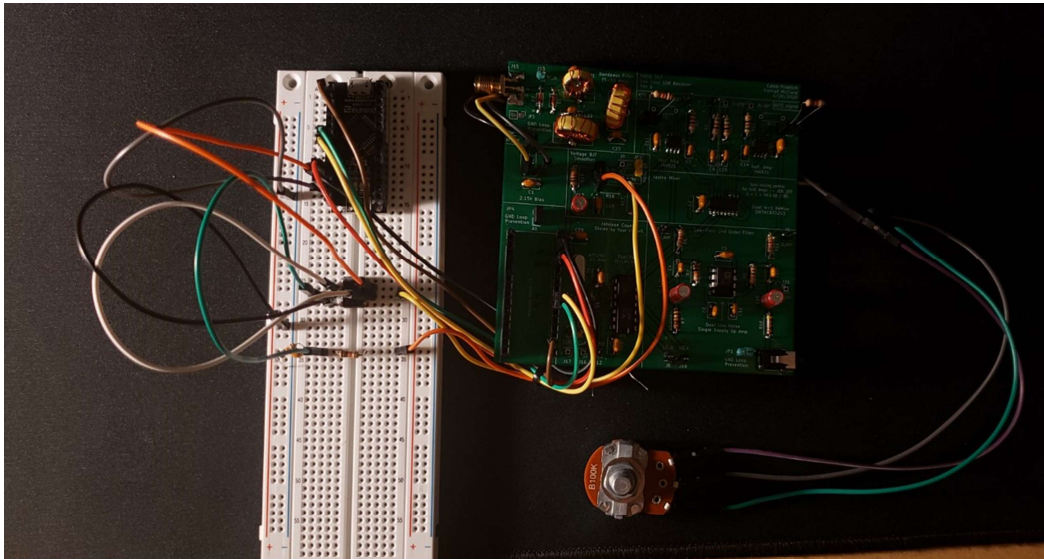
Figure 1 - Board prototype as is. Arduino and voltage buffer for setting GNDA are on the left. Potentiometer shown below for adjusting the input voltage offset.

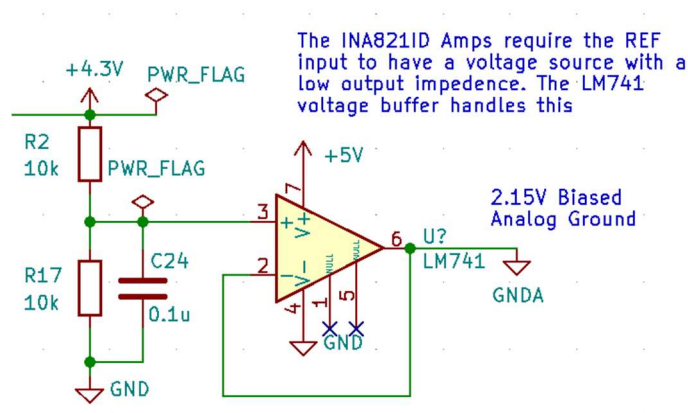
Caleb was nice enough to mail me one of his LM741 Op Amps to set up a voltage buffer with. It appears to correct the output impedance problem. It is now set up on the breadboard like so:

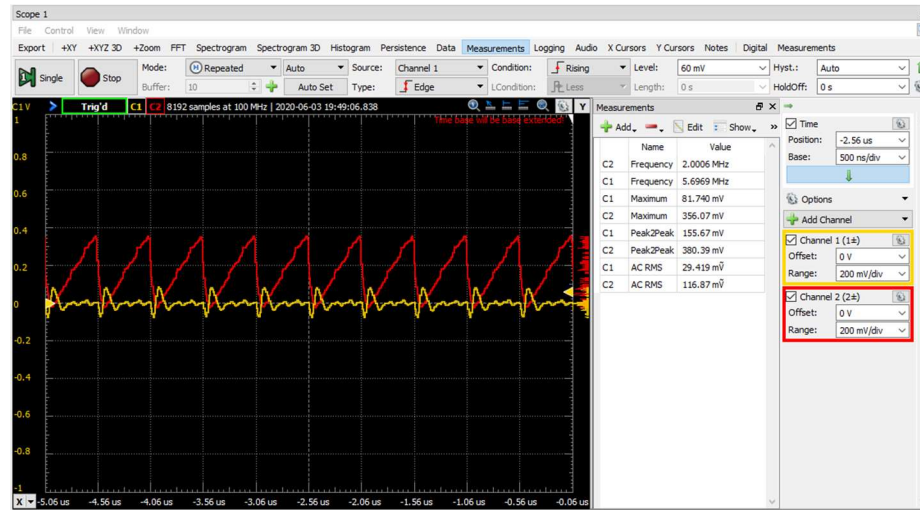
Figure 2 - Signals seen on either side of bandpass filter even when no signal was input on antenna
YELLOW = RF_IN Pin, RED = RF_OUT Pin.

After correcting the previous problems, I saw that, with no signal input on the antenna, the above noise appeared on either side of the bandpass filter. When putting a signal in, this noise would overpower it. The frequency of the signal was equal to that of my LO signals, so I determined it must have been coming from there somehow. At Dr. Frohne's suggestion, I dialed the clock generator back so that the LO signal would be at 3kHz so it would be easier to see the signal. Using the RF_OUT jumper pin, I put a 1V DC signal directly into the input of the MUX to observe the switching behavior. The results can be seen below

On the MUX, LO_I = S0 (low bit), LO_Q = S1 (high bit). If we look at the input and LO signals together, we can see that **the input signal is connected to ground at the 01 state of the MUX**. Visually observing the board, I found that the capacitor C14's legs were touching on the back side. After clipping them, the problem disappeared for both the low and high frequency cases.

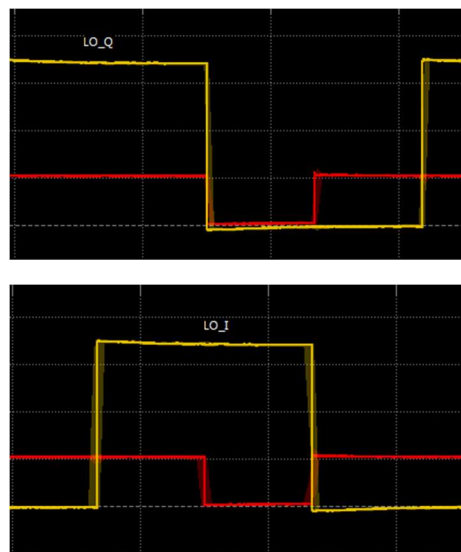
Figure 3 - RED = input signal at RF_OUT (1V DC), YELLOW = LO_I or LO_Q
