# In-service stress corrosion cracking of AISI 316L stainless steel in an H<sub>2</sub>S environment

**Article** in Corrosion Engineering Science and Technology · August 2014

S. T. Adair\* and P. A. Attwood

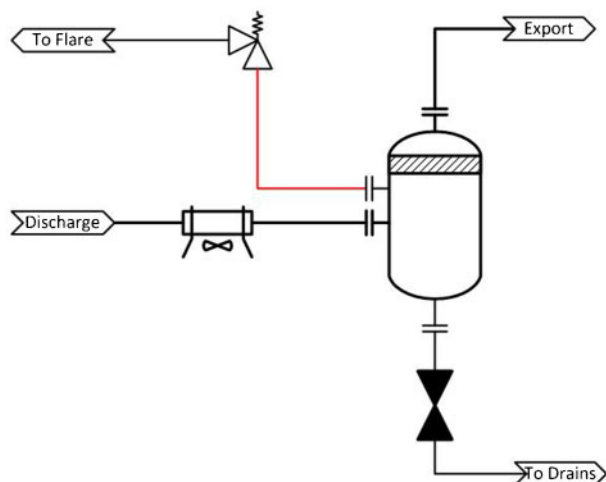
Over the course of two days, three leaks were reported in two upstream pressure safety valve flare tail pipes on adjacent compressor trains (the failures occurred in line shown in red in Fig. 1).

1 Process schematic showing failure location

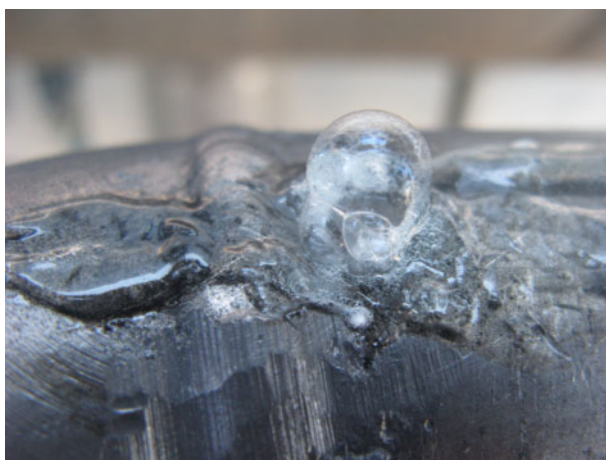
Each failure occurred at a pipe to elbow weld in a horizontal section of the line, with the leak situated in the heat affected zone (HAZ) of the weld (Fig. 2), and in top section of the pipe.

2 Leakage occurred at elbow to pipe weld, with leak occurring in HAZ

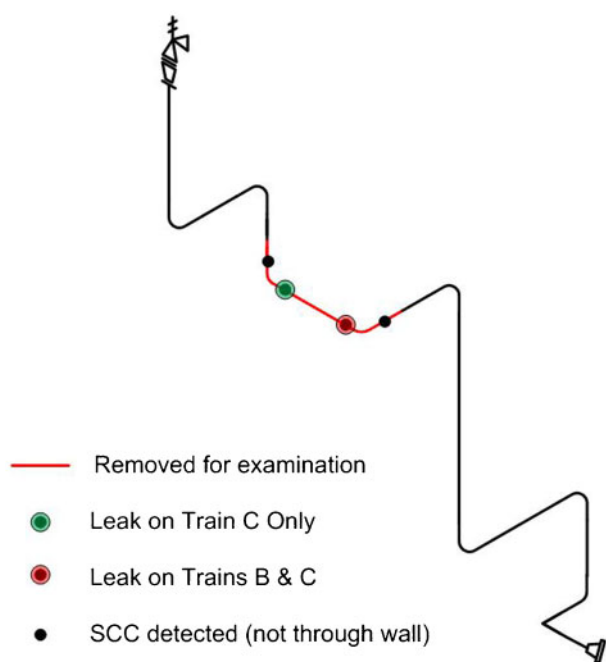
Initial *in situ* visual examination indicated fine pitting on the external surface but radiographic examination was inconclusive. All sections containing failures were removed for metallographic examination (Fig. 3).

3 Isometric showing locations where leaks occurred together with section of pipe removed for metallurgical examination

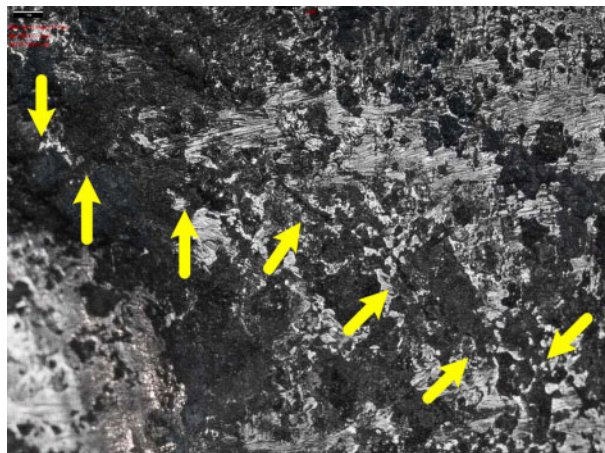
Microscopic examination in the as received condition identified the presence of cracking on the outside surface (Fig. 4), with a hair-line crack extending about 13 mm from the weld edge into the straight pipe at an angle of about 30°. Cracking was also visible internally, starting at the fusion boundary of the weld. However, thick and tenacious corrosion product obscured much of the crack.

4 Crack viewed from external surface of pipe

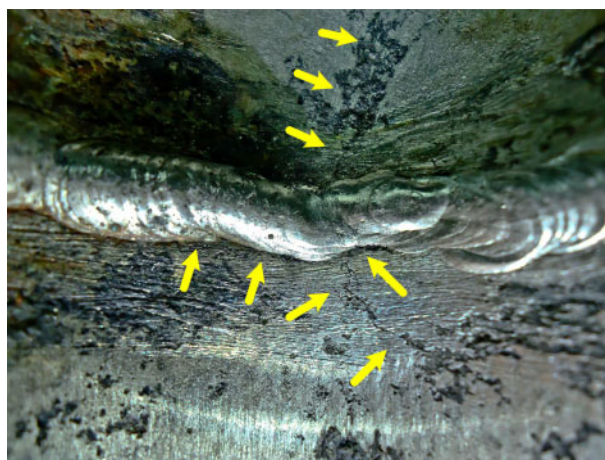
After cleaning in dilute nitric acid solution to remove the black corrosion product, the internal cracking was visible to the naked eye (Fig. 5). The crack appears to start at the fusion boundary, close to a start-stop location in the weld root. From this location the crack runs along the fusion boundary in one direction, into the straight pipe in the other direction, as well as crossing the weld and running at 90° to the weld into the elbow.

5 Following chemical cleaning cracking was visible with naked eye. Crack runs from weld fusion line into parent metal, and also along fusion boundary

Finally, the surface condition of the weldment, specifically the presence of heat tint on the weld and heat affected zone, could have a significant influence on corrosion.<sup>11</sup> Figure 5 shows that pitting corrosion is more prevalent in the HAZ. Heat tint in this area is

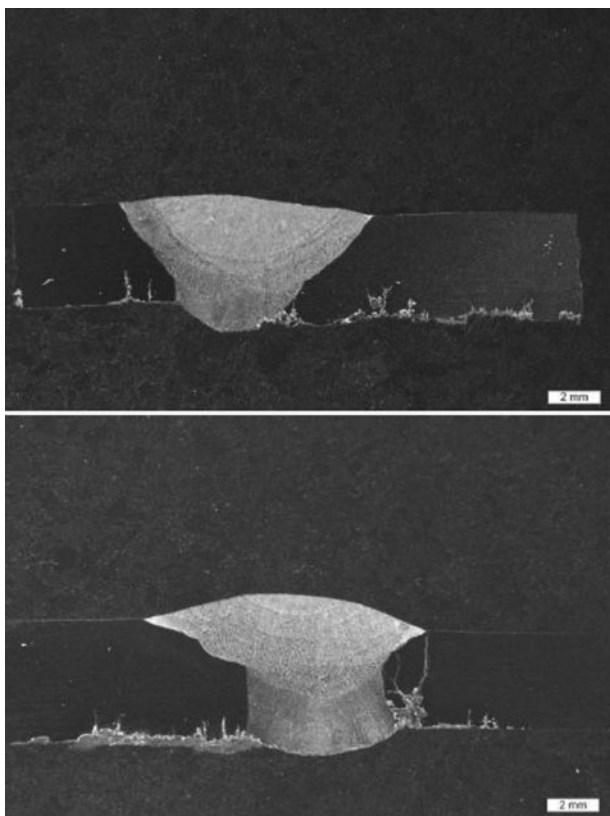
Macrophotographs show that whilst the most severe pitting and cracking occurred in the weldment, it was also present in the parent material (Fig. 6).

6 Macrophotographs showing both pitting and cracking

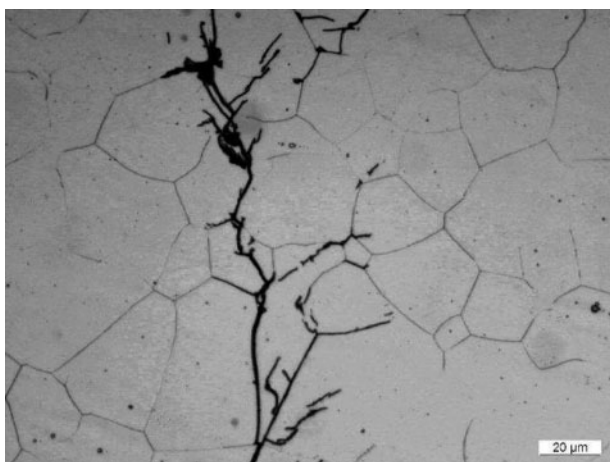
Cracking is predominantly intergranular with some branching, exhibiting a morphology typical of stress corrosion cracking (Fig. 7).

7 Optical micrograph of cracking showing characteristic typical of stress corrosion cracking

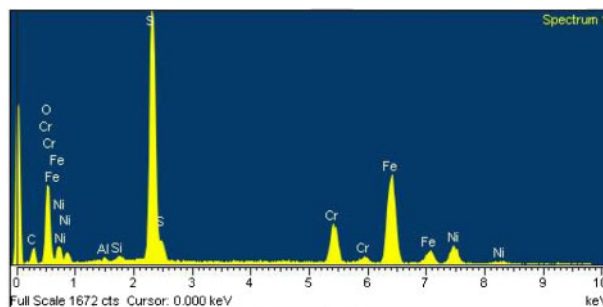
SEM examination included EDX analysis of corrosion products at the internal surface (see Fig. 8) and deep within the cracks (see Fig. 9). High levels of sulphur were detected at both locations. These findings are consistent with sulphide cracking.

8 Chemical analysis of corrosion products at internal pipe surface (S measured at 25 wt-%)

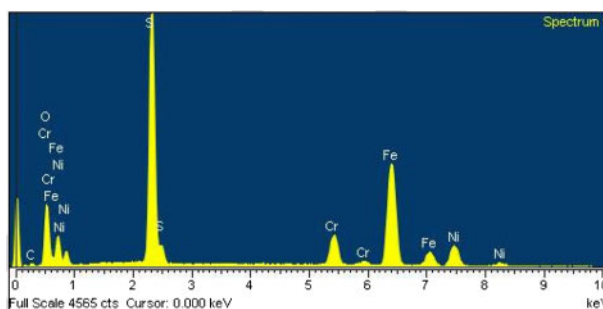
9 Chemical analysis of corrosion products inside crack (S measured at 19 wt-%)

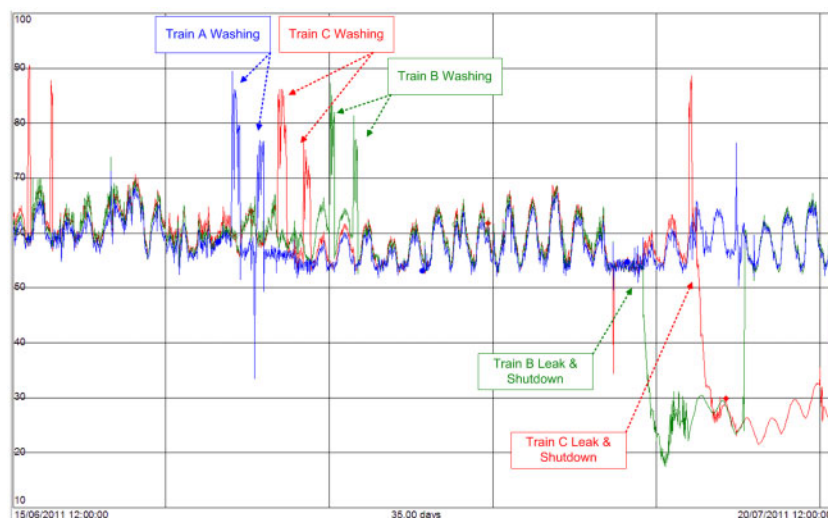
two cooler bays per cooler). During this procedure the cooler fans are switched off, resulting in a high temperature excursion for the duration of the procedure. Following the washing operation the heat transfer of the exchanger is improved and cooler discharge temperatures are achieved (Fig. 10).

10 Cooler discharge temperatures showing washing operations and times of failure

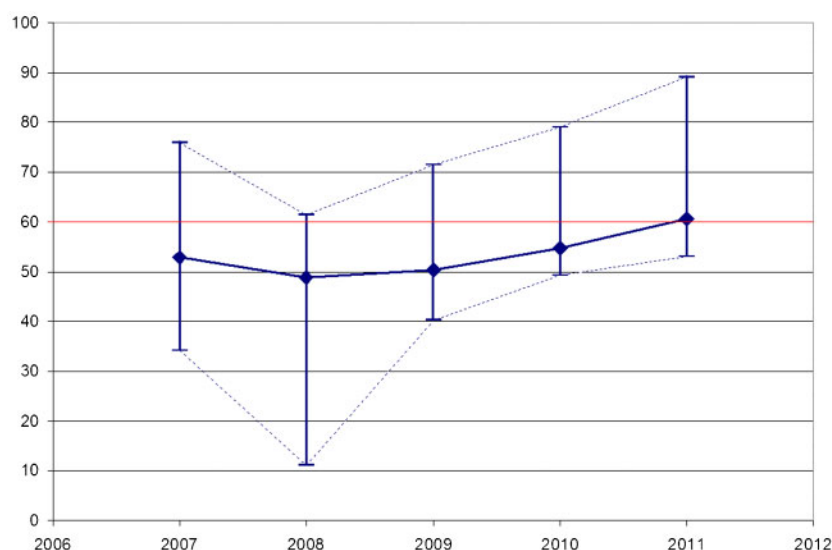
In 2011 a fourth oil and gas train was commissioned. However, commissioning difficulties associated with the acid flash gas compressor resulted in the acid flash gas from the new train being diverted to the pre-existing trains. The increased flow to these trains resulted in increased temperatures, with the average temperature of the discharge from the coolers rising above 60°C (Fig. 11) and the high temperature excursions associated with the washing operations also rising.

11 Cooler discharge temperature profile between 2007 and 2011. Bold line indicates average operating temperature, whilst tolerance bars indicate maximum and minimum operating temperature

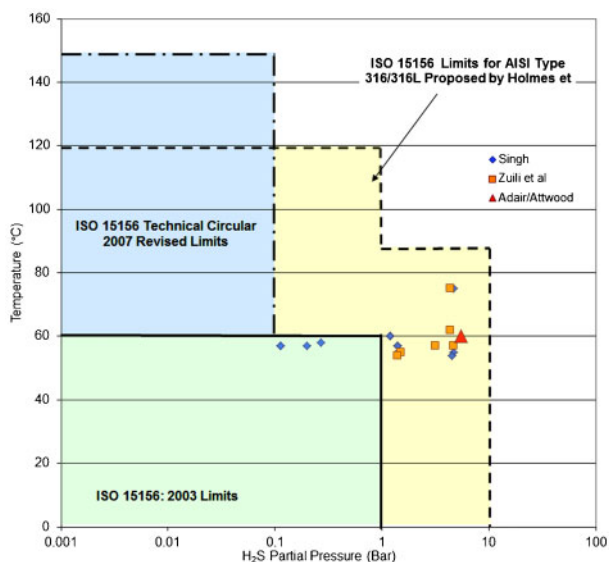
Clearly there are a small number of reported industrial failures that have occurred in what is currently regarded as a 'non-susceptible' or 'safe' region by the current edition of the code. However, there are a significant number of failures which appear out with the current limitations of the code, but within the relaxation proposed based solely on laboratory testing. It appears, therefore, that there is a very significant disparity between the laboratory tests and actual industry experience.

**12 Plot of industrial failures against ISO 15156 limitations (current and previous) for AISI 316L for maximum chloride content of 1000 mg L<sup>-1</sup>**

It is recommended that any future relaxation of the current ISO 15156 restrictions takes due cognisance of industrial experience in addition to data derived from laboratory testing.
