Site Visit Report

Scope: Rack organization, network stabilization, CCTV troubleshooting and recommendations

Location: Saifee Villa, Matheran.

Performed by: BlewMind Solutions

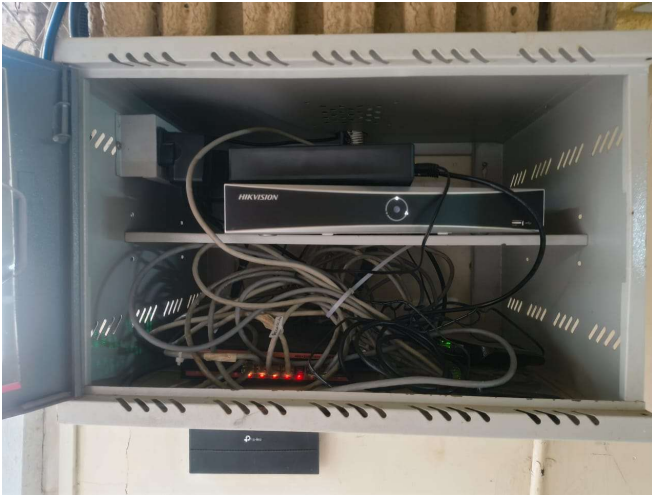
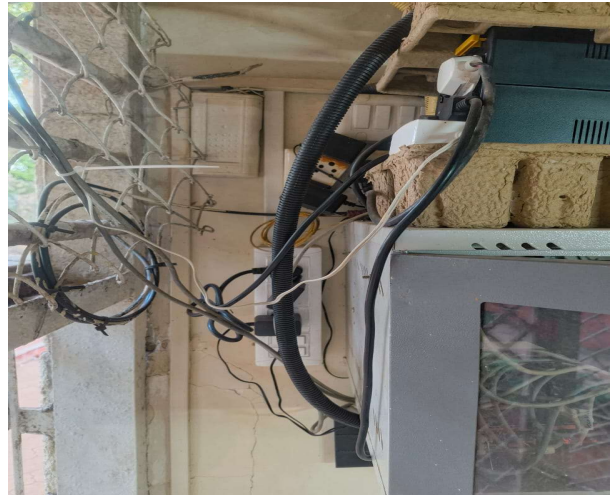
Before Rack Image

- Network rack was unorganized, making troubleshooting difficult and time-consuming.
- Cables (PoE and non-PoE) were randomly terminated across switches with no logical segregation.
- Two cables were connected from the Deco unit without clear identification or purpose.
- Core devices (main router and media converter) were powered directly from mains supply, while internal switches were powered via UPS.
- Several LAN cable crimps were found loose, causing intermittent connectivity when cables were moved.
- **Inline LAN couplers were found in use.**

- Entire rack was reorganized and structured for clarity and maintainability.
- PoE and non-PoE cables were properly identified, planned, and terminated to appropriate switches.
- All network cables were neatly dressed to ensure clear visibility and avoid accidental disruption during troubleshooting.
- Power architecture was corrected: **all network devices are now powered through existing UPS power source**, ensuring uninterrupted operation during power outages.
- All cables were re-crimped for stable connectivity.
- **Inline couplers were removed and replaced with proper I/O connectors to ensure secure termination, signal stability and long-term reliability.**

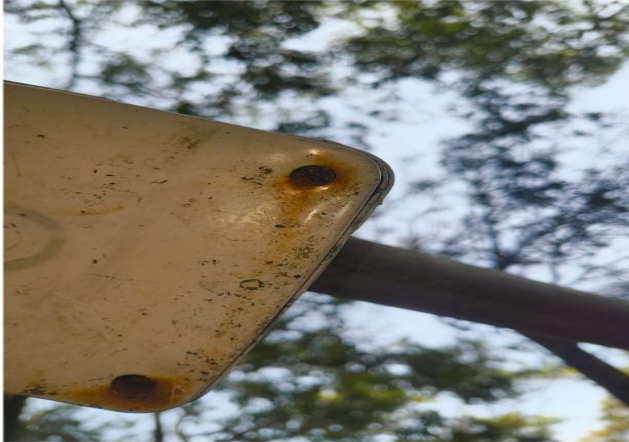
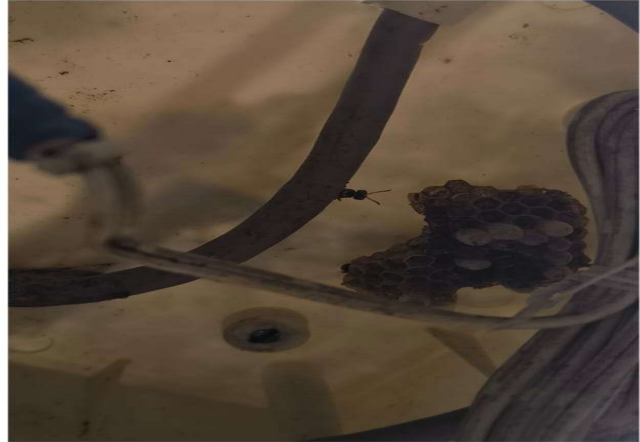
- Existing camera cabling and enclosures are **not water-resistant**.
- Water ingress was observed inside LAN cables.
- Honeycomb formation was found inside camera junction box.
- Several IMOU cameras showed signs of rust.
- Cameras were configured on a **Wi-Fi network operating on a different IP series than the NVR**, resulting in frequent camera offline issues. 📺
- **Cameras and camera junction boxes were mounted using cable ties, which is not durable.**
- **The existing cable ties were found weakened due to prolonged weather exposure, posing a risk of camera movement, misalignment or damage.**

Honeycomb & Water found in Camera Boxes

- Upgrade to **waterproof junction boxes and waterproof camera mounting stands.**
- Replace existing outdoor cameras with **outdoor-rated bullet PoE cameras**, which:
 - Are better suited for external environments
 - Eliminate dependency on separate power supplies (LAN already available)

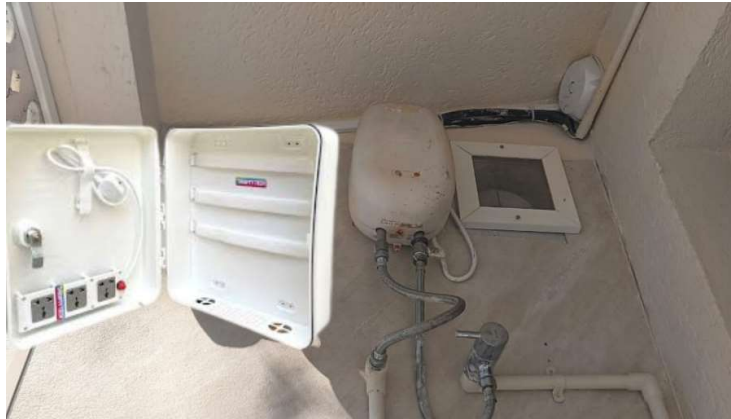
Sample edited image of the suggested location with mini junction box

- Relocate existing cable terminations to the location highlighted in the attached image.
- Install a **mini junction box** at this location to:
 - Consolidate all connections & devices into a single enclosure
 - Improve security, organization, and water resistance
