QUALITY AUTO SURVEY

DAMAGE SURVEY REPORT

FILE NUMBER	12981122
POLICY NUMBER	DJQRTY

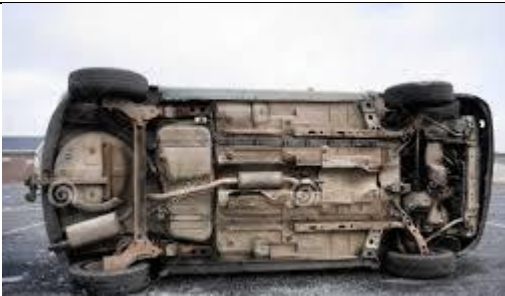
No	PICTURES
1

There has been damage to the front portion of the vehicle the bumper and the engine parts. Air bags have been releases during the accident. There has been a leak in the floor of the car.
