Leak diagnosis of polymer electrolyte membrane fuel cell stacks

Saeed Asghari ^{a,*}, Bahman Fouladi ^b, Naser Masaeli ^b,
Bagher Faghih Imani ^b

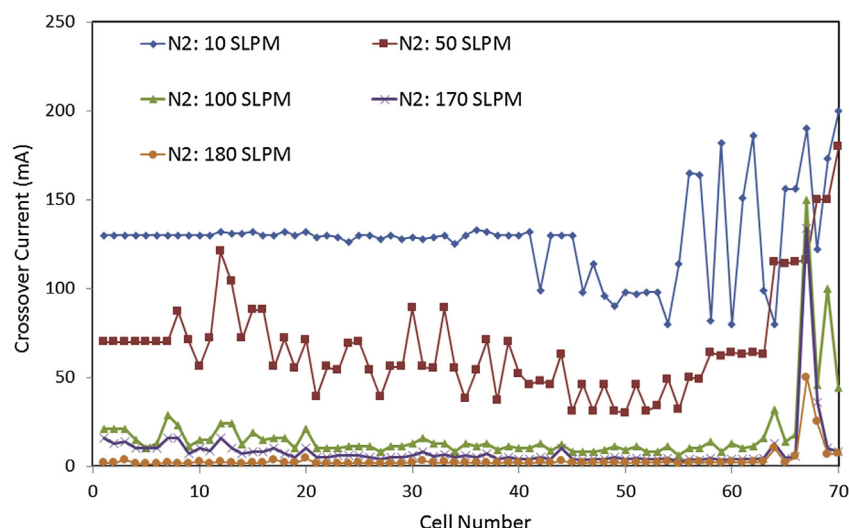
Fig. 5 – Effect of nitrogen flow on the crossover current of individual cells.

nitrogen flow rate has a considerable effect on the cell crossover current. The crossover current decreases as the nitrogen flow increases. Even though the curve related to the flow rate of 100 SLPM shows similar results with the 170 and 180 SLPM curves in most of individual cells, 100 SLPM curve shows a leakage in Cell 69 while 170 and 180 SLPM curves do not show such a leak in this cell. It is due to the fact that when the nitrogen flow rate is not as enough as required, the leaked hydrogen in the defected cell may transfer easily to the adjacent cells through the manifolds. In this way, the crossover current test shows leak in intact cells by wrong.

On the other hand, 170 and 180 SLPM give almost the same results. The diagram related to the flow rate of 180 SLPM clearly shows that Cells 67 and 64 have leak.

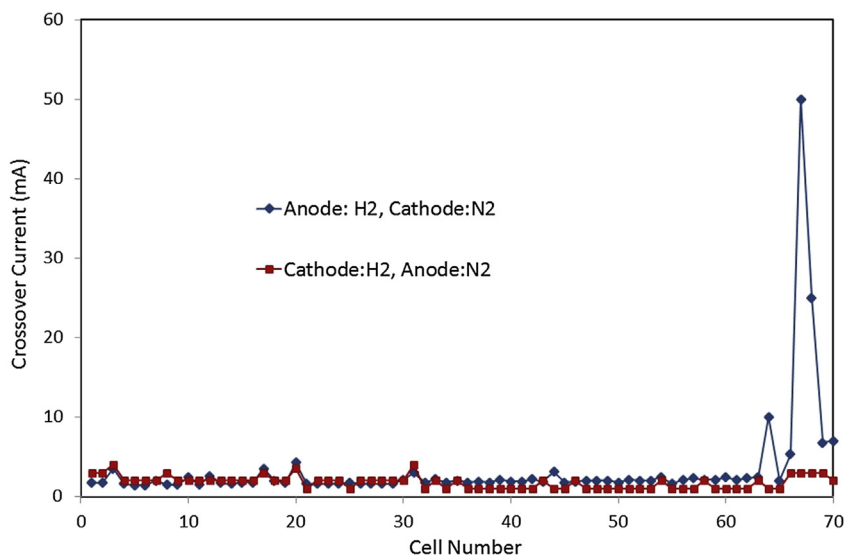
One of the solutions is carrying out the crossover current test while the hydrogen and nitrogen sides are reversed. In this test, hydrogen and nitrogen were delivered to the cathode and anode sides, respectively. The test was carried out at different nitrogen flow rates. The test results showed that the nitrogen flow rate of 180 SLPM was suitable for locating the leak source. Fig. 6 shows the comparison between crossover currents in the direct and reverse tests. As seen from this figure, in contrast to the direct test which indicates leak locations in Cells 67 and 64, the reverse test shows no leakage in the stack.

If the leak originates from any membrane hole, both tests should locate the same cells as the defected cells. Since this is not the case, some other leak source(s) should be found. The most probable source is the leak from the anode port to the cathode flow field or the leak from cathode port to the anode flow field.

By further inspection of Fig. 6, it is clear that there are low crossover currents in Cells 20 and 31 in both the direct and the reversed tests. The magnitude of the currents in these cells are much lower than those in Cells 64 and 67 which can be an indication of lower hydrogen crossover leakage in these cells. Since crossover current has been recorded in both the direct and the reversed tests, the source of leakage may be due to some inherent holes in the membrane which may be resulted from the manufacturing processes. The importance of the leak issue in Cells 20 and 31 can be more investigated by analyzing the results of the OCV decay test.

Fig. 6 – Comparison between crossover currents of individual cells in the direct and reverse crossover current tests.

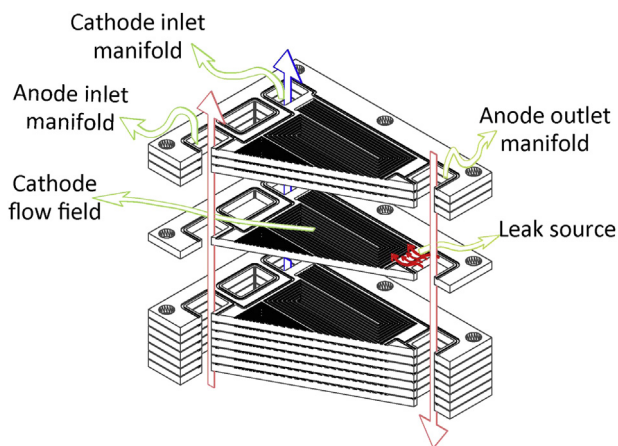
(nitrogen side) in Cells 67 and 64. In the reverse test, in which hydrogen and nitrogen sides are reversed, these breaches in Cells 64 and 67 cause hydrogen leak from the cathode flow fields into the anode manifold where nitrogen flows. If the manifold where the hydrogen is leaked in it, is the inlet manifold, the leaked hydrogen will flow into nitrogen side of the subsequent cells (Cells 65 ... 70) and will affect them. Therefore, the subsequent cells should indicate a kind of leakage. Since the crossover currents of the subsequent cells do not show such a behavior, it can be concluded that the manifold where the hydrogen is leaked in it, is the outlet manifold. In this way, the leaked hydrogen will flow out of the stack. According to the above discussion, it can be concluded that there may be a leak between the gasket and the membrane at the anode outlet manifold in the Cells 64 and 67. A schematic of such a probable leak type is shown in Fig. 7.

Fig. 7 – A schematic of leak type in the stack; reactant gases flow from anode inlet manifold into cathode flow field through a breach in the seal.

Finally, disassembling of the stack showed that there were some gasket defects in Cells 64 and 67 which caused anode/cathode leakage.

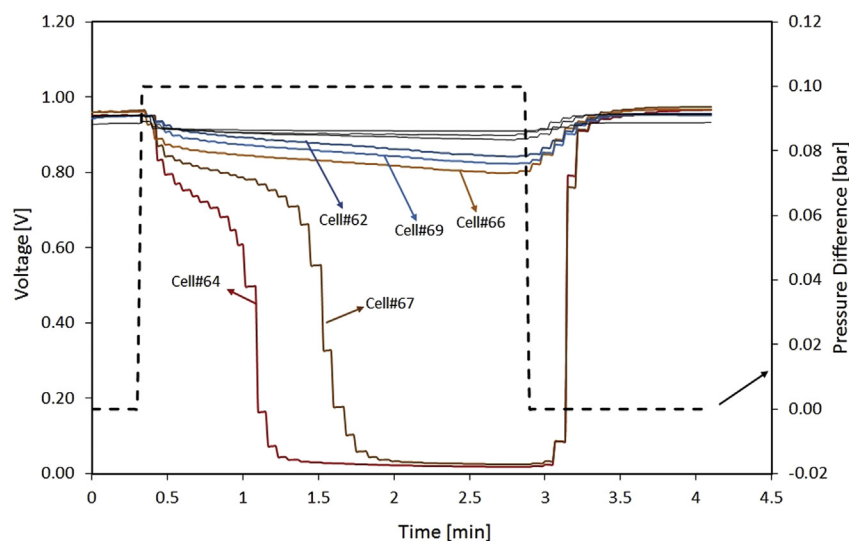
pressurizing the hydrogen side, and after 2.7 min, when the pressure difference is removed, the voltages of these cells increase again and return to a little higher values than the initial ones. The quick decrease of the potentials in the defected cells can be explained by the rapid oxygen consumption in the cathode electrodes, which leads to fast decrease of the O₂ partial pressure available at the reaction interfaces. Like as the crossover current test, this test does not say anything about the type of leaks in Cells 64 and 67.

As Fig. 8 shows, in addition to Cells 64 and 67, the OCVs of Cells 62, 66 and 69 have dropped slightly by pressurizing the hydrogen side. Now the main question is: are these voltage drops in Cells 62, 66 and 69 caused by any leak in them? Or they are due to natural diffusion of hydrogen through the membrane or they are due to transferring of leaked hydrogen from the adjacent defected cells to the air sides of these cells? This question cannot be easily answered by the OCV decay test, but it may be answered by referring to the results of

crossover current tests. The diagrams in Fig. 6 show that there are not considerable crossover currents in Cells 62, 66 and 69 which is an indication of no evident leak in these cells. Therefore, it can be concluded that the voltage drops in Cells 62, 66 and 69 are not due to direct leak in these cells. They may be due to transfer of leaked hydrogen from the adjacent defected cells (Cells 64 and 67) to the air side of these cells through the inlet or the outlet air manifolds.

Fig. 8 – Evolution of the cell open circuit voltages during the pressurizing cycle of the hydrogen side.

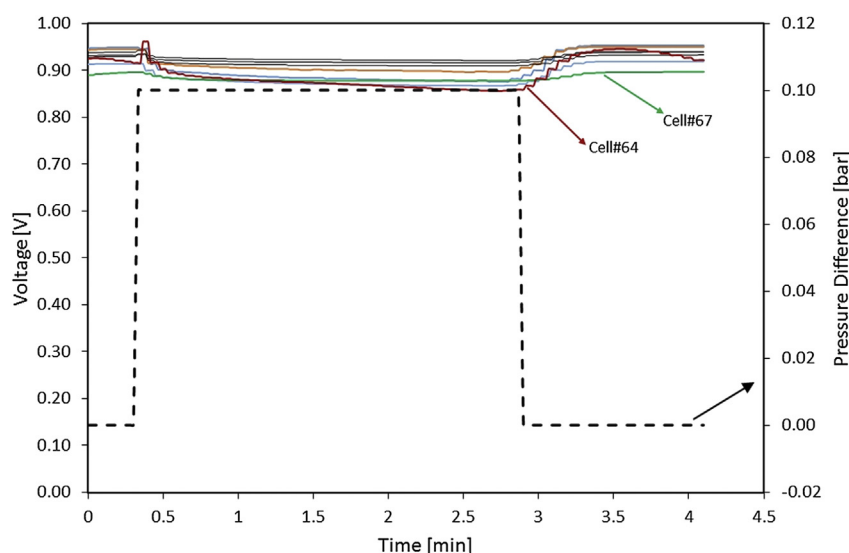
Fig. 9 shows the record of the cell voltages before and after pressurizing the hydrogen side. For the sake of clarity, the voltage–time diagrams of most of normal cells are not displayed. As seen from this figure, the cell voltages are not much influenced by the pressure difference between the hydrogen and air sides. It means that if there is any leak from hydrogen side to the air side, it does not leak into anode flow field of cells (air side), because, if this the case, we should see OCV drop in the cells with leak. It seems that if there is any leak from the hydrogen side to the air side, it exits the stack via the anode (air side) outlet manifold without entering to air side of any cell in the stack.

Fig. 9 – Evolution of the cell open circuit voltages during the pressurizing cycle of the hydrogen side in the reversed test.

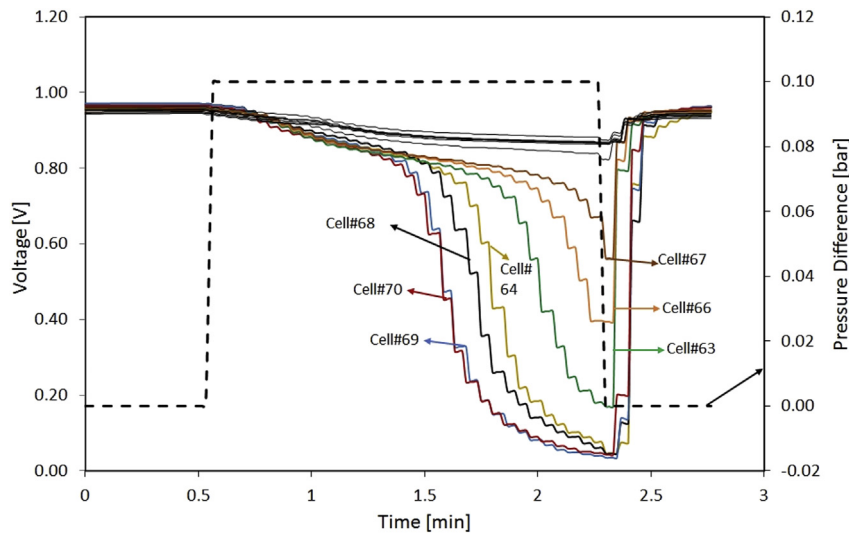
In order to confirm this hypothesis, it was decided to reverse the air inlet and outlet ports. In this way, air entered and exited the stack via the anode outlet and inlet manifolds, respectively. Fig. 10 shows the record of the cell voltages after pressurizing the hydrogen side. As this figure shows, the OCVs of Cells 63, 64 ... 70 start to fall with different rates according to the cell positions in the stack by pressurizing the hydrogen side. Therefore, only OCVs of cell 63 and subsequent cells are mainly affected by the leak. It seems that there may be some leaks from cathode flow field (hydrogen side) to the anode outlet manifold (air inlet manifold) which causes flowing of hydrogen to the air sides of cell 63 and the subsequent cells. According to the above discussion, the existence of a leak from the cathode flow fields of cell 63 and/or subsequent cells to the anode outlet manifold, as shown schematically in Fig. 7, is most probable.

Fig. 10 – Evolution of the cell open circuit voltages during the pressurizing cycle of the hydrogen side in the reversed test in the case where air enters the stack via anode outlet port.

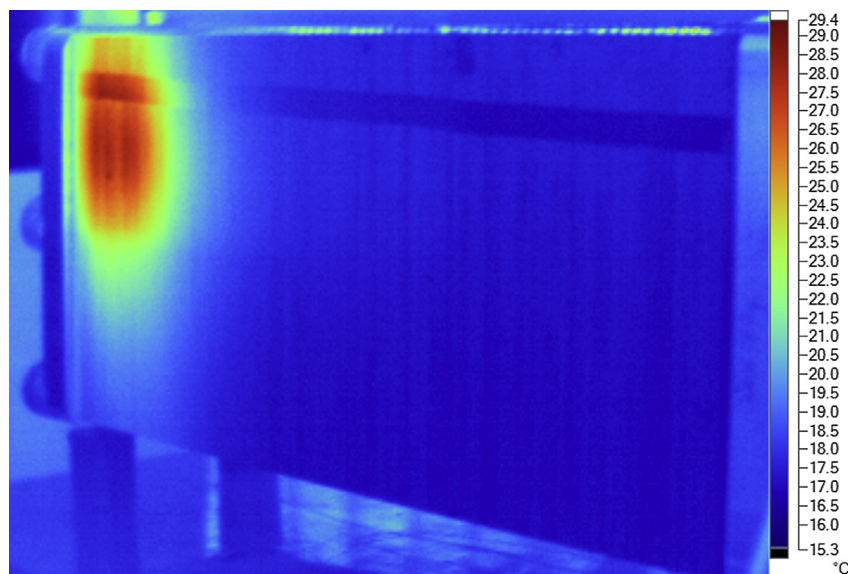
The infrared picture of the stack under test is shown in Fig. 11. As this figure shows, there is a local temperature increase at the upper left corner near to the end of the stack. This higher temperature region is located close to the anode outlet manifold. Hence, it is clear that there is a leak from the anode manifold to the cathode flow field in this region which causes combustion, heat generation and temperature increase. This picture clearly shows that the leak is occurring around the one end of the stack. However, it is almost hard to exactly determine the location of the defected cells.

decay tests. The main limitation of the method is the restricted ability to find the exact location of the leak in the stack. Because, the generated heat in the defected cell transfers to the adjacent cells by the conduction through the bipolar plates or by the flowing air which leads to the temperature increase in these adjacent cells. The heat transfer leads to the formation of a wide area with increased temperature around the defected cell.

Fig. 11 – Infrared thermal image of the first stack under thermography test.

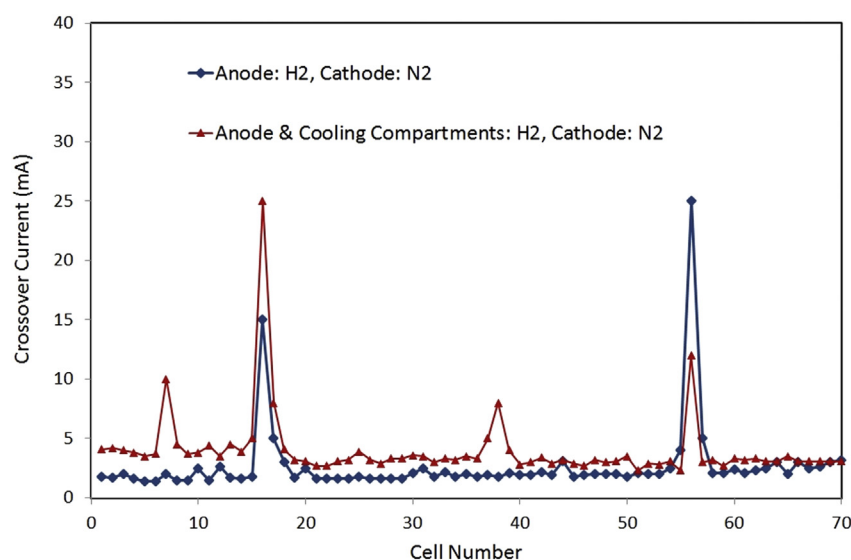
Fig. 12 – Comparison between crossover currents of individual cells in two cases: 1) anode and cathode are fed with hydrogen and nitrogen, respectively, and cooling compartment is free, 2) anode and cooling compartments are fed with hydrogen and nitrogen is delivered to cathode.

Fig. 12 shows the crossover currents of cells in the stack obtained in the two above-mentioned tests at the nitrogen flow rate of 180 SLPM. The test results in the case of cooling compartment being free of hydrogen indicate that there are leaks in Cells 16 and 56. But as seen from this figure, when the cooling compartment is fed by the hydrogen and pressurized along with the anode side, two more cells (Cells 7 and 38) show leak. Hence, it can be concluded that there are anode/cathode leakage in Cells 16 and 56; and cooling/cathode leakage in Cells 7 and 38.

Opening the stack assembly revealed that there was bipolar breakage during the assembly process in Cells 7 and 38 which caused cooling/cathode leakage. There were also some gasket defects in Cells 16 and 56 which caused anode/cathode leakage.

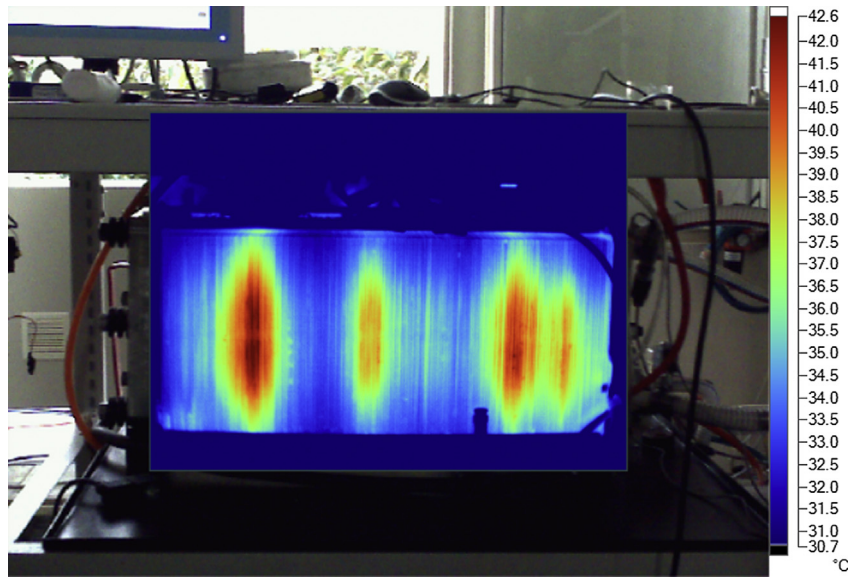
Some infrared pictures were taken during the crossover current test in the case where hydrogen was delivered simultaneously to the anode and the cooling compartments. Fig. 13 shows the infrared picture of the stack under test. The leak locations can be visualized easily as for the first stack. As this picture shows, there are about four local temperature increases at different locations in the stack. Further investigation reveals that these temperature increases are located around Cells 7, 16, 38 and 56. In addition, intensity of temperature increase is higher at Cells 16 and 56 where there are anode/cathode leakages. This can be an indication of higher leak flow in these cells than the cooling/cathode leak flow exists in Cells 7 and 38.

Fig. 13 – Infrared thermal image of the second stack under thermography test.

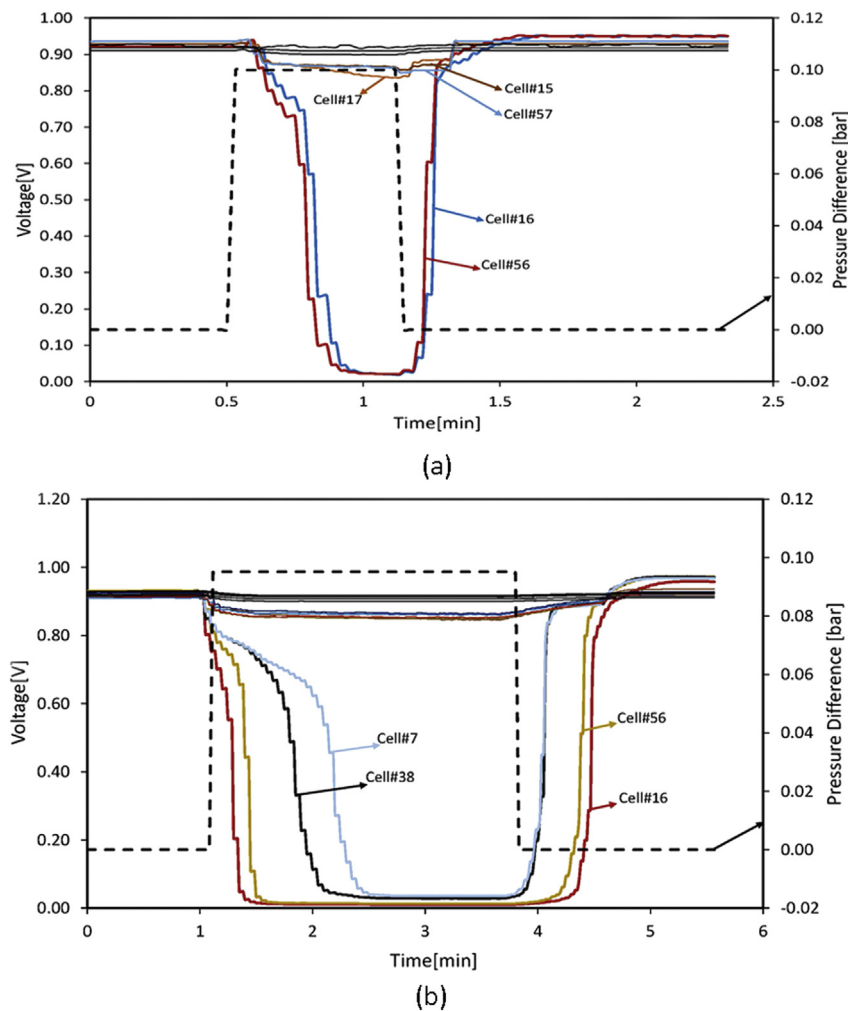
pressurizing the hydrogen side. For the sake of clarity, the voltage–time diagrams of most of intact cells are not displayed. As seen from part (a) of this figure, in the case where hydrogen is only supplied to the anode side, the OCVs of Cell 16 and 56 fall rapidly, but in the case where hydrogen is delivered to the cooling side along with the anode side (Fig. 14b), the number of cells whose OCV drops quickly, increases up to four cells. Like the other tests have shown so far, this test confirms the idea that the leak type in Cells 7 and 38 is of cooling/cathode type.

Fig. 14 – Evolution of the cell open circuit voltages during the pressurizing cycle of the hydrogen side in two cases: a) Hydrogen is supplied to anode and cooling compartments and air is delivered to cathode side. b) Hydrogen and air are supplied to anode and cathode, respectively, and cooling compartment is free.

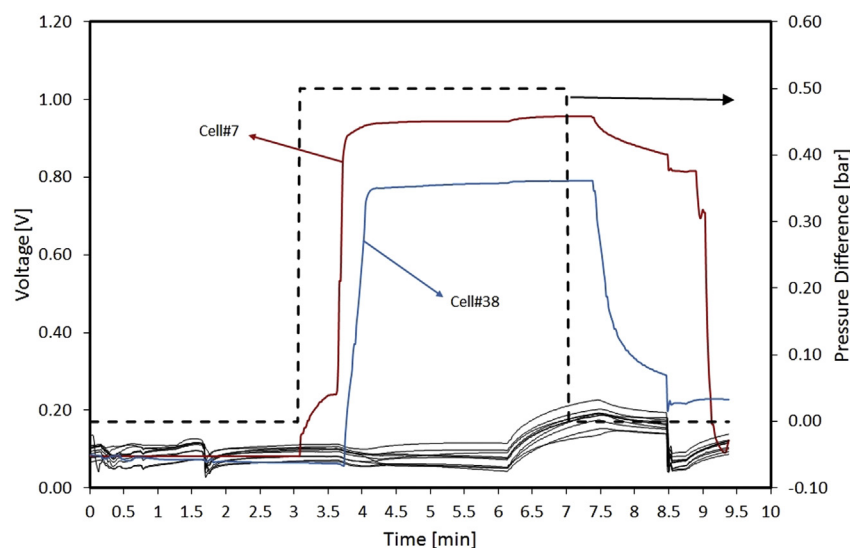
This test was done according to the procedure and conditions described in section [Leak testing from cooling compartment to other compartments \(OCV growth test\)](#). Fig. 15 shows the evolution of cell open-circuit voltages during pressurizing cycle in the cooling compartment. As seen from this figure, the OCVs of Cells 38 and 7 start to increase, respectively, as the cooling compartment is pressurized. This is an indication of the cooling/cathode leak type which causes leakage of hydrogen from the cooling compartment to the cathode compartment. However, after a while, the OCVs of all cells in the stack start to grow, because amount of leakage is high enough to cause transfer of hydrogen from cells with leak to intact cells via inlet and outlet manifolds.

Fig. 15 – Evolution of the cell open circuit voltages during the pressurizing cycle of the hydrogen side in the OCV growth test.

just one test. The main limitation of this technique, as seen from Fig. 15, is restriction on the duration of the test. Because in the cases where the test lasts long, the leaked hydrogen from the defected cells has enough time to be transferred to the intact cells via the manifolds (especially when the leakage rate is high) and therefore the OCV of the intact cells start to raise as a result. By this way, the intact cells may be grouped into defected cells by wrong. On the other hand, in the cases where the test duration is short, there is not enough time to let the hydrogen to leak from the cooling compartment to the anode or cathode compartments (especially in the cells with low leakage rate) and to increase the OCV in the defected cells. Therefore, the number of defected cells with reactant gas/cooling leak type may be underestimated. Therefore, the test duration needs to be optimized.
