## Two stack overflows were found in DIR-615Jx10 Devices

### Affected versions:

All firmware versions of D-Link DIR-615Jx10

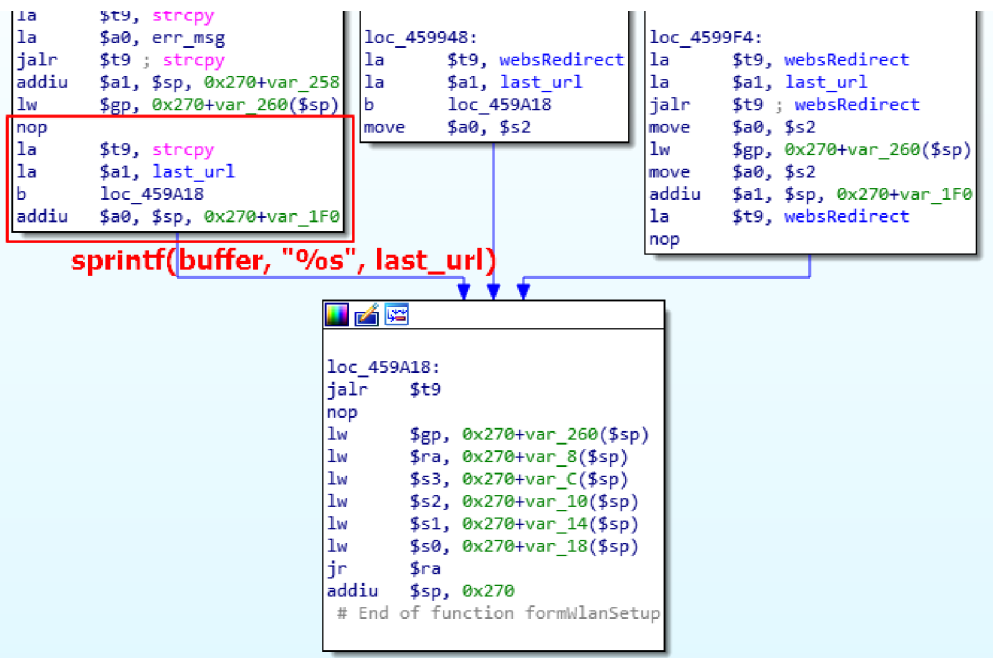
Download the GPL source code and the firmbin from D-Link official websites. Open the source file “/boa/src/fmwlan.c” since the HTTP service is implemented by boa in these devices. As we can see in the function “formWlanSetup”, value of the parameter “webpage” is copied to the variable “buffer” without any string length checking, which causes the stack overflow. The same analysis can be done in the function “formWlanSetup\_Wizard”.
