**Date of Report: October 26, 2020****BURNED-AREA REPORT****Introduction:**

A USDA Forest Service (USFS) Burned Area Emergency Response (BAER) team was ordered on September 30, 2020 to evaluate the Holiday Farm Fire burn scar to assess its post-fire watershed response, and to perform an assessment of risks from post-fire conditions to critical values on National Forest System lands. The BAER team assesses risks to life and safety, property, and critical cultural and natural resources on burned areas of the National Forest by identifying critical values and threats to them from erosion, sedimentation, falling trees, rockfall, flooding, debris flows, and other natural hazards whose magnitude or effects have increased post-fire. The Bureau of Land Management (BLM), Army Corps of Engineers (ACOE), US Geological Survey (USGS), National Weather Service (NWS), State and Private Land Erosion Threat Assessment/Reduction Team (ETART) and Oregon Department of Transportation (ODOT) have worked collaboratively with the BAER team to assess values at risk outside the Forest boundary, using watershed response information generated by the BAER team. This synthesis of information is shared with coo

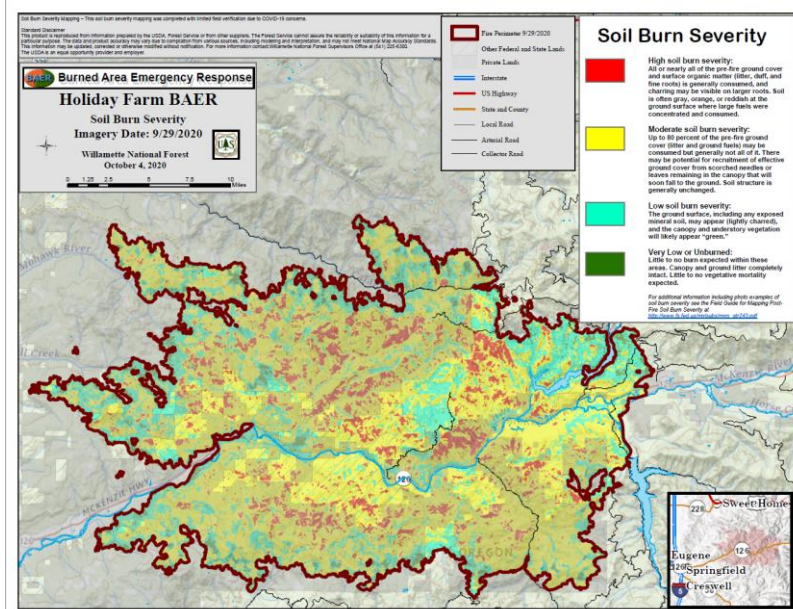
**A. Burn Severity (acres):** Soil burn severity totaled ~8% high, ~54% moderate and ~34% low, with ~3% unburned. See Map 1 and Table 7 for acreages.

Figure 1. Shows the distribution of Soil Burn Severity classes across the fire area

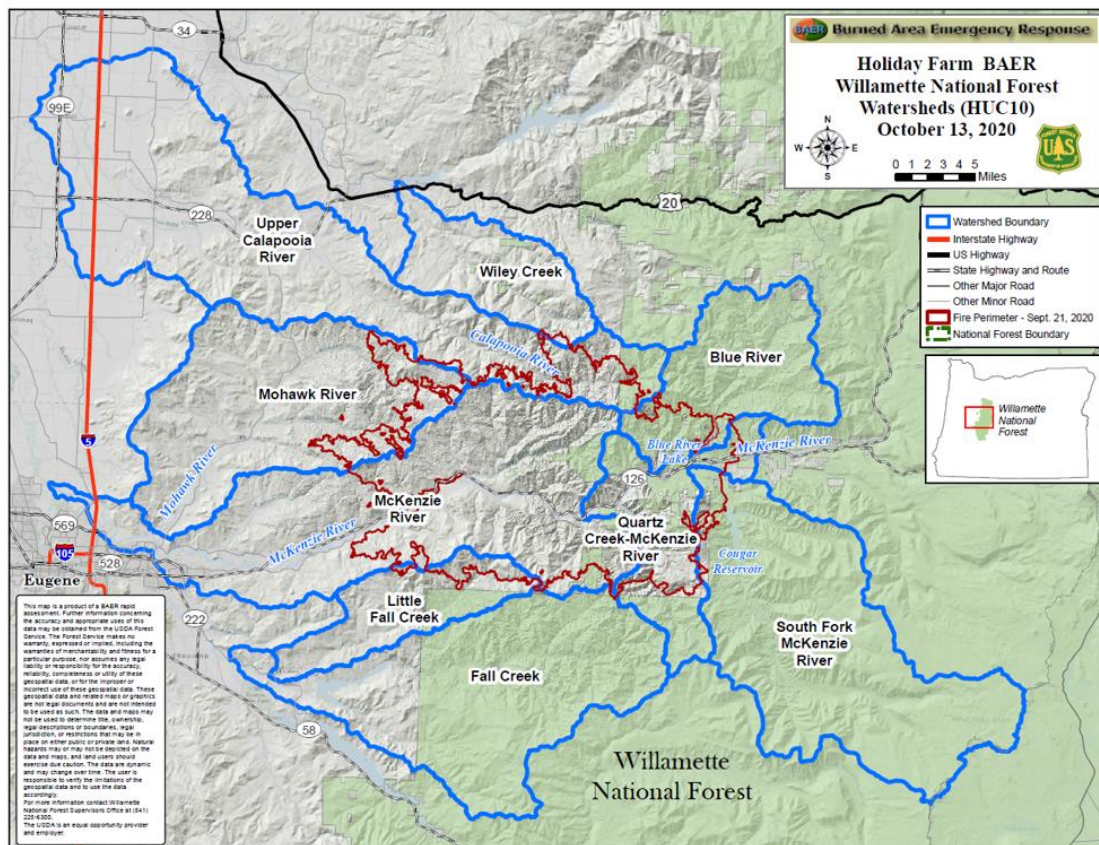
**G. Estimated Hydrologic Response (brief description):** The fire burned across 20 sub-watersheds, with Gate Creek, Ritchie Creek, East Fork Deer Creek, Lower Blue River all >80% burned.

Figure 1. Map of HUC10 Watersheds affected by the Holiday Farm Fire

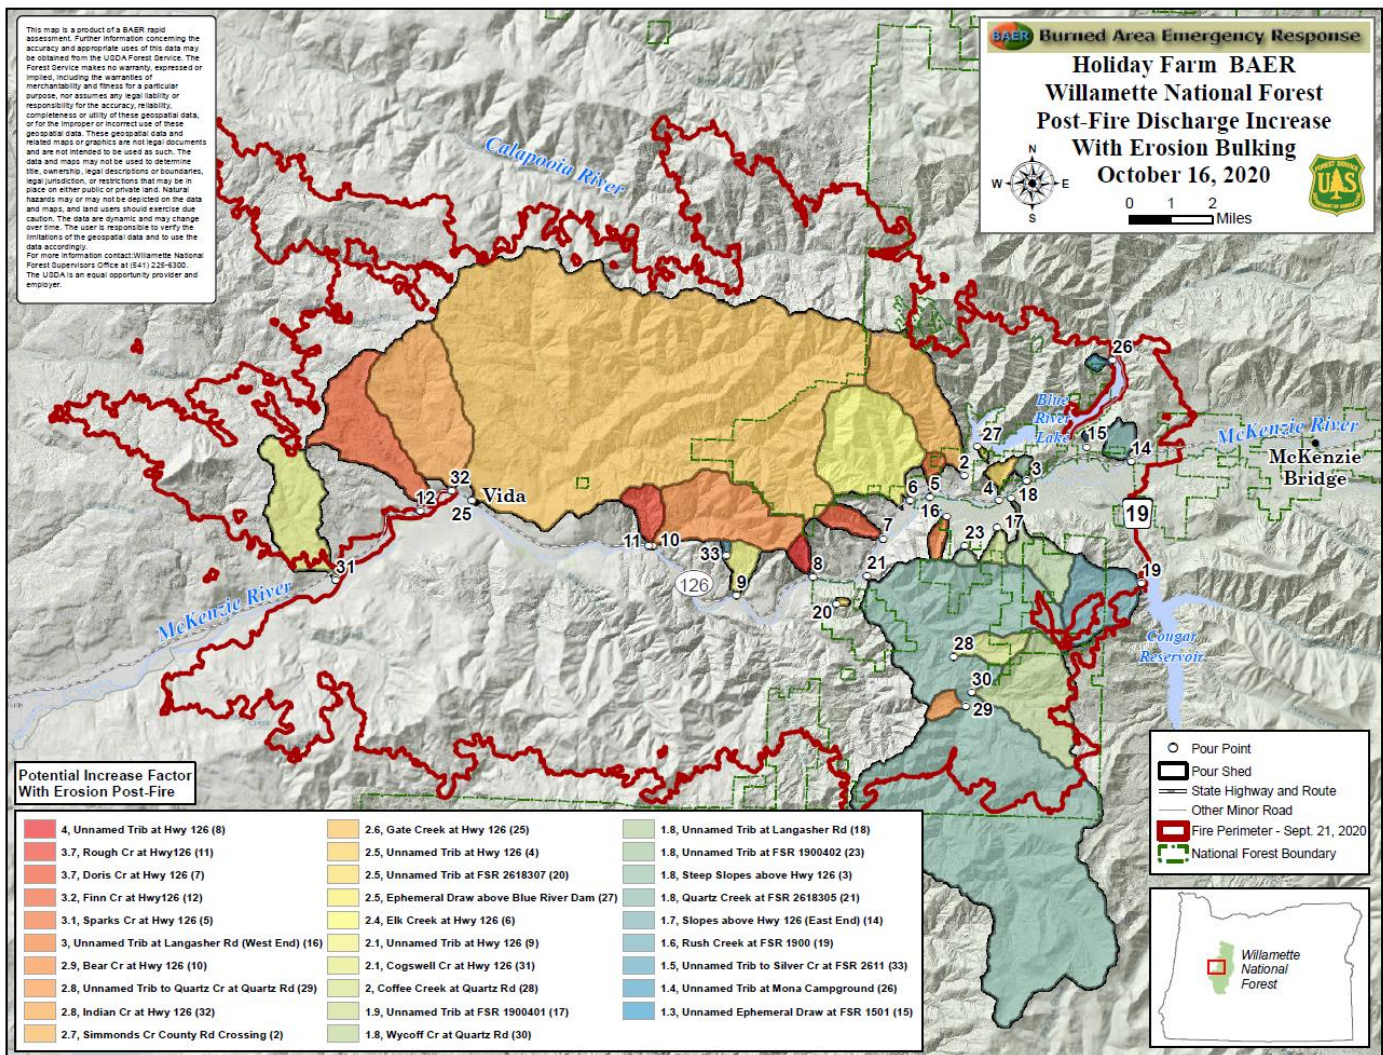
The runoff response for the fire area was evaluated using a probable storm precipitation total and the Wildcat5 rainfall-runoff model. Wildcat5 is a model that uses a distributed runoff curve number approach. Runoff curve numbers were selected using the Wildcat5 User's manual, the posted "Burned Area Emergency Response Tools" <https://forest.moscowfs.wsu.edu/BAERTOOLS/ROADTRT/Peakflow/CN/supplement.html>, professional judgment, and discussions with the NWS, local hydrologists and researchers at the H.J. Andrews Experimental Forest for reference. The pre-fire runoff from a 10-yr, 24-hr storm of 5.5 inches is approximately 178 cfs/square mile, with a post-fire flow model estimate of over 329 cfs/square mile. Post-fire runoff, especially in the first few precipitation events, will likely be bulked with ash, bedload, sediment and debris, and result in flows with a higher specific gravity due to ash in the water column. Flows may become hyper-concentrated flash floods until vegetation has re-established in the burned areas. Using a bulking factor of 25%, the estimated peak flows are displayed in Figure 3, showing peak flow increases from 1.3 to 4 times the pre-fire estimated flows, depending on drainage area, soil burn severity, soil erosion risk rating, slope and vegetative cover.

Figure 3. Post-fire Discharge Increase with (25%) sediment bulking factor.
