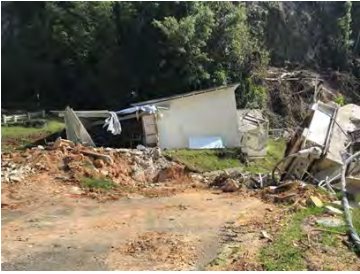
01/11/2021	Cable Car House damage from the collapse.	Thornton Tomasetti
2

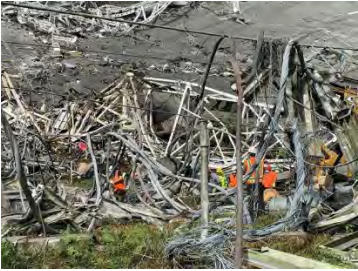
12/11/2020	The cleanup team was on site shortly after the collapse to assess the damage. The team developed safe and environmentally sound plans to complete the cleanup.	Jacobs
8

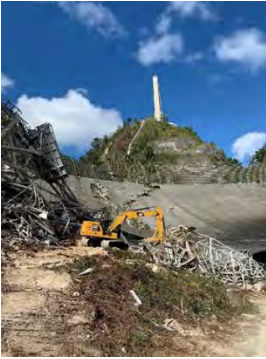
12/11/2020	Soon after the collapse, the cleanup team began debris removal to gain access to the site and assess the damage to the reflector dish structure and surrounding environment.	Jacobs

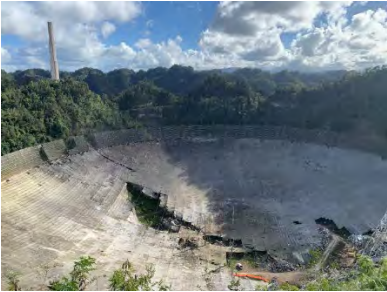
12/11/2020	The platform collapse damaged approximately 35 to 55 percent of the reflector dish area, as well as the ground screen.	Jacobs
10

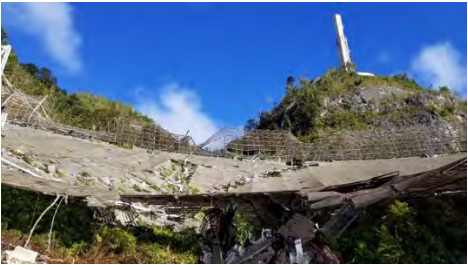
01/13/2021	A view of the damage from the bottom of the reflector dish up to Tower 12 on top of the mountain.	Thornton Tomasetti
12

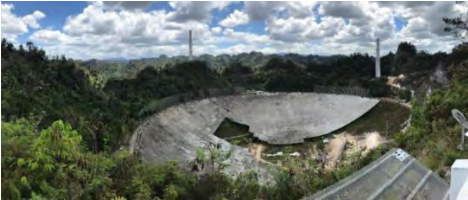
03/22/2021	Overview of the site in March 2021, when the platform and damaged panels in the reflector area were being removed.	Thornton Tomasetti

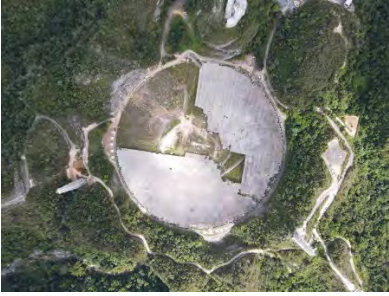
09/07/2021	By September 2021, the area under the reflector had been stabilized. This view shows vegetation regrowth and the beginning of rim wall repair work.	Thornton Tomasetti
14

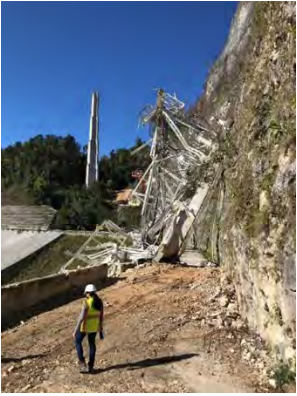
03/22/2021	The platform fell more than 300 feet, damaging the rim wall and ground screen and impacting the mountainside. Tower 8, in the background of the photo, also sustained damage.	Thornton Tomasetti
17

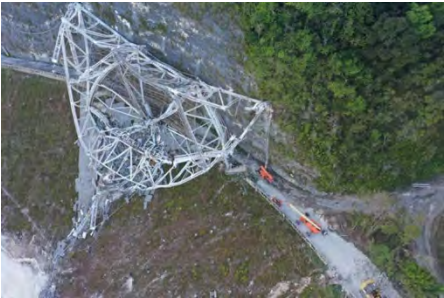
02/23/2021	An aerial view of the collapsed platform shows work crews removing pieces of the platform. The crews spent several months carefully dismantling the structure to maintain integrity and stability of the area and ensure safety while performing the work.	Thornton Tomasetti
18

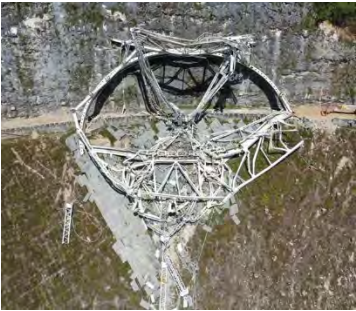
03/23/2021	This view shows the damage to the rim wall, the damaged platform, and fallen panels from the reflector dish underneath the platform.	Thornton Tomasetti

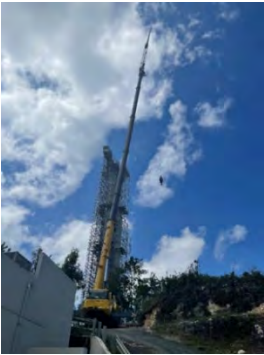
07/29/2021	At Tower 12, a large crane was used to remove debris after the tower top was wire saw cut, to lift materials and equipment, and to serve as a second mean of egress for the workers on the scaffolding.	Jacobs

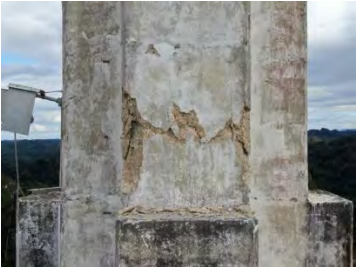
12/07/2020	The collapse resulted in damage to Tower 12. A structural evaluation was performed to determine needed repairs to the concrete structure to make the tower structurally sound and safe.	Thornton Tomasetti
26

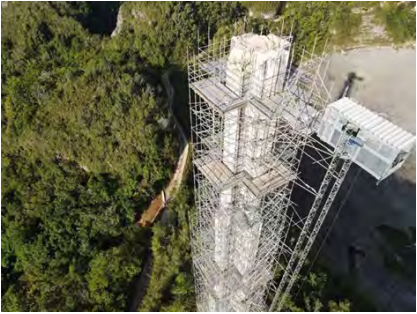
An aerial photograph showing a tall, lattice-structured tower (Tower 4) surrounded by dense green forest. The tower is heavily encased in a complex network of metal scaffolding, which extends from the base up to the top of the structure. A small white building or platform is visible at the top of the tower.	09/10/2021	The Tower 4 scaffolding allowed crews to clean, perform wire saw cutting, and then level the top of the tower to create a workable waterproof surface after the loss of the top quarter of the tower during the collapse. Structural studies were performed to determine tower stability and needed repairs.	Thornton Tomasetti
30

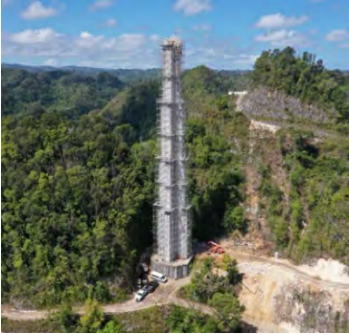
A photograph of a tall, slender tower (Tower 8) situated on a steep, forested hillside. The tower is made of a lattice of metal. The surrounding area is lush with green trees and vegetation. A dirt road or path is visible at the base of the tower.	04/30/2021	Tower 8 underwent a similar cleanup and repair process as the other towers. Fallen concrete pieces and broken cables and sockets were cleaned up from the area around the tower and the hillside was stabilized to allow work vehicles and equipment to access the tower.	Thornton Tomasetti

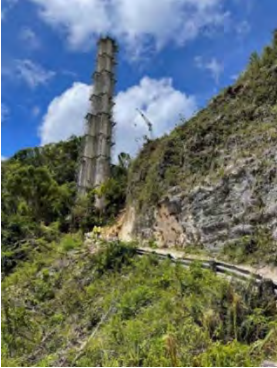
A photograph showing Tower 8 from a lower angle, emphasizing its position on a very steep, rocky hillside. The tower is a tall, vertical structure made of metal lattice. The hillside is covered in green vegetation and some exposed rock faces. A road or path is visible at the bottom of the frame.	06/28/2021	Tower 8 is on a steep hillside, which presented a challenge for heavy equipment to reach the structure.	Thornton Tomasetti

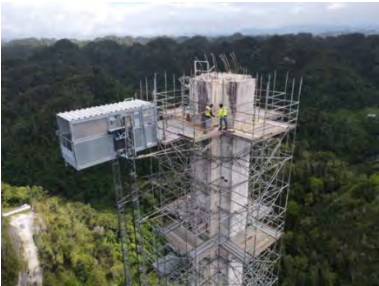
09/17/2021	Workers evaluating the concrete at Tower 4.	Thornton Tomasetti

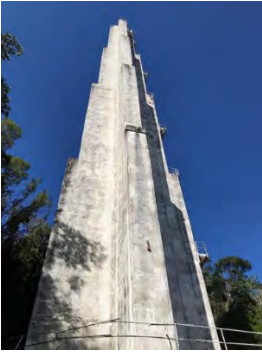
03/22/2021	Tower 8 before scaffolding installation. The top third of the tower broke off during the collapse.	Thornton Tomasetti
36

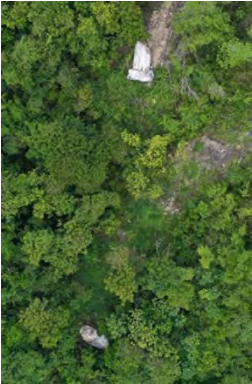
04/13/2021	Two pieces of concrete fell off of the top tier of Tower 4 and were recovered to avoid them sliding down the hillside.	Thornton Tomasetti
39

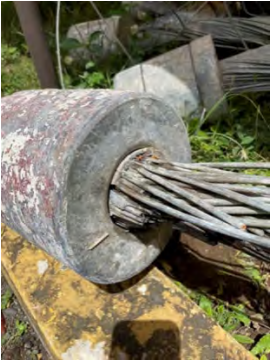
06/29/2021	A failed cable and socket recovered from the debris. Some of the cables and sockets were tested and evaluated to help determine the cause of the collapse.	Thornton Tomasetti
43
