RACK INSPECTION REPORT FOR:

INFRATEC UK LTD

MIDDLESBROUGH

29TH APRIL 2025

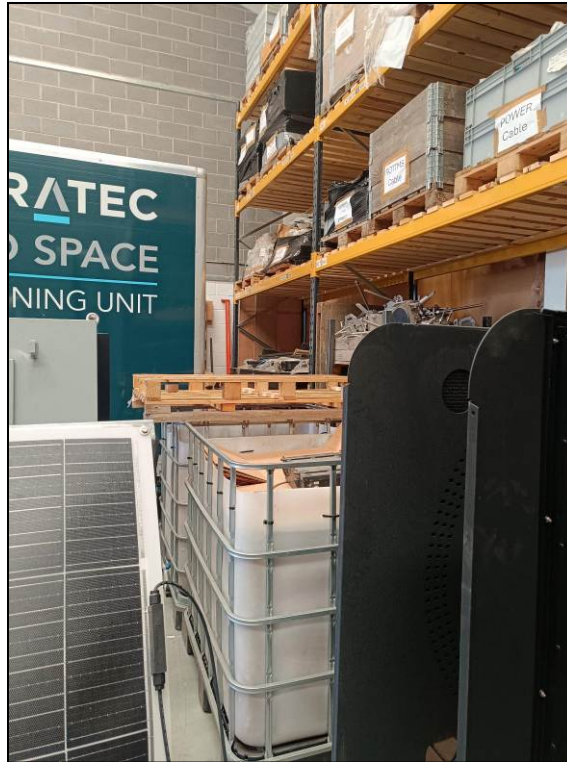
Limited access for inspection
