## Premature fracture in automobile leaf springs

### Abstract

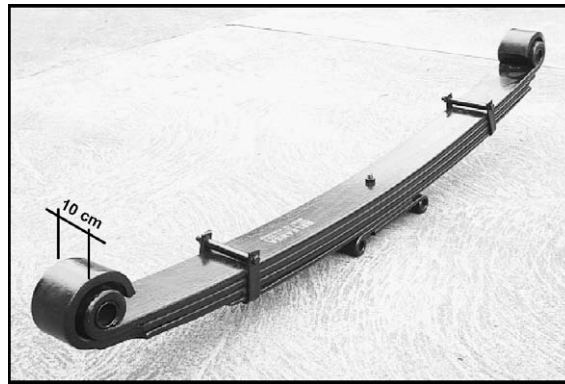
As can be seen in Fig. 1, the studied springs were of the semi-elliptical type and consisted of six steel leaves of which four served as major leaves and two as secondary leaves. This suspension component is connected at both ends with the bus chassis and rests on the wheel axle. Some mayor leaves fractured within six months of service.

Fig. 1. Visual appearance of the leaf spring.

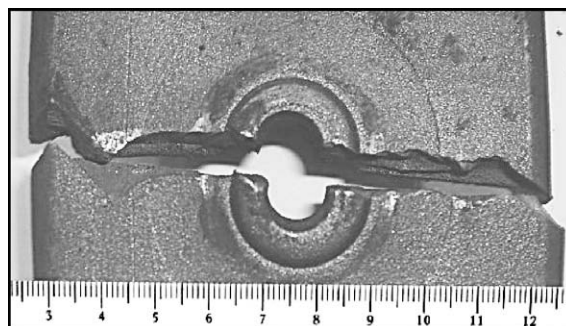
The studied spring was subject to visual and macroscopic inspection with a magnifier. The photograph of Fig. 2 is a plan view of the fracture, which occurred in the second leaf after six months of service. The fracture started at the central hole, in a plane normal to the leaf major axis, with no evidence of a prior plastic deformation. Fig. 3 shows the appearance of the fracture surface.

Fig. 2. Photograph of the fractured second leaf of a specimen which failed during service.

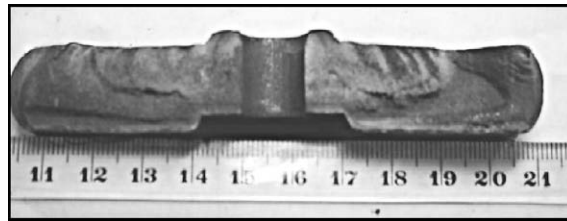
Morphologically, the fracture surface was typical of fatigue failure [3]. Thus, it consisted of a smooth region exhibiting ring marks extending into the crack origin on both sides of the hole and spanning nearly one half of the fractured area. The remaining material which was unable to withstand the service loads had suddenly broken by effect of overloading. The crack propagated normally to the main axis of the spring leaf. In summary, the fractographic evidence was typical of fatigue fracture. Also, the marks observed suggested that the crack originated in the vicinity of the top corner of the hole front (see Fig. 3); this was a region concentrating a high stress owing to its high and low relief, which, as expected, had reduced the fatigue strength of the material [4].

Fig. 3. Photograph of the fracture surface in the second leaf.

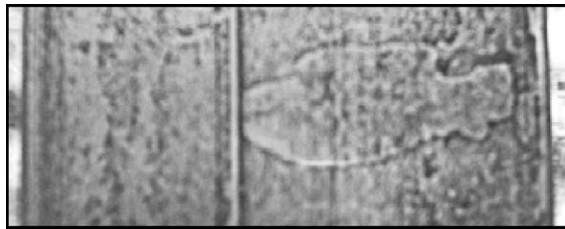
Fig. 4. Surface (tensile side) of a leaf exhibiting rolling lines and scabs.

In addition, the leaves exhibited surface defects on both their outer sides and the hole inner side. Fig. 4 illustrates the condition of the surface of the first (master) leaf in a spring representative of a production batch. As can be seen, the leaf exhibited surface discontinuities in the form of scabs and rolling marks.

Additional measurements of assistance with a view to increasing the fatigue strength of the springs include improving the surface quality of the leaves as regards both starting material (steel sheets) and manufacturing process (by avoiding fibering or the formation of inner notches in the hole). The use of a bolt threaded only at its ends might prove effective in this respect.

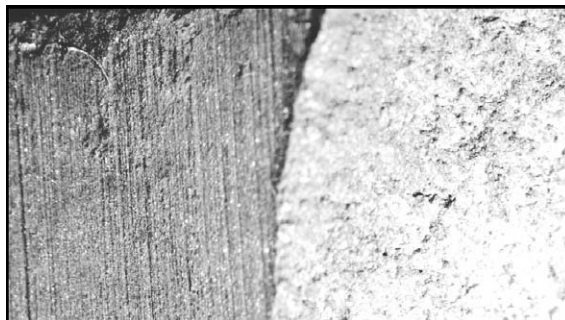
Fig. 5. Fibering in the hole surface of a fractured leaf.

As can be seen in Fig. 5, the fractured springs also exhibited parallel deformation lines (fibering) in the thickness direction on the hole surface. This surface unevenness was a result of hot piercing with a punch during the manufacturing process. All these surface defects detract from fatigue strength [4]. Moreover, the steel was unclean (Fig. 6). The amount and size of inclusions were higher than it is recommended in current practice. This is especially harmful for fatigue resistance.

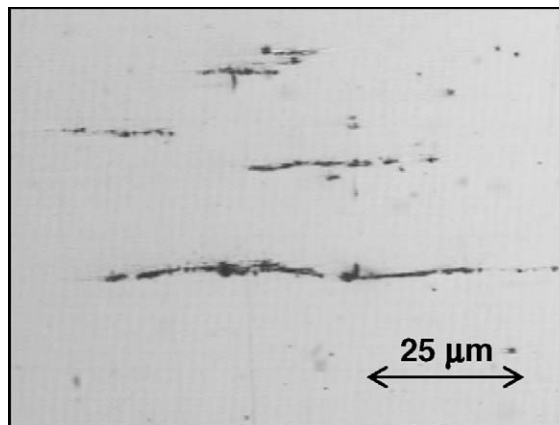
Fig. 6. Large aligned inclusions in the starting as-rolled steel sheet.

One effective way of preventing fatigue failure is by minimizing stress concentrators resulting from design, metallurgical or manufacturing factors. The specific measures to be adopted for lengthening spring life begin with the selection of clean steel, free of surface defects. The leaf hole should be round and flat. Moreover, after heat treating the top corners of the major leaves should be trimmed into curved (rounded) form to further decrease the stress-raising action. This operation also eliminates partially the decarburized layer at the most critical hole region.

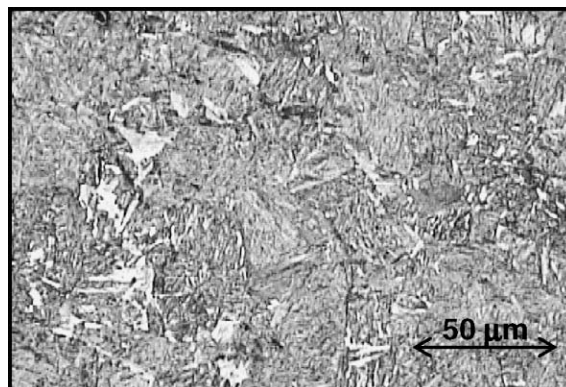
The micrograph of Fig. 7 shows the region adjacent to the fracture in a broken specimen in a lengthwise section normal to the rolling surface (Orientation E in ASTM E3 standard). In addition to the tempered martensite structure, which is typical of the quench-and-temper condition, the material exhibited islands of ferrite, which is the white constituent. This microstructure is consistent with a deficient quenching of the material.

The presence of ferrite, which is a soft constituent, can considerably reduce the fatigue limit [5].

Fig. 7. Micrograph of a zone in the vicinity of the fracture surface, taken in the E orientation.

Decarburization of the leaves during the manufacturing process must be prevented. Likewise, heat treating should be conducted so as to obtain a pure tempered martensite structure. For a more detailed explanation, see Section 5.

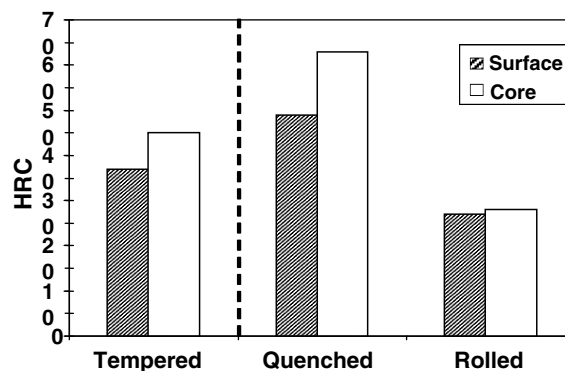
Fig. 8. Hardness of the fractured region – tempered – as opposed to that obtained after quenching and hot rolling.

As can be seen in Fig. 8, the HRC value for the fractured specimen was 18% lower at the surface than in the core (37 versus 45 HRC). The former value is lower than the SAE recommended value (42–49 HRC) [9]. The quenched leaf also exhibited a disparate hardness at the surface and core (49 versus 63 HRC), but little difference between the two was found in the as-rolled condition (27 versus 28 HRC).

Based on the previous results, the hardness of the leaf surface was considerably reduced by the thermo-mechanical manufacturing process. This was mainly the result of steel decarburization, due to the lack of right control in the protective atmospheres of the heating equipments (forges and furnaces).

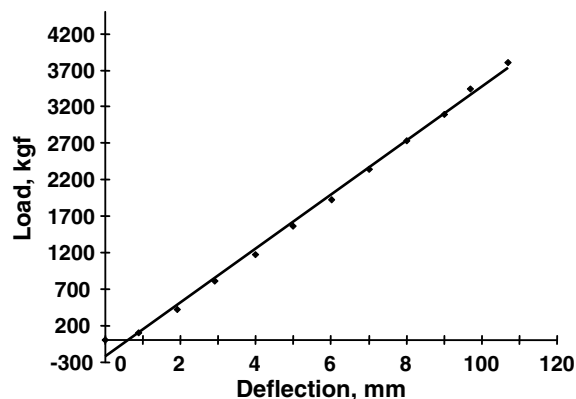
Static loading tests were performed with a universal dynamometer. The spring was placed upside-down and gradually bent in the range from 0 to 107 mm, respectively, under a load 0 to 3810 kgf. Fig. 9 illustrates the linear relationship between the applied load and the extent of reversed bending, which is suggestive of an elastic behaviour. Flattening the spring required bending it by 97 mm with a 3560 kgf load. The maximum deformation (10 mm departing from the flattened position) was obtained with a load of 3810 kgf. After unloading, the spring regained its initial shape. Based on these results, the spring behaved elastically under static loads even as high as 3600 kgf – a value exceeding the design load (1940 kgf).

Fig. 9. Load versus deflection plot in the static loading test.

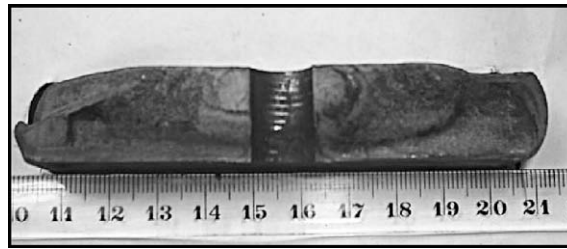
Fig. 10. Deformation marks caused by the threaded bolt in the hole of the master leaf in a spring subjected to the fatigue test.

no spring with a cup-shaped hole, (i.e., no BAC specimen) reached 24,000 loading cycles; on the other hand, the flat-hole springs withstood more than twice that number (52,000 cycles). This can be ascribed to the increased stress concentration in the cup-shaped holes and its favouring earlier failure. Therefore, the cup-hole design is a poor design. Also worth noting is the fact that the springs with flat round holes performed relatively better despite the formation of ring-shaped marks normal to the hole axis (Fig. 10). Such marks were caused by the thread of the SAE 1020 steel bolt joining the leaves. The bolt is threaded by plastic deformation. The marks resulted from surface damage in the form of true notches in each leaf hole that reduce the fatigue strength of the steel; also, their presence in the hole inner walls indicates that the walls were not hard enough, probably by effect of decarburization.

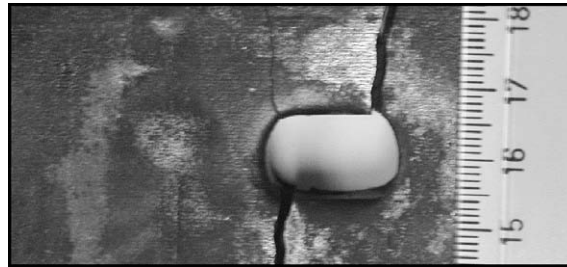
Fig. 11. Primary and secondary cracks in a leaf with a rectangular hole after fatigue testing.

The rectangular shape of the hole in the second leaf (Fig. 11), which was intended to facilitate fitting in assembling the springs, is also inadvisable as it favours stress concentration. As can be observed in this figure, the largest fatigue cracks were those starting at the corners of the rectangular holes. Such corners were quite sharp and acted as highly efficient stress concentrators that promoted fracturing. Fig. 11 also shows a secondary crack that started at the top left corner of the hole.
