On-Site Ambulance Crash Investigation

Case Number DS15009

Vehicle: 2009 Ford E-350 Type II Ambulance

Crash Date: July 2015

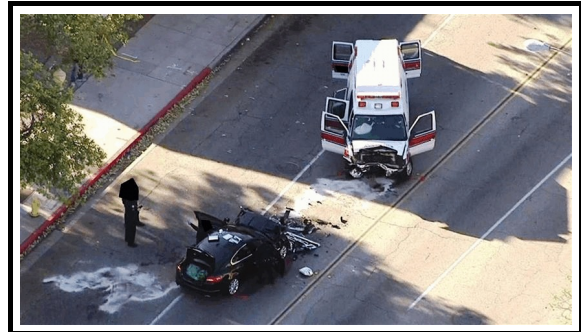
The crash consisted of one event in which the front plane of the Ford impacted the front plane of the Jaguar (Event 1). Contact damage to both vehicles was distributed across their front planes. The POI was located in the second southbound lane from the right, mid-block and 7.4 m (24.2 ft) east of the west curb line. Following the impact, both vehicles rebounded rearward. The Ford traveled rearward approximately 2.3 m (7.5 ft) and rotated slightly counterclockwise, and came to rest facing southeast in the same lane as the impact. The Jaguar traveled rearward approximately 1.7 m (5.6 ft) and rotated slightly clockwise, and came to rest facing northeast in the same lane as the impact (**Figure 4**). During the crash, the patient in the Ford was displaced from his cot belt restraints and his head impacted a cabinet surface located at the forward aspect of the patient compartment. He came to rest on the compartment floor. The cot remained attached to the ambulance at the floor and left panel fastening points. Additional details regarding the patient cot and restraints usage are discussed in the Patient Cot section of this report.

Figure 4. Final rest positions 2009 Ford E-350 Type II ambulance and 2014 Jaguar XF 3.0 (news photo)

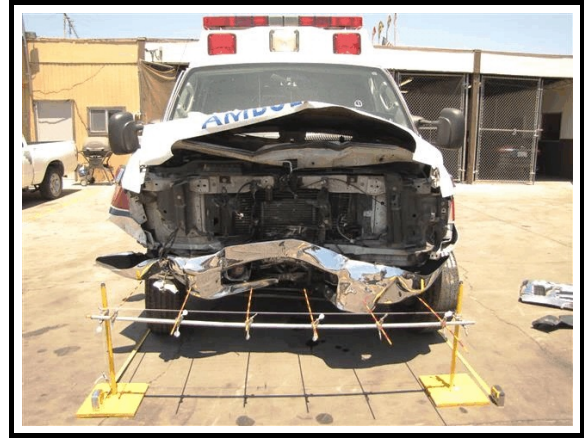
The Ford sustained moderate severity damage to the front plane caused during the impact with the Jaguar in Event 1. The direct damage was distributed across the front end extending from bumper corner to bumper corner and measured 162.0 cm (63.8 in). Six crush measurements were taken at bumper level as follows (**Figure 6**): $C_1 = 14.0$ cm (5.5 in), $C_2 = 13.0$ cm (5.1 in), $C_3 = 43.0$ cm (16.9 in), $C_4 = 48.0$ cm (18.9 in), $C_5 = 31.0$ cm (12.2 in), $C_6 = 31.0$ cm (12.2 in). Maximum crush was located at C_4 and the Collision Deformation Classification (CDC) for the Ford in this event was 12FDEW3.

Figure 6. Front end crash measurements, 2009 Ford E-350 Type II ambulance

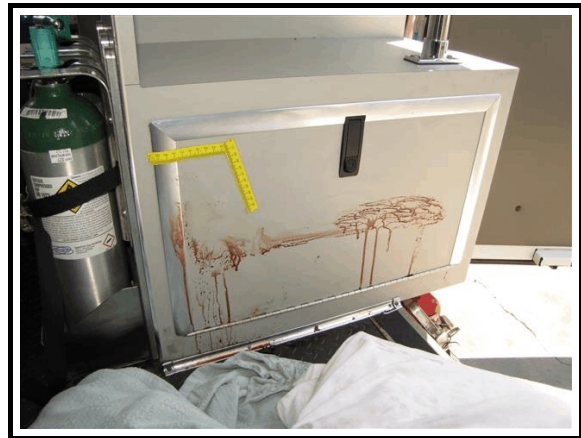
The Ford's cab interior revealed minor damage from air bag deployments and occupant contacts. Minor occupant loading was documented on the driver's safety belt. There was no intrusion into the occupant compartment and no deformation of the steering wheel rim or compression of the column. There were no deformations to any of the seats. The doors remained closed and operational. The windshield was fractured in the lower right corner. The patient compartment revealed contact evidence including loading marks to the manual lap belt on the cot, and blood and skin transfers on the cabinet surface where the patient's head contacted the cabinet.

A storage cabinet configured with a hinged drop-down access door was located at the front right aspect of the patient compartment. This cabinet was set on the floor and against the forward wall panel. The front surface of this cabinet measured 35.0 cm (13.7 in) in height and 44.0 cm (17.3 in) in width, and it protruded 34.0 cm (13.4 in) rearward of the front wall. It was positioned forward and to the right of the ambulance cot. The linear distance measured diagonally from cot to cabinet was approximately 1.0 m (3.3 ft). The front panel of this cabinet exhibited occupant contact evidence including blood and skin deposits (**Figures 7 and 8**), indicating that the patient's head contacted this cabinet during the crash.

Figure 7. Patient compartment, cabinet at forward aspect was an injury source for the patient, 2009 Ford E-350 ambulance

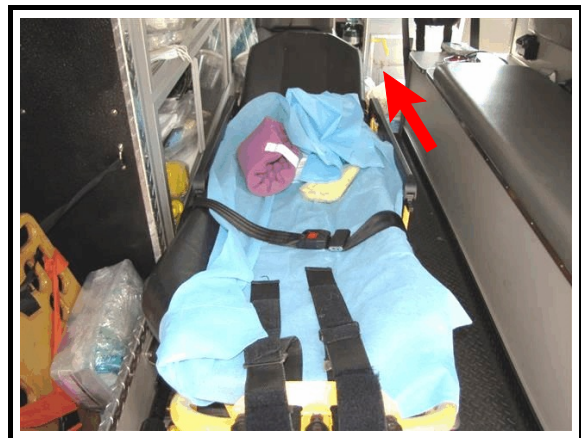
Figure 8. Stryker EMS Model 6082 MX-PRO R3 Ambulance Cot (foreground), patient contact evidence (background/arrow)

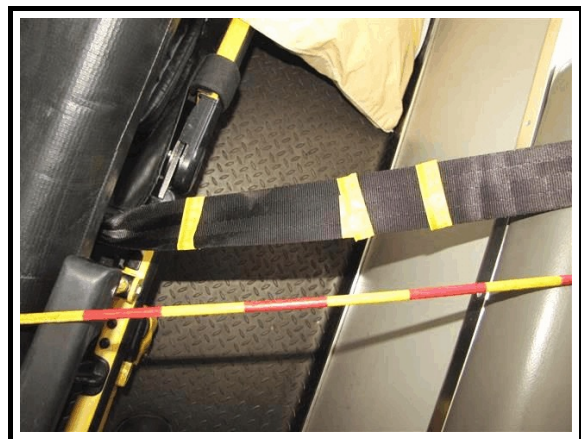
At the time of the SCI inspection, the ambulance cot was secured in place by the fastening system. The investigator released the mechanism for inspection and it was determined to be functional and undamaged. The cot was equipped with a manual restraint system consisting of two lap type belts with locking latch plates (**Figure 10**), the lower of which was used to restrain the legs and the upper which was used to restrain the chest. The webbing, latch plates and buckles were examined by the investigator and found to be functioning properly. The chest belt revealed occupant loading evidence in the form of scuff marks to the webbing (**Figure 11**). The leg

Figure 11. Occupant loading of chest belt, Stryker EMS Model 6082 MX-PRO R3 Ambulance Cot

There was no visible damage to the cot's metal frame or fastening system. The mattress revealed possible patient loading evidence in the form of scuff marks. These scuff marks were linear in nature and located within the vinyl on the middle to upper aspects of the mattress. The longest of these scuff marks measured 25.0 cm (9.8 in) in length and was oriented similarly to the probable at-impact trajectory of the patient. An on-scene police image shows the chest belt was buckled (**Figure 12**). The investigation concluded that the chest belt was either buckled but loosened by the EMT prior to the crash, or unbuckled prior to the crash.

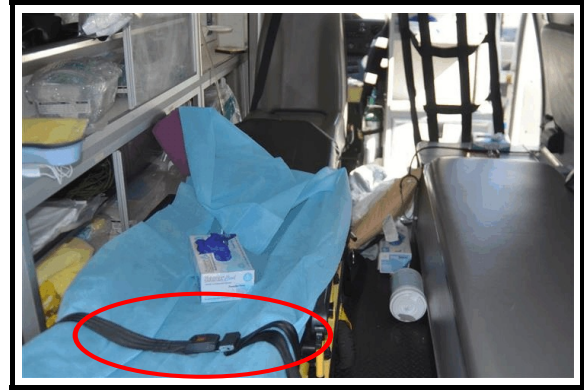
restraint was unremarkable. The police noted in their report that, after reviewing their on-scene photos, they determined the leg belt was definitely buckled following the crash. They could not determine with certainty whether the upper belt was buckled although it did not appear to be so. During the subsequent police vehicle inspection, the officer noted the upper chest belt was unbuckled.

Figure 12. On-scene image showing chest belt in buckled position (police image)

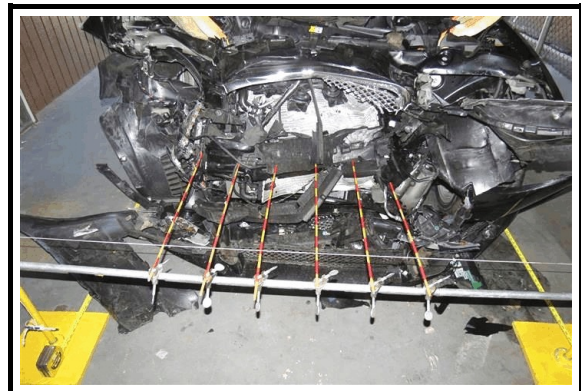
The Jaguar sustained moderate severity damage to the front plane caused during the impact with the Ford in Event 1. The direct damage was distributed across the front end extending from bumper corner to bumper corner and measured 75.0 cm (29.5 in). The front bumper fascia was displaced from the vehicle and the backing bar was used to obtain crush measurements. Six crush measurements (**Figure 13**) were taken at bumper level as follows: $C_1 = 27.0$ cm (10.6 in), $C_2 = 55.0$ cm (21.7 in), $C_3 = 48.0$ cm (18.9 in), $C_4 = 38.0$ cm (15.0 in), $C_5 = 38.0$ cm (15.0 in), $C_6 = 37.0$ cm (14.6 in). Maximum crush was located at C_2 and the CDC for the Jaguar in Event 1 was 12FDEW3.

Figure 13. Front end crush measurements, 2014 Jaguar XF 3.0
