ON-SITE AMBULANCE CRASH INVESTIGATION

CASE NUMBER - IN13025
LOCATION - WISCONSIN
VEHICLE - 2009 E450 TYPE III AMBULANCE
CRASH DATE - July, 2013

1. <i>Report No.</i> IN13025		2. <i>Government Accession No.</i>		3. <i>Recipient's Catalog No.</i>	
4. <i>Title and Subtitle</i> On-Site Ambulance Crash Investigation Vehicle - 2009 Ford E450 Type III Ambulance Location - Wisconsin				5. <i>Report Date:</i> May, 2014

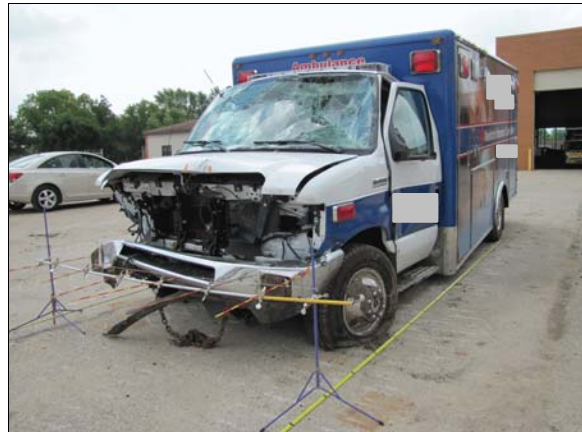
Figure 1: The damaged 2009 Ford E450 Type III ambulance

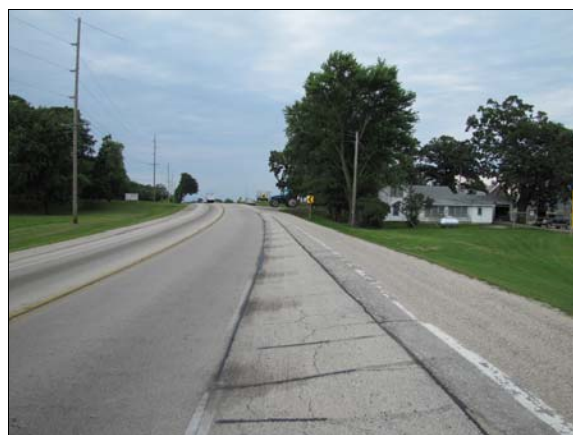
Pre-Crash: The driver of the ambulance was traveling north in the through lane negotiating the slight left curve (**Figure 2**) when the vehicle departed the east side of the roadway. The driver told police that the right front wheel went onto the gravel shoulder and he tried to steer back to the left, but crossed the shoulder into the ditch. He stated he did not apply the brakes and provided no statement to police as to why the vehicle departed the roadway. The pre-crash data reported by the vehicle’s Event Data Recorder (EDR) are presented in the following table.

Figure 2: Northbound approach of the ambulance to east roadside departure

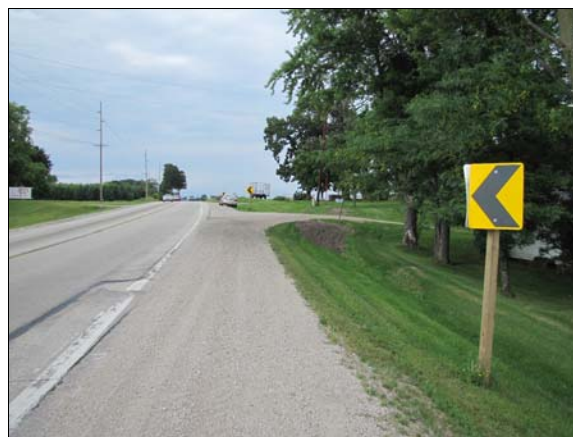
Crash: The ambulance departed the right shoulder and the top of the front right corner of the patient compartment impacted a curve warning sign (**Figure 3**, event one). The ambulance traveled 16 m (53.5 ft) down a 15% grade into a ditch and the front plane and front undercarriage (**Figure 4**) impacted a culvert located at a residential driveway (**Figure 5**). The force direction on the ambulance was within the 12 o'clock sector and the impact deployed stage one of both frontal air bags. The vehicle's EDR reported the maximum longitudinal and lateral Delta Vs for this impact as -33.08 km/h (-20.55 mph) and -10.19 km/h (-6.33 mph), respectively. The ambulance traveled 11 m (36 ft)

Figure 3: Northbound approach of the ambulance to impact with the curve warning sign and culvert

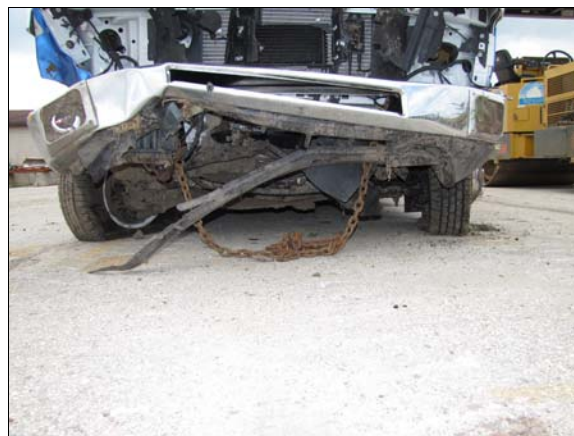
Figure 4: Damage to the front plane and front undercarriage from the impact with the culvert

Exterior Damage, Event 2: The ambulance sustained damage to the full width of the front plane from the impact with the culvert. The direct damage resided on the bottom of the bumper and extended onto the undercarriage. Heavy deposits of dirt were embedded in the front axle, wheels, and undercarriage. The cab of the vehicle was displaced vertically, which bent the frame and buckled the roof, roof side rails, and A-pillars (**Figure 6**). The direct damage began at the front right bumper corner and extended 177 cm (69.7 in) across the bottom of the bumper. Crush measurements were taken on the front bumper, but there was no residual crush.

Damage Classification, Event 2: The TDC was 12FDLW1 (10 degrees). The vehicle's EDR reported the maximum longitudinal and lateral velocity changes as -33.08 km/h (-20.55 mph) and -10.19 km/h (-6.33 mph), respectively

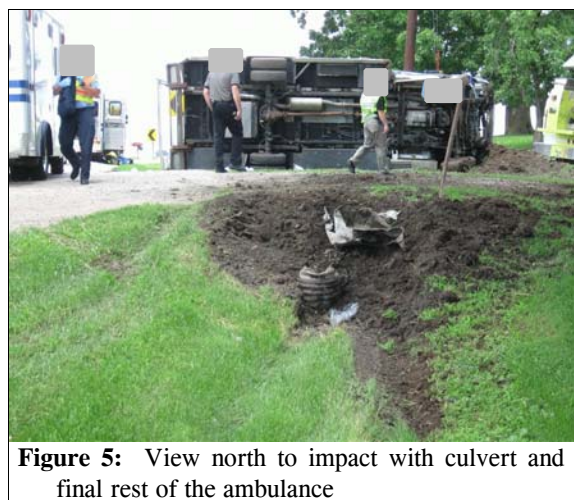
across the driveway as it rotated clockwise 90 degrees following the culvert impact and then rolled over, left side leading, one quarter turn. The distance traversed during the rollover was approximately 4 m (13 ft). The ambulance came to final rest on its left plane heading southeast (**Figure 5**).

Figure 5: View north to impact with culvert and final rest of the ambulance

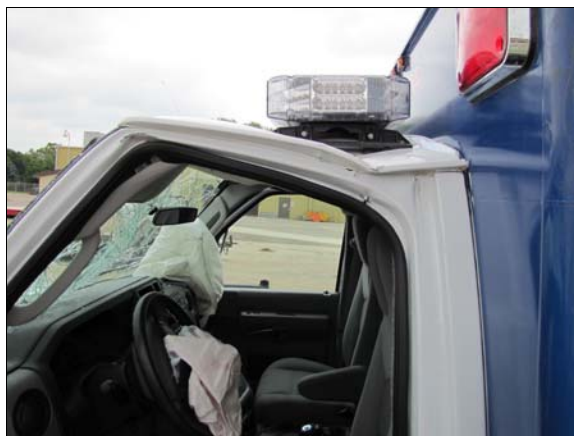
Figure 6: Induced damage to the roof, left roof side rail, and A-pillar

Exterior Damage, Event 3: The ambulance sustained damage to the left plane during the rollover. The damage consisted of dirt deposits in the left front wheel, broken left rear view mirror, and dirt deposits on the side of the patient compartment at the front and rear extending from the roof side rail to the bottom of the patient compartment. There was no lateral or vertical crush to the patient compartment or cab of the ambulance.

Damage Classification, Event 3: The TDC was 00LDAO1. The severity of the damage was minor.

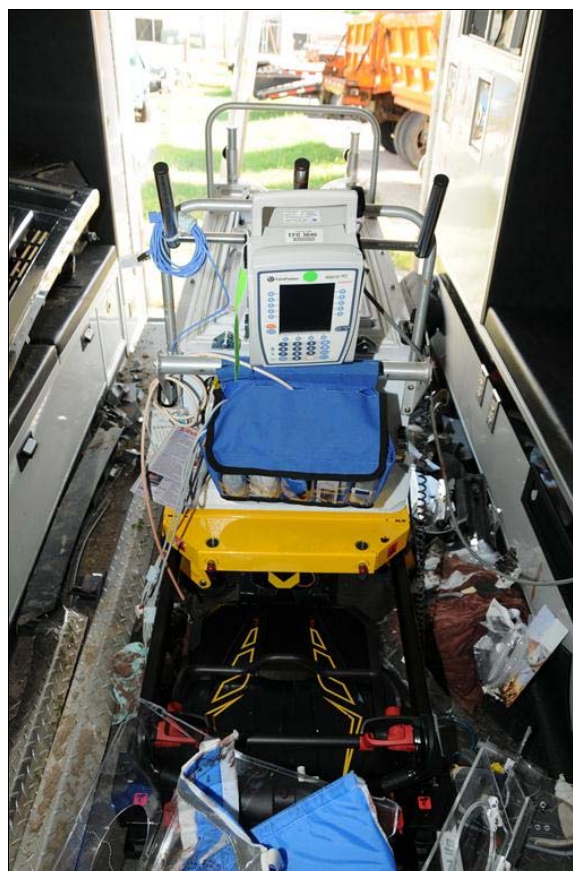
Patient Compartment: There was no intrusion to the patient compartment and no damage to the interior components other than a broken plexiglass door on the top left storage cabinet. There were at least two unsecured objects in the patient compartment: A laptop computer that was in use by the rear-facing box-mount seat passenger and a small cooler bag located on the EMT work area on the right side of the patient compartment. A transport case and small box of medical supplies was secured in the storage cabinet on the right side of the patient compartment. The police photographs showed that the Stryker Power Pro IT powered incubator unit remained secured to the Stryker Power Load cot fastener system (**Figure 7**). It was reported during the SCI interview with the rear-facing box mount seat passenger that two pumps on the end of the incubator unit facing this passenger came off during the crash. The extent of their displacement could not be determined.

Figure 7: Police photo of the Stryker Power Pro IT powered incubator unit

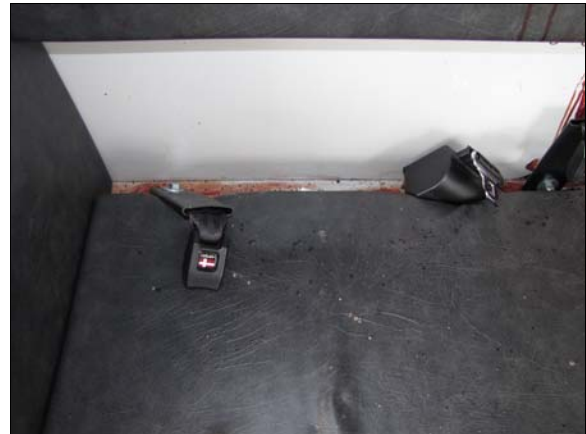
The pediatrician, who was seated in the rear position of the left inward-facing bench seat, was restrained by the lap belt. Inspection of the safety belt assembly revealed that the retractor and buckle brackets were bent inward and toward the front of the ambulance (**Figure 8**), and the forward edge of the plastic belt guide on the retractor was fractured. Inspection of the safety belt assemblies for the three remaining occupants in the patient compartment was inconclusive for use or non-use. The occupant who was seated in the rear position of the right inward-facing bench seat stated during the SCI interview that all the occupants in the patient compartment were restrained at the time of the crash. Injuries sustained by the two occupants seated on the right inward-facing bench seat were consistent with lap belt usage. The occupant seated in the rear-facing box-mounted seat sustained only minor injuries, suggesting she was probably restrained as well.

Figure 8: The safety belt assembly for the pediatrician, who was seated in the rear position of the left inward-facing bench seat

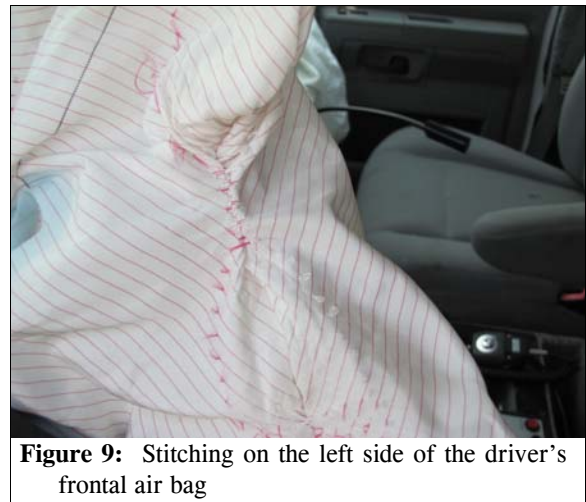
Figure 9: Stitching on the left side of the driver's frontal air bag

The ambulance was equipped with dual stage frontal air bags. The driver air bag deployed. The driver's air bag was constructed with stitching that was designed to separate. An area of stitching approximately 5 cm (2 in) long at the top left of the air bag did not separate (**Figure 9**). The front right passenger's air bag was equipped with an instrument panel-mounted On/Off switch. The switch was in the "On" position and the air bag deployed during the crash.

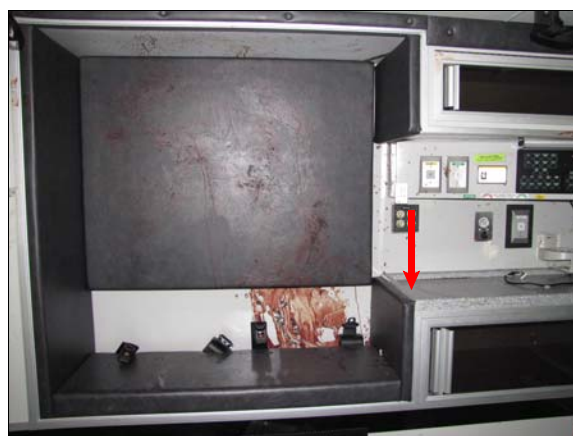
The rear passenger (a pediatrician) of the left inward-facing bench seat was restrained by the lap safety belt and seated in an upright position. The frontal impact with the culvert displaced the passenger toward the front of the patient compartment and slightly to the right. The passenger loaded the safety belt and the left side of his head and face contacted the edge of the EMT work table located on the left side of the patient compartment immediately to the passenger's left (**Figure 10**). He sustained cerebral edema, intraventricular hemorrhage, subarachnoid hemorrhage, epidural hemorrhage, multiple skull fractures, multiple facial fractures, dislocation of the right temporomandibular joint, laceration of the left internal carotid artery, and facial abrasions/lacerations. The passenger also sustained a left pneumothorax from contacting the vertical surface of the EMT work table. The passenger was redirected to the left when the vehicle rolled over, left side leading, onto its left plane coming to rest on the side of the patient compartment behind his seat position. Emergency responders removed the passenger from the patient compartment through the rear patient loading doors and transported him by air to a trauma center where he was admitted. He was pronounced deceased 33 hours and 13 minutes following the crash according to his medical records.

Figure 10: The rear passenger in the left inward-facing bench seat contacted his head and face on the edge of the EMT work table (arrow) during the frontal impact

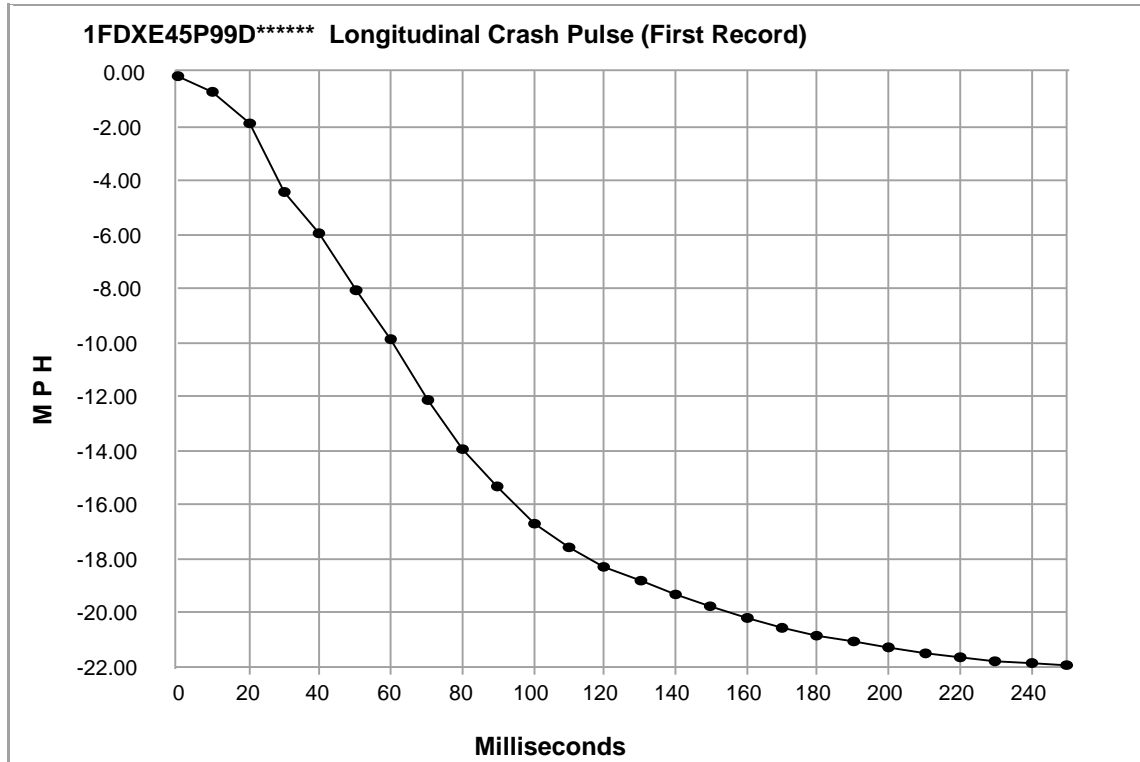
Longitudinal Crash Pulse (First Record)

Time (msec)	Delta-V, longitudinal (MPH)	Delta-V, longitudinal (km/h)
0	-0.12	-0.20
10	-0.74	-1.19
20	-1.86	-2.99
30	-4.40	-7.08
40	-5.96	-9.58
50	-8.08	-13.01
60	-9.90	-15.93
70	-12.12	-19.50
80	-13.93	-22.41
90	-15.31	-24.63
100	-16.72	-26.92
110	-17.54	-28.23
120	-18.29	-29.43
130	-18.78	-30.22
140	-19.33	-31.11
150	-19.75	-31.79
160	-20.22	-32.53
170	-20.52	-33.02
180	-20.80	-33.48
190	-21.04	-33.85
200	-21.27	-34.24
210	-21.48	-34.57
220	-21.61	-34.77
230	-21.76	-35.02
240	-21.86	-35.18
250	-21.95	-35.33

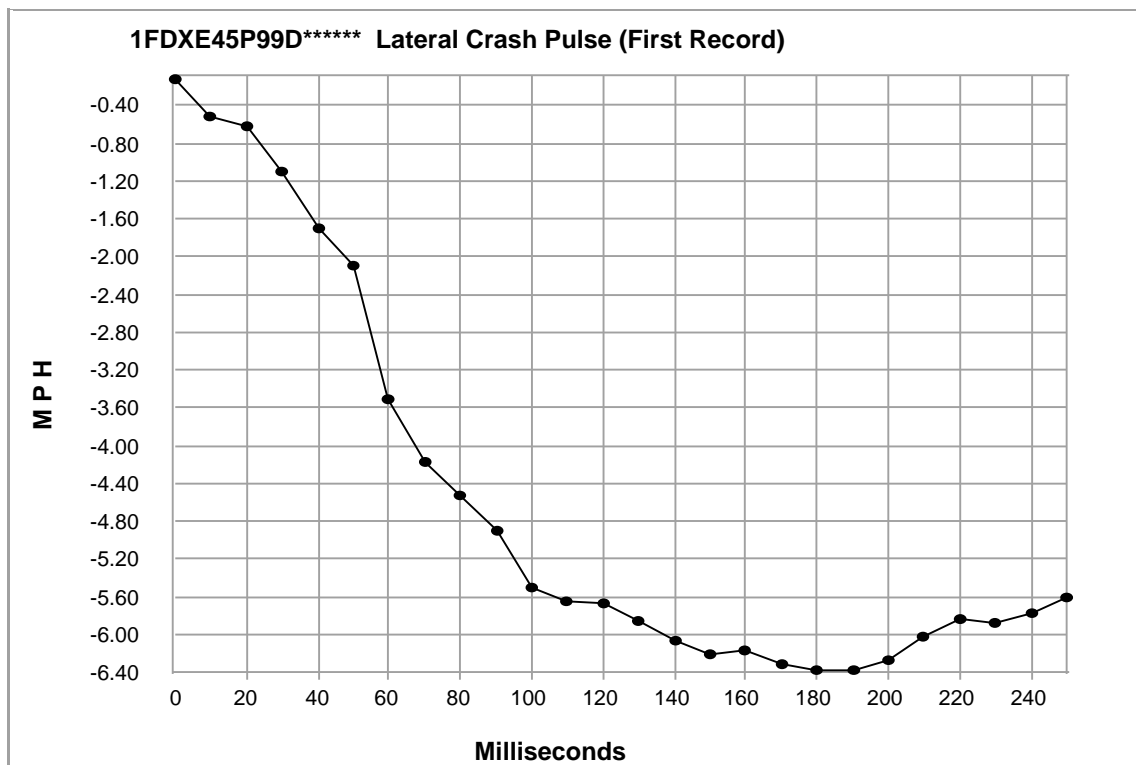
Lateral Crash Pulse (First Record)

Time (msec)	Delta-V, lateral (MPH)	Delta-V, lateral (km/h)
0	-0.12	-0.19
10	-0.51	-0.82
20	-0.62	-1.00
30	-1.11	-1.78
40	-1.70	-2.74
50	-2.10	-3.37
60	-3.51	-5.64
70	-4.18	-6.73
80	-4.53	-7.28
90	-4.89	-7.88
100	-5.51	-8.88
110	-5.64	-9.08
120	-5.68	-9.13
130	-5.86	-9.43
140	-6.07	-9.77
150	-6.20	-9.99
160	-6.18	-9.94
170	-6.31	-10.16
180	-6.38	-10.26
190	-6.38	-10.27
200	-6.27	-10.09
210	-6.02	-9.69
220	-5.84	-9.40
230	-5.87	-9.45
240	-5.78	-9.30
250	-5.60	-9.02
