**CASE NO.: CR14057**

**ON-SITE AMBULANCE CRASH INVESTIGATION**

**VEHICLE: 2011 FORD E350 TYPE III AMBULANCE**  
**AMBULANCE BODY: WHEELED COACH CITIMEDIC PLUS VII**

**CRASH DATE: AUGUST 2014**

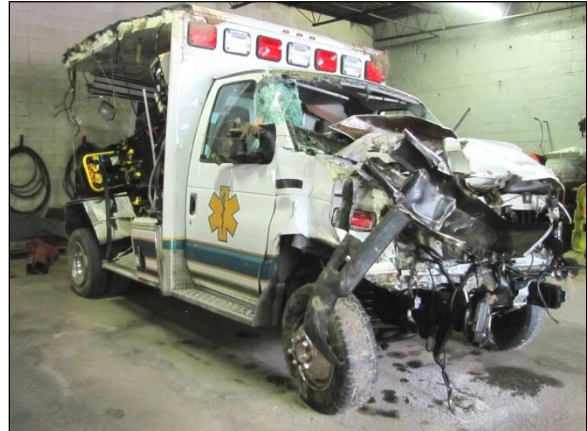
**Figure 1:** Involved 2011 Ford E-350 Type III ambulance at the time of the SCI inspection.

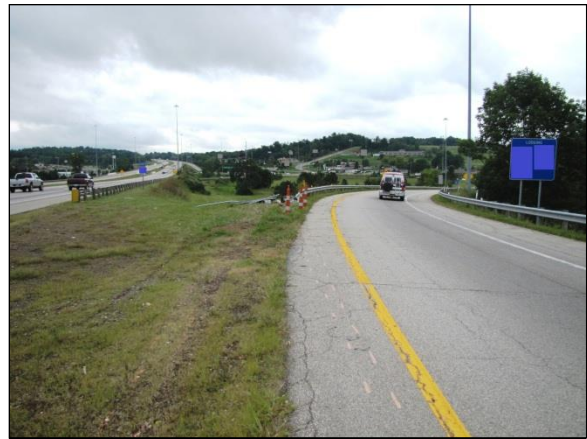
**Figure 4:** Crash event travel path of the ambulance viewed from the Event 1 impact location.

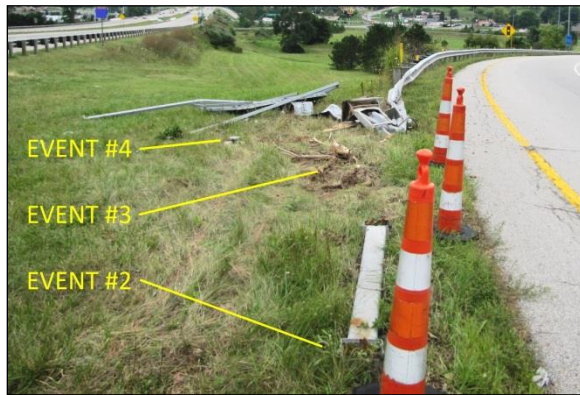
Similar to preceding events, the Event 4 impact was not of sufficient magnitude to affect or alter the ambulance's trajectory. **Figure 5** depicts the location of the second, third, and fourth impact Events.

**Figure 5:** Second, third, and fourth crash events within the ambulance's multiple event crash sequence.

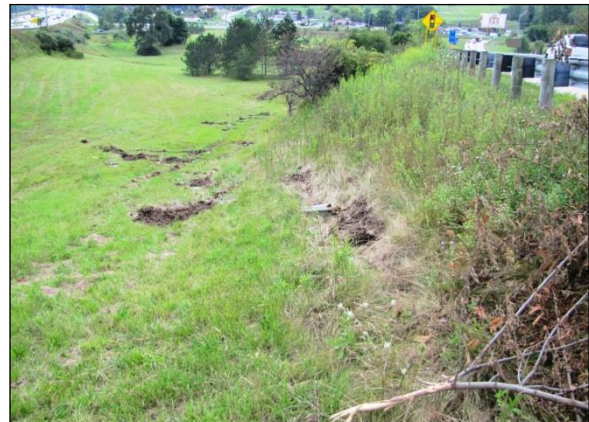
**Figure 6:** Fall-over initiation location for the ambulance's rollover (Event 5) within the embankment/swale area.

The ambulance maintained its forward travel path and deformed the guardrail, which deflected downward. The vehicle then overrode the deformed portion of the guardrail, which snagged on the driveshaft and sheared it from the chassis. The ambulance maintained its forward trajectory and began to negotiate the steep negative embankment of the interchange ramp. Due to the slope of the embankment and the mass of the ambulance, its rear aspect began to translate the downslope and a clockwise (CW) yaw was initiated. An instability was created as the vertical axis of the ambulance's center of mass deviated left from the normal axis with respect to the cross-slope of the embankment. This initiated a fall-over rollover sequence off of the embankment (Event 5). **Figure 6** depicts the rollover initiation location and trajectory of the ambulance, as well as the embankment and broad grass area between the limited-access roadway and the exit interchange ramp.

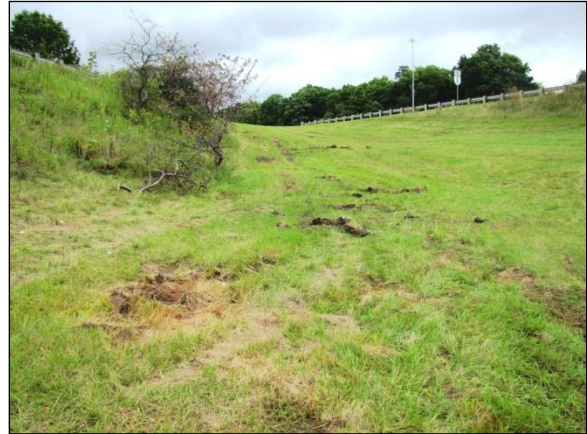
During the rollover sequence, the ambulance's front plane struck the branches of a 15 cm (6.0 in) diameter tree (Event 6). Although the branches were sheared by the associated forces, the impact was not of sufficient magnitude to interrupt or alter the ambulance's rollover sequence. The ambulance maintained its rollover and came to final rest with its left plane facing upward (with the open right plane area down) after having completed eleven quarter-turns. The overall distance of the rollover from the initiation point to the final rest position measured 45.0 m (147.6 ft). **Figure 7** depicts a lookback view from the ambulance's final rest position to the rollover path and Event 6 impact location.

**Figure 7:** Lookback from the ambulance's final rest position to the Event 6 impact and Event 5 rollover path.

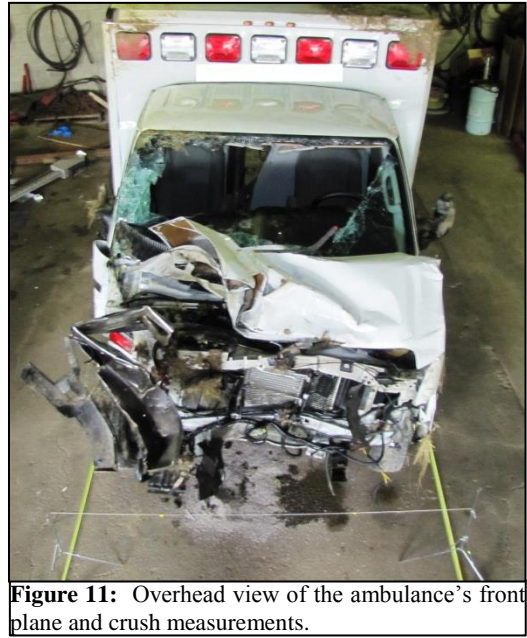
Direct contact damage associated with the guardrail (Event 2) was distributed across the Ford's front plane. Although initial engagement was narrow based on the 38 cm (15.0 in) width of the energy absorbing end terminal, prolonged engagement with the deforming guardrail and its posts resulted in damage across the Ford's entire 178 cm (70.0 in) front end width. Frontal components, including the bumper beam, grille, radiator, headlight assemblies, fascia, and hood were deformed rearward by associated contact and crash forces. Damaged frontal components separated in whole or in part during the subsequent crash sequence events. At the time of the SCI vehicle inspection, the metallic front bumper was completely separated from its frame rail mounts.

**Figure 11:** Overhead view of the ambulance's front plane and crush measurements.

Using the documented undamaged cab length, the SCI Investigator obtained damage measurements to the exposed frame rail ends (**Figure 11**). Based on exemplar measurements, no deflection of the frame rail ends resulted from the crash. The CDC assigned to the ambulance for the Event 2 guardrail impact was 12FREW2. No WinSMASH calculations could be performed for the Event 2 impact due to the yielded status of the guardrail and posts and lack of measurable deformation.

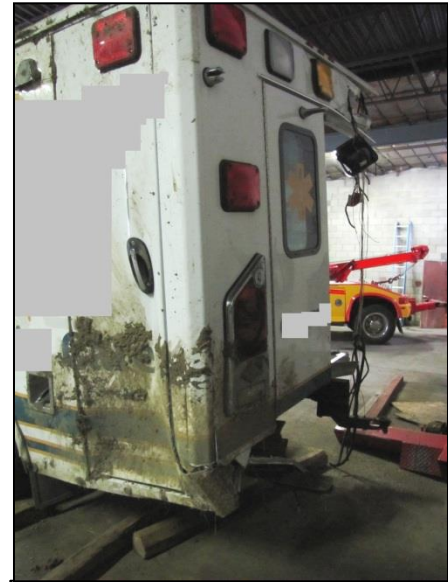
Severe damage and integrity loss was sustained by the ambulance during Event 5. The entire right plane and the right half of the rear plane of the patient compartment separated completely from the vehicle during the eighth and ninth quarter-turns of the rollover. On the ambulance's rear plane, only the left corner aspect, rear header, and left rear loading door remained. The right rear loading door, lower door frame, right rear corner aspect, and rear step bumper were completely separated. **Figure 12** depicts a left rear oblique view of the ambulance and its remaining components. Note the deflection and deformation to the lower left rear corner and sill. The complete separation of the right plane is depicted in **Figure 13**. The separation of the right plane resulted from the fracture of all welded joints of the roof and floor structure to the right plane. Some of the joints were welded circumferentially, while others were spot welded (**Figure 14**).

**Figure 12:** Left rear oblique view of the ambulance and remaining components.

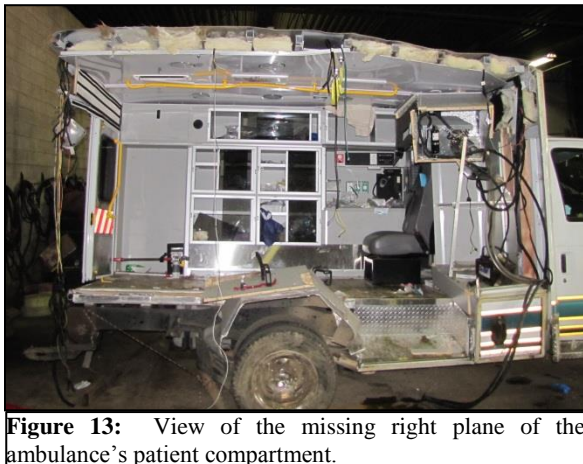
**Figure 13:** View of the missing right plane of the ambulance's patient compartment.

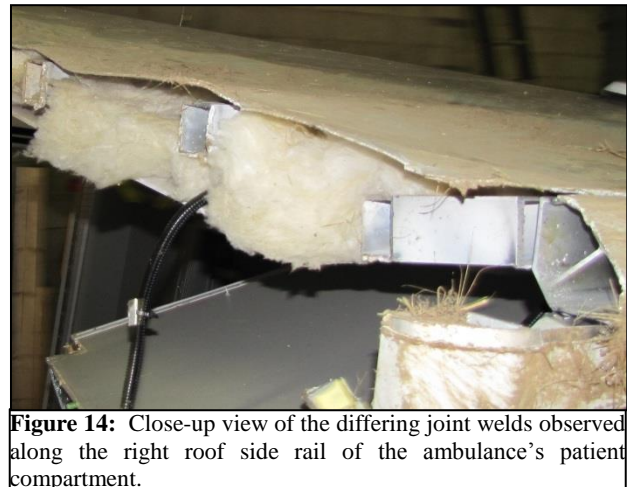
**Figure 14:** Close-up view of the differing joint welds observed along the right roof side rail of the ambulance's patient compartment.

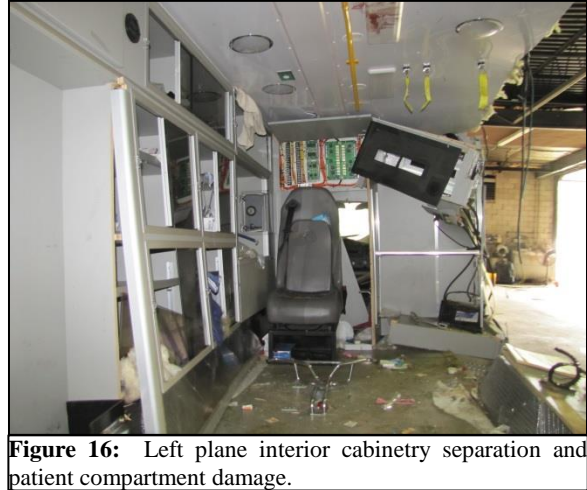
The majority of the EMS supplies originally contained within the left side cabinetry prior to the crash was released from within their respective cabinets during the rollover sequence and ejected following separation of the joint seams and displacement of the sliding polymer doors. The collapsible stair chair that was strapped against the wall within the left rear corner of the patient compartment's interior became dislodged during the crash sequence and was also ejected during the rollover. All other EMS equipment and supplies within the interior of the patient compartment, including those within the cabinetry at the right front corner aspect, were ejected following the integrity loss of the right plane. **Figure 16** depicts the interior of the patient compartment at the time of the SCI vehicle inspection.

**Figure 16:** Left plane interior cabinetry separation and patient compartment damage.

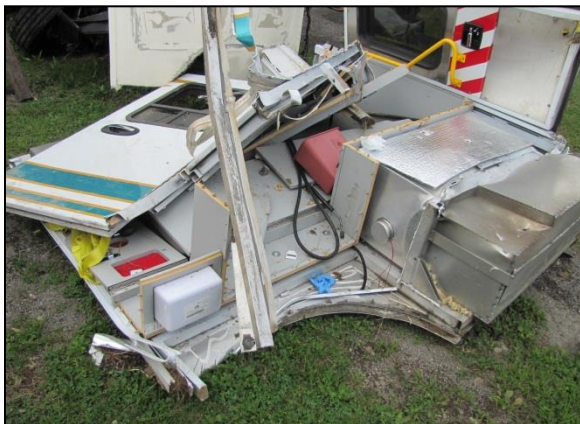
**Figure 17:** Separated right plane of the patient compartment and its components.

Cabinetry and the HVAC unit mounted to the forward wall of the patient compartment also became separated during the rollover sequence. All right plane cabinetry, including the bench seat, remained affixed to the separated right plane. **Figure 17** depicts the separated right plane of the patient compartment. Note separated components, including the right side occupant loading door, right rear loading door, bench seat, right rear wheel well, right rear exterior compartment, and interior cabinetry components.

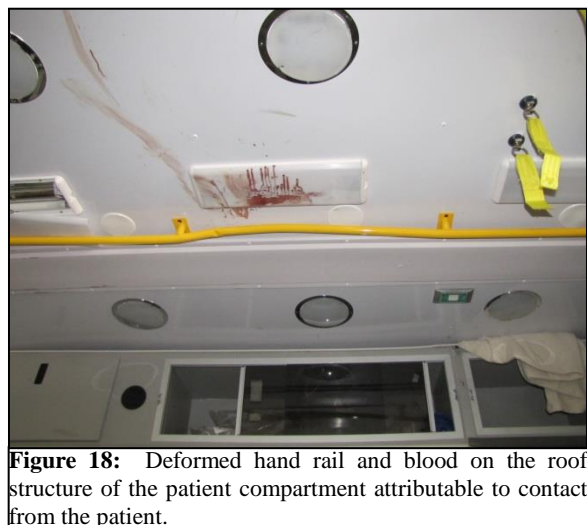
Occupant contact damage was located on the roof of the patient compartment's interior and was attributable to contact and loading from the displaced patient during the rollover crash event sequence. This contact and loading consisted of the deformation of the yellow aluminum hand rail mounted to the roof structure and large blood splatter on the roof's surface (**Figure 18**). The blood splatter displayed high velocity characteristics and was accompanied by a smear that extended from its origin location on the roof laterally toward the open right plane.

**Figure 18:** Deformed hand rail and blood on the roof structure of the patient compartment attributable to contact from the patient.

The blood splatter and smear were consistent with the patient having contacted the hand rail and roof components with his head and then remaining engaged with the roof structure as he initiated and completed his ejection path. There was no discernable contact evidence identified during the SCI vehicle inspection that could be associated with the male EMT's kinematics.

During the rollover sequence (SCI Event 5), centrifugal and loading forces acting on the cot surpassed the aluminum frame rail’s shear strength load and sheared the lower frame rail within the area of the locking pin. Subsequently, the cot became dislodged from the fastening system. The cot and patient then contacted the roof structure of the patient compartment’s interior, which resulted in multiple facial and head injuries to the patient and deformed the aluminum hand rail mounted near the roof structure’s centerline (*refer to **Figure 18** above*).

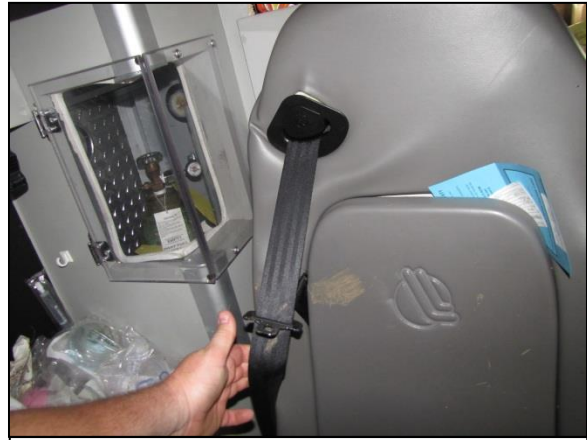
The captain's chair safety belt system also had an ELR with continuous loop webbing and utilized a sliding latch plate. The retractor was integrated into the seat back, while the lower anchor and buckle were mounted to the swivel base. The captain's chair was further equipped with a 5-point harness that was integrated into a folding flap within the seat back. At the time of the SCI inspection, the ELR was locked (**Figure 20**) and the webbing was devoid of crash-related occupant loading evidence. In conjunction with the male EMT's ejection, it was apparent that the captain's chair safety belt system was not in use at the time of the crash.

**Figure 20:** Locked ELR of the captain's chair safety belt system at the time of the SCI inspection.

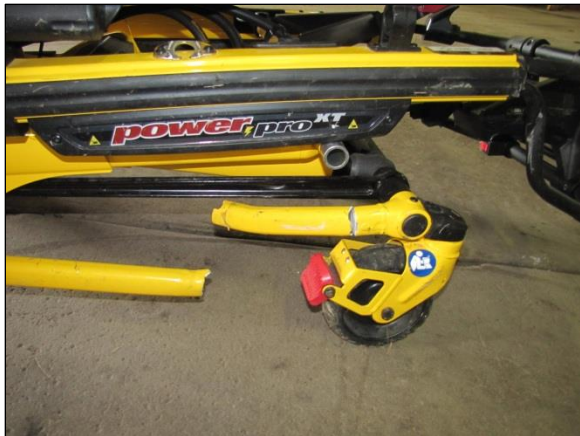
The Stryker cot sustained major damage as a result of the multiple-event crash. Initial damage during the crash sequence consisted of deformation sustained by the right lower frame rail due to loading and inertial forces. Those forces exceeded the shear strength load of the aluminum, and the frame rail sheared at the securement location of the locking pin. Following the shear of the tubular aluminum frame rail, the cot became dislodged from the fastening system and was subjected to unrestricted movement within the patient compartment.

**Figure 23:** Fractured lower frame rail of the Stryker cot at the location of the locking pin.

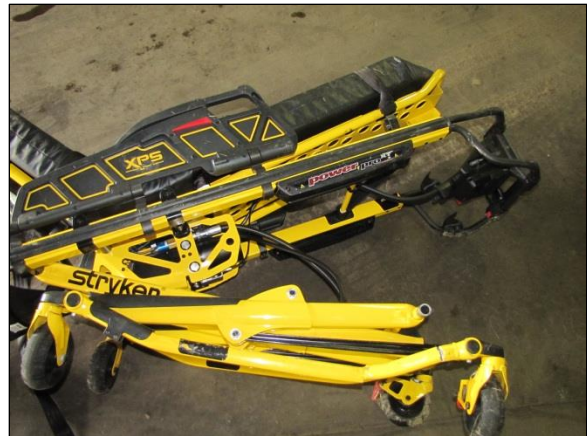
The tumbling trajectory of the cot deformed the telescopic portion of the cot's platform frame beneath the head portion of the mattress bed. The X-frame support legs separated from the cot's platform frame at the foot end of the cot. The mattress bed and platform also appeared deformed. **Figures 23 and 24** depict the damaged cot at the time of the SCI inspection.

**Figure 24:** Separated X-frame support legs at the foot end of the Stryker cot.

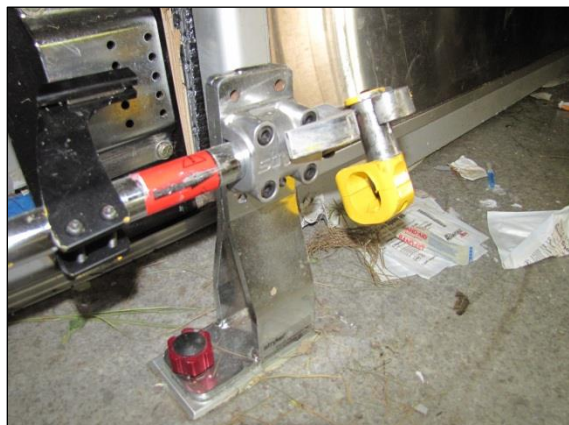
During the crash sequence, longitudinal, lateral, and centrifugal forces associated with the crash induced multi-directional movement to the cot. Forces associated with the rollover (Event 5) resulted in deformation to the rail-clamp mechanism of the cot fastening system and the fracture of the cot's frame. The moment force of the cot's loading was transferred to the rail-clamp mechanism via the engagement of the locking pin within the clamp, resulting in the left lateral rotation of the rail-clamp mechanism. At the time of the SCI inspection, the locking pin remained engaged within the clamp mechanism, rotated approximately 30-degrees (**Figures 25 and 26**). There was no apparent deformation or deflection of the forward antler bracket.

**Figure 25:** Locking pin engaged within the rail-clamp mechanism at the time of the SCI inspection.

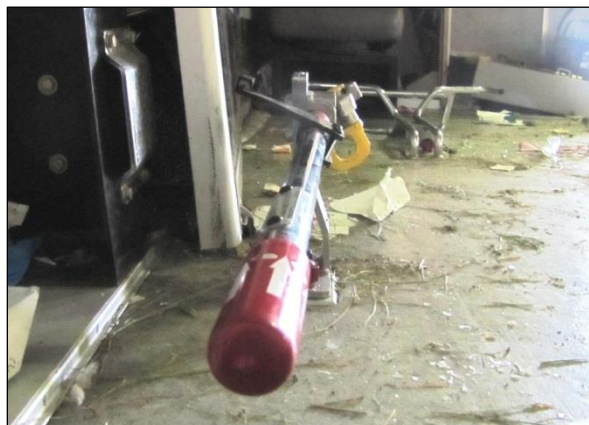
**Figure 26:** Rail-clamp mechanism and locking pin rotated counterclockwise (CCW).
