ON-SITE AMBULANCE CRASH INVESTIGATION

SCI CASE NO.: CR14003

VEHICLE: 2010 CHEVROLET G3500 TYPE III AMBULANCE

AMBULANCE BODY: PL CUSTOM MEDALLION SERIES 80

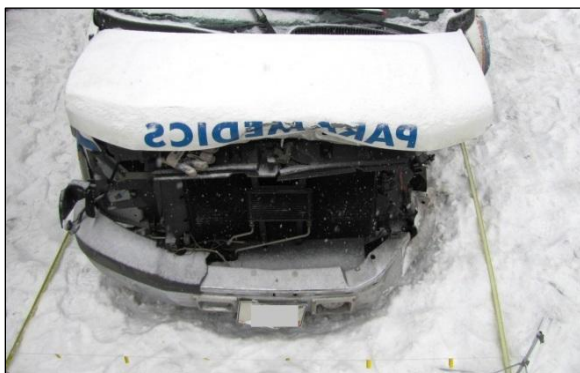
Associated with the Event 1 frontal impact with the GMC was longitudinal deformation and direct contact damage that began 22 cm (8.7 in) right of center and extended 104 cm (40.9 in) to the left front bumper corner (**Figure 10**). The combined direct and induced damage length measured 164 cm (64.6 in) and spanned the entire frontal width. The direct and induced damage extended 395 cm (155.5 in) down the left plane from the displaced front bumper corner to immediately forward of the center of the left rear axle on the fender flare and wheel well (**Figure 11**). The left front corner of the patient compartment module was displaced rearward 40 cm (15.7 in).

Figure 10: Frontal crush profile to the Chevrolet ambulance.

A residual crush profile consisted of the following measurements: C1 = 47 cm (18.5 in), C2 = 18 cm (7.1 in), C3 = 6 cm (2.4 in), C5 = 1 cm (0.4 in), C5 = 0 cm, and C6 = 1 cm (0.4 in). The Collision Deformation Classification (CDC) assigned to the ambulance for the Event 1 damage pattern was 12FYEW3. Although the ambulance was a modified vehicle, the Damage Algorithm of the WinSMASH model was used to calculate a borderline reconstruction of the Event 1 impact for analysis purposes. The calculated delta-V of the ambulance for the impact with the GMC was 8 km/h (5 mph). Lateral and longitudinal components of the calculated delta-V were 1 km/h (0.6 mph) and -8 km/h (-5 mph), respectively.

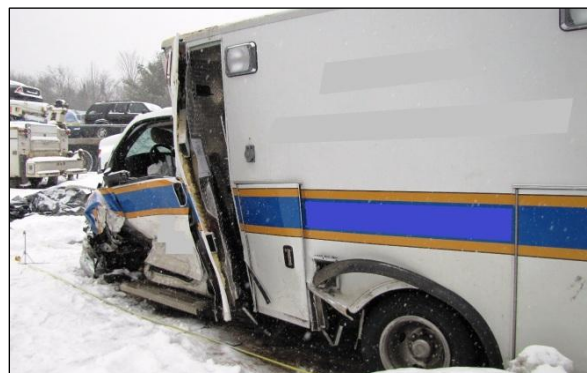
Figure 11: Damage extension onto the left plane of the ambulance associative to the Event 1 impact.

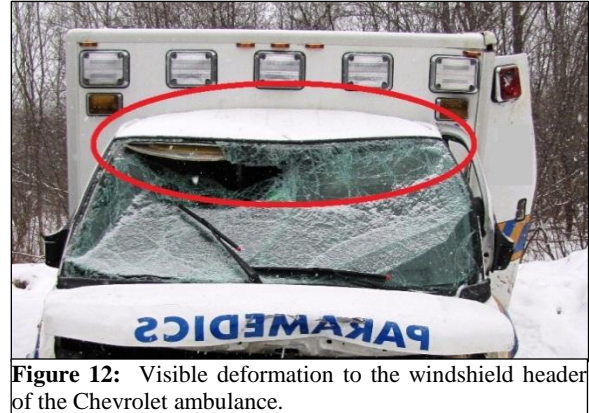
Rollover damage sustained by the ambulance (Event 2) was minimal. This was attributable to the deep snow present at the time of the crash and the dynamics of the rollover down the steep embankment. Only minor contact evidence was visible along both roof side rails, with no evidence of deformation or deflection to the roof structure of the patient compartment. There was 1 cm (0.4 in) of vertical deflection of the center aspect of the windshield header (Figure 12). The CDC for the Event 2 rollover was 00TDDO2.

Figure 12: Visible deformation to the windshield header of the Chevrolet ambulance.

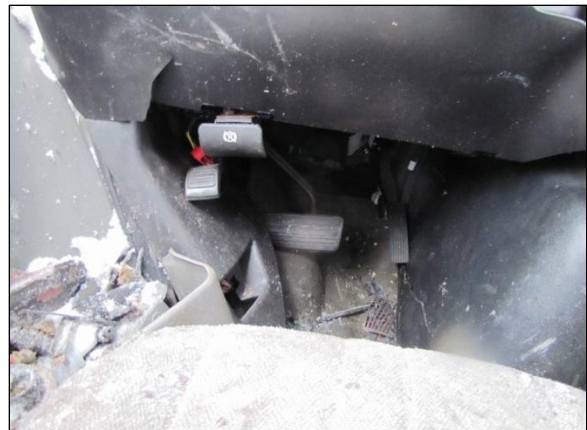
Intrusion within the cab of the ambulance was present on the left side, attributable to the Event 1 impact. The left front door was intruded laterally and engaged against the left aspect of the box-mounted driver's seat. A measurement obtained at the forward lower quadrant of the left front door produced a lateral intrusion with magnitude of 14 cm (5.5 in). Longitudinal intrusions were observed to the left front toe pan with a magnitude of 18 cm (7 in), left lower A-pillar with a magnitude of 12 cm (4.7 in), and left instrument panel with a magnitude of 4 cm (1.6 in). **Figure 13** depicts the left portion of the ambulance cab, with identified intrusions visible.

Figure 13: Identified intrusions within the left aspect of the ambulance's cab.

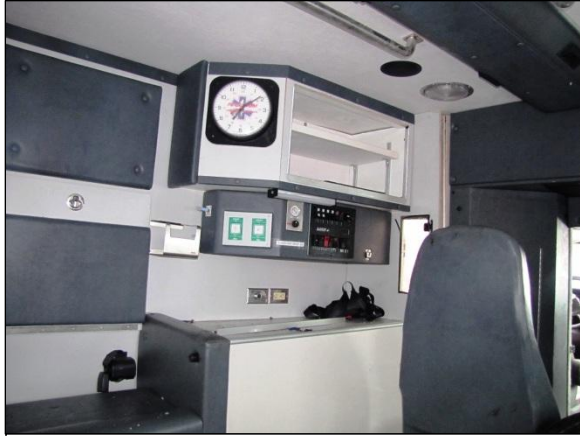
Minor interior damage within the patient compartment of the ambulance was identified. This damage was located on the left and forward aspects of the patient compartment module, attributed to the Event 1 impact and contact from displaced occupants and EMS equipment/supplies during the rollover sequence. Cabinetry at the left front corner of the patient compartment, immediately left of the captain's chair and forward of the CPR seat, was separated at major joints and displaced rearward. The plywood surface below the CPR seat and forward countertop was fractured, and several pieces of aluminum fascia and trim were separated from the cabinetry.

All of this damage was induced as a result of the deformation sustained to the left front corner of the patient compartment module by the Event 1 impact with the GMC. **Figure 14** depicts the left front area of the patient compartment with the identified damage, while **Figure 15** depicts the fractured plywood and occupant contact.

Figure 14: Forward left area of the patient compartment and damaged object area.

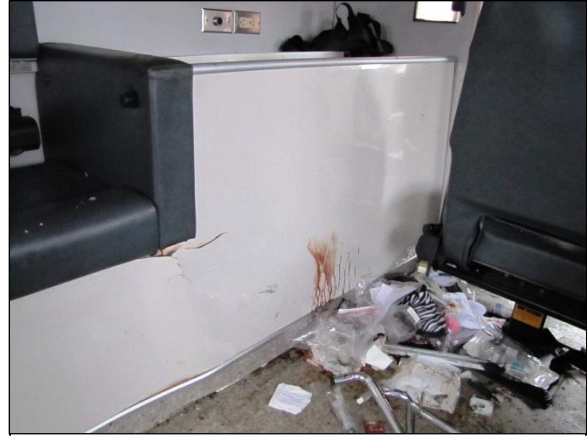
Figure 15: Fractured plywood surface and occupant contact in the forward left area of the patient compartment.

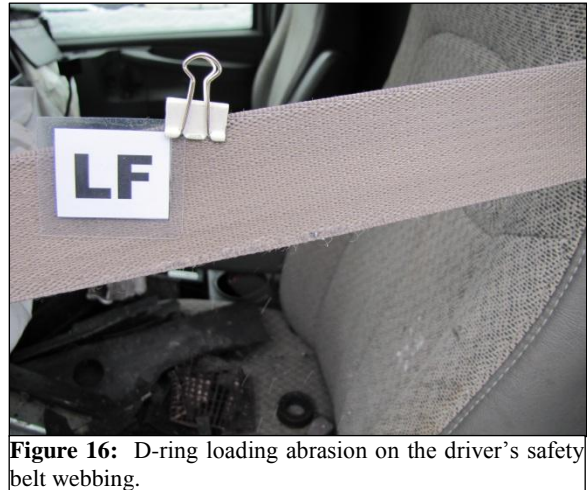
Figure 16 depicts the D-ring loading abrasion identified on the driver's safety belt webbing. There was no loading evidence present on the front right safety belt system; however, the front right seat was unoccupied at the time of the crash. The interior of the patient compartment was equipped with manual lap safety belt systems at all five seating positions. All utilized continuous loop webbing with sewn latch plates and ELR retractors. The components of the safety belts for the CPR seat and bench seat were mounted to the patient compartment walls, whereas that of the captain's chair were mounted to its swivel base. All five lap belts displayed little to no evidence of historical use, and as such restraint usage by the paramedic could not be confirmed or disputed based solely on the post-crash condition of the lap safety belt systems. Based on the paramedic's statements, he did not utilize the available manual restraints at the time of the crash due to his engagement in providing patient care (not specified). The lap belt for the forward-most bench seat position had been cut post-crash, resulting in an unknown length of the webbing having been retracted onto the retractor and thus unable to be inspected.

Figure 16: D-ring loading abrasion on the driver's safety belt webbing.

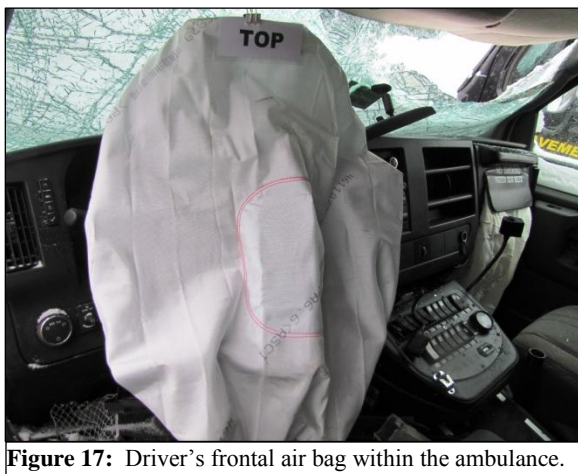
The frontal crash impact (Event 1) resulted in the deployment of the Chevrolet's frontal air bag system. **Figures 17** and **18** depict the driver's and front right passenger's frontal air bags at the time of the SCI inspection.

Figure 17: Driver's frontal air bag within the ambulance.

The driver's air bag deployed through the I-configuration cover flaps without damage. An 18 cm (7.1 in) diameter center circular stitching secured the interior tethers to the air bag's face. The air bag was 62 cm (24.4 in) diameter overall in its deflated state. There were two 2 cm (0.8 in) vents on the rear aspect of the air bag. No obvious contact evidence or damage was discernable. The passenger's air bag deployed through the U-configuration cover flap without damage. In its deflated state, the air bag was 56 cm (22 in) wide and 46 cm (18.1 in) tall, with 25 cm (9.8 in) overall rearward excursion. There was no contact evidence or damage present. Both air bags were installed by the original manufacturer and had not required any service or maintenance.

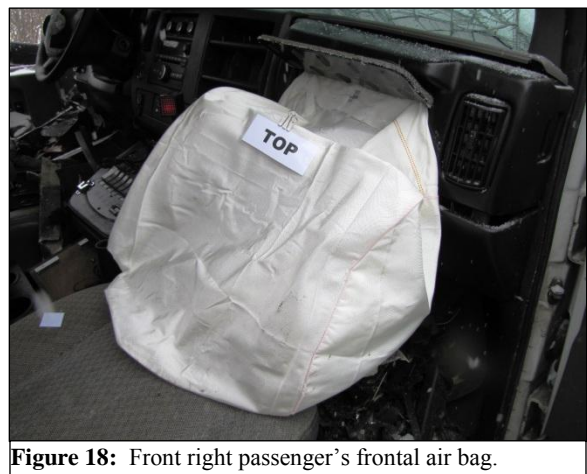
Figure 18: Front right passenger's frontal air bag.

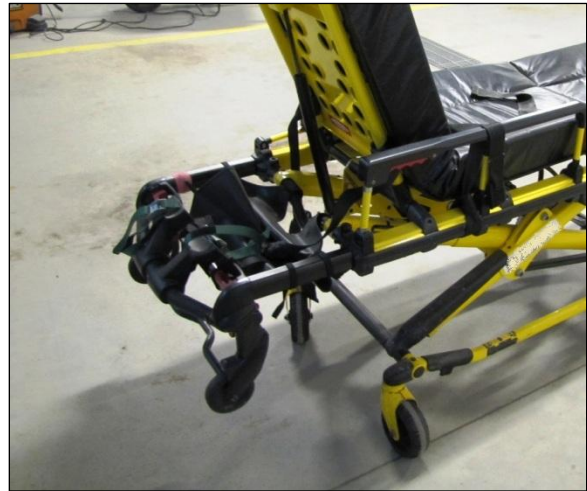
The patient cot sustained minor damage attributable to occupant loading in relation to the first and second crash events (frontal impact and rollover) and was removed from service by the agency. The telescopic support bracket of the cot's frame, located forward of and beneath the reclinable backrest, sustained longitudinal and lateral loading that resulted in the minor deflection of the tubular frame. This deflection limited the support's telescopic adjustment functionality, and in its damaged state, the telescopic frame could not fully retract. **Figure 20** provides an overall view of the forward aspect of the cot at the time of the SCI inspection.

Figure 20: Telescopic support partially retracted at the time of the SCI inspection.

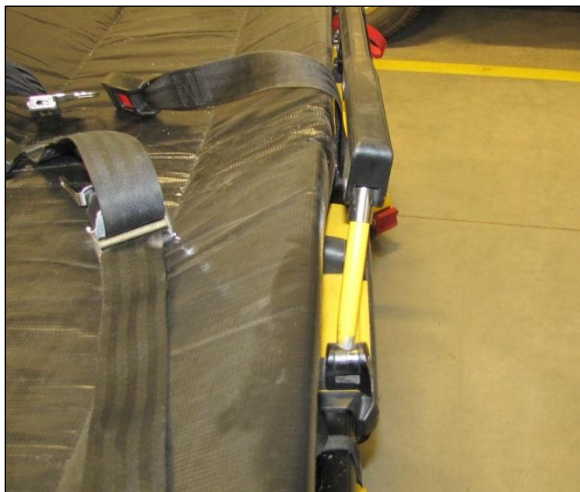
Figure 21: Lateral deflection of the right armrest bracket resultant from occupant loading.

The right armrest bracket (with respect to the patient's orientation) was deformed laterally at its forward aspect as a result of direct occupant contact and loading (**Figure 21**). The anchor pin (**Figure 22**), which secured into the locking clamp of the cot fastening system, displayed evidence of significant historical use. Although the set screw was fully tightened, the pin itself was slightly loose and wiggled slightly on the tubular frame rail. This movement was not of a measurable magnitude.

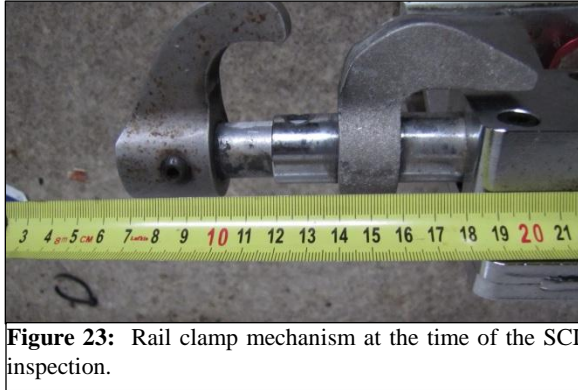
Figure 23: Rail clamp mechanism at the time of the SCI inspection.

During the crash sequence, longitudinal, lateral, and centrifugal forces associated with the crash induced multi-directional movement to the cot. Longitudinal forces associated with the frontal impact (Event 1) resulted in the compression of the cot's telescopic frame as the forward aspect of the cot loaded the antler bracket. In turn, the locking pin affixed to the frame rail of the cot loaded the rail clamp, forcing the clamp forward. This longitudinal loading associated with Event 1

deformed the rail clamp and damaged its internal mechanism. At the time of the SCI inspection, the rail clamp remained 2 cm (0.8 in) from its fully-closed position (**Figure 23**).

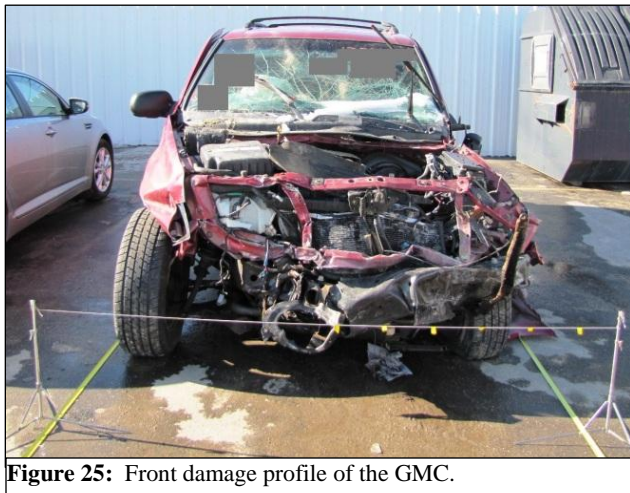
Damage to the exterior of the GMC was identified on the front plane, associative to the Event 1 impact with the ambulance. Front plane damage included displacement of the bumper beam and fracture of the grille, with deformation to the hood and disintegration of the headlight assemblies. There was visible lateral displacement of frontal plane components, with moderate longitudinal deformation. The crankshaft of the left front axle was separated at the universal joint, though the left front tire and wheel assembly remained attached to the vehicle by the suspension and shock absorber.

Deformation to the left front fender and longitudinal crush to frontal components further restricted the left front tire. In the left front tire/wheel's restricted position, the left wheelbase was shortened by 10 cm (4 in). Direct contact damage associated with the Event 1 frontal impact with the ambulance spanned the entire 165 cm (65 in) frontal end width.

Based on the damage measurements, the CDC assigned to the GMC for the Event 1 impact damage pattern was 81FDEW2. **Figure 25** depicts the Event 1 frontal damage and crush profile, while **Figure 26** depicts an overhead view of the front plane damage.

Figure 25: Front damage profile of the GMC.

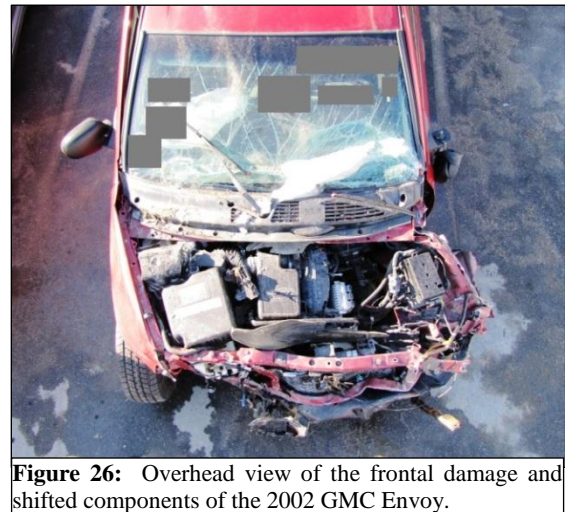
Figure 26: Overhead view of the frontal damage and shifted components of the 2002 GMC Envoy.
