ON-SITE AMBULANCE CRASH INVESTIGATION

CASE NUMBER - IN11023

VEHICLE - 2010 CHEVROLET EXPRESS G3500 TYPE III AMBULANCE

CRASH DATE - July 2010

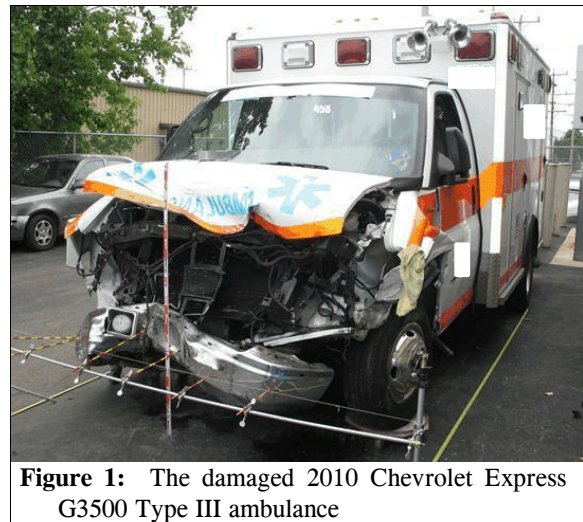
Figure 1: The damaged 2010 Chevrolet Express G3500 Type III ambulance

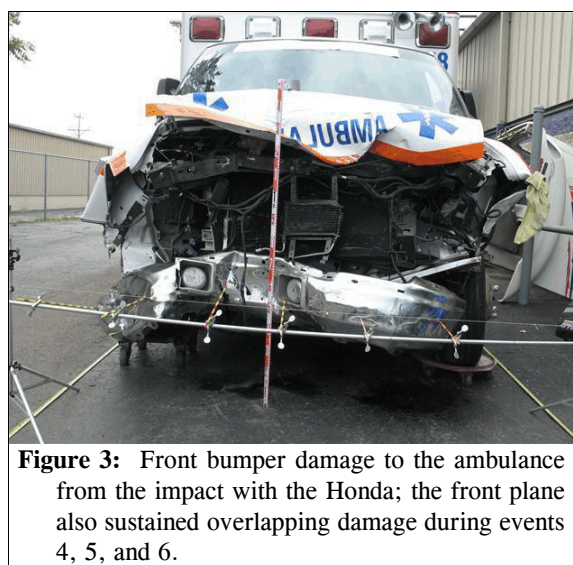
Figure 3: Front bumper damage to the ambulance from the impact with the Honda; the front plane also sustained overlapping damage during events 4, 5, and 6.

Exterior Damage, Event 1: The ambulance sustained overlapping front plane damage during the impacts with the Honda (event 1), electrical junction box (event 4), and street sign (event 5). Analysis of the police on-scene photographs and the damage to the vehicle indicated that the crush

sustained by the bumper was primarily from the impact with the Honda. The direct damage began at the front left bumper corner and extended 161 cm (63.4 in) across the bumper. The Field L was also 161 cm (63.4 in). The crush measurements were taken at the bumper level and the maximum residual crush was 46 cm (18.1 in) occurring at C₄. The crush values were: C₁=0 cm, C₂= 6 cm (2.4 in), C₃=37 cm (14.6 in), C₄= 46 cm (18.1 in), C₅= 32 cm (12.6 in), C₆= 40 cm (15.7 in). The right side wheelbase was reduced 7 cm (2.8 in), while the left side wheelbase was extended 2 cm (0.8 in).

Damage Classification, Event 1: The Collision Deformation Classification (CDC) for the impact with the Honda was 11FDEW3 (320 degrees). The Missing Vehicle Algorithm of the WinSMASH program calculated the total Delta V as 17 km/h (10.6 mph). The longitudinal and lateral velocity changes were -13 km/h (8.1 mph) and 11 km/h (6.8 mph) respectively. The vehicle's EDR reported the maximum longitudinal and lateral velocity changes as -15.6 km/h (-9.69 mph) and 10.67 km/h (6.63 mph), respectively.

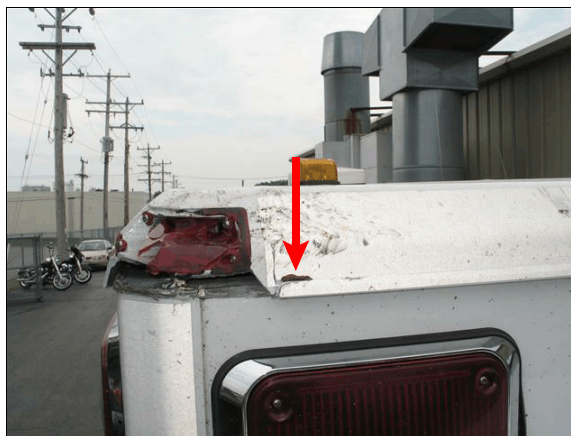
Figure 4: Damage on the upper front right corner of the patient compartment from impact with the tree; arrow shows bark from tree

Exterior Damage, Event 6: The ambulance also sustained non-horizontal damage to the front of the patient compartment when it impacted a 60 cm (23.6 in) diameter tree while the ambulance was on its left plane on the top plane of the Honda. The siren horns and top right corner of the patient compartment were damaged.

Damage Classification, Event 6: The CDC was 00FDGW8. The severity of the damage was minor.

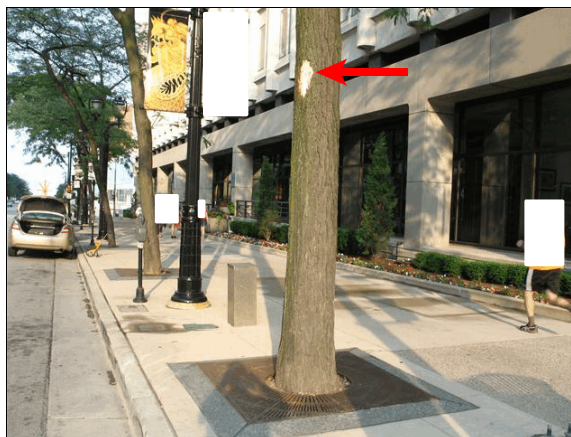
Figure 5: View southeast; arrow shows damage to the tree from the impact by the upper front right corner of the ambulance's patient compartment

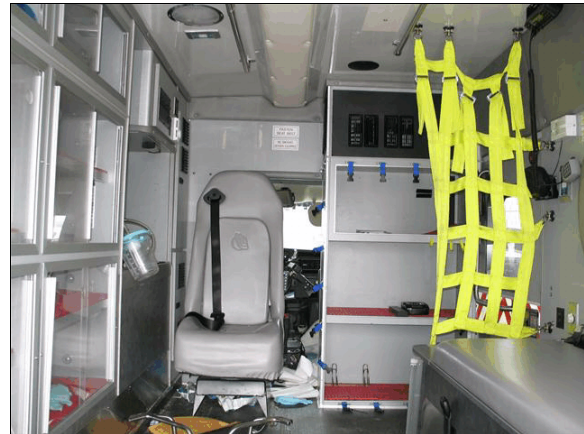
A nylon net was located on the forward end of the bench seat (**Figure 6**). It was attached to the ceiling, right wall of the patient compartment, and the header panel on the base of the bench seat. The header panel was glued to the base of the bench seat, which was constructed of plywood. The unrestrained EMT, who was seated in the front seating position on the bench seat, contacted the net during the impact with the Honda (event 1), which separated the header panel from the base of the bench seat (**Figure 7**). The EMT contacted the roof to the right of the rear-facing seat during the rollover leaving two scuff marks on the roof.

Figure 6: Patient compartment of the ambulance and the net at the front end of bench seat

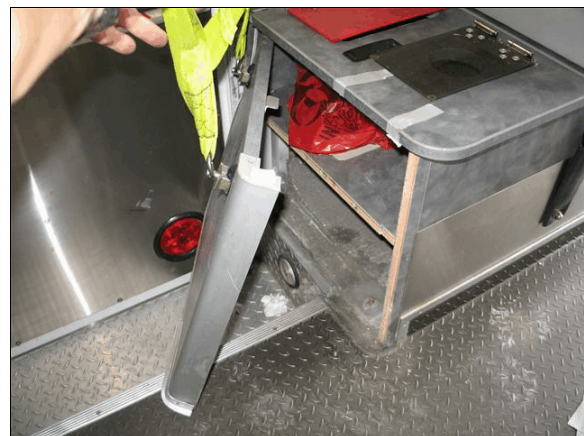
Figure 7: The displaced header panel at the front end of the bench seat

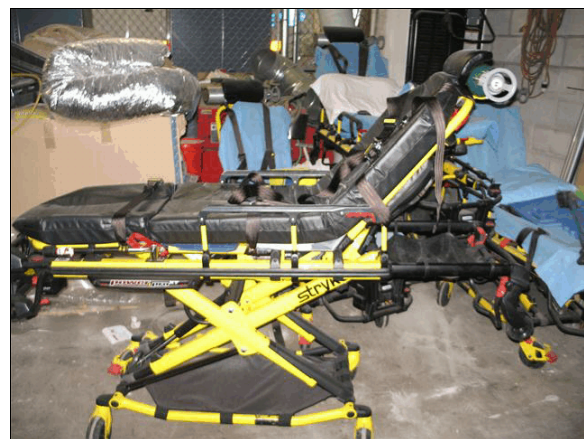
Patient Cot: The cot that was used to transport the patient was a Stryker 6500 Power-Pro XT (**Figure 8**), serial number 101140625. The cot was an aluminum X-frame design and its maximum weight capacity was 318 kg (700 lb). It was equipped with a 24 volt battery hydraulic lift system. The standard length and width of the cot was 206 cm (81 in) and 58 (23 in), respectively. It's lowest adjustable position was 36 cm (14 in) and the highest was 105 cm (41 in). The cot was equipped with two torso restraints, two shoulder straps, and leg restraints. A removable oxygen cylinder was located at the head of the cot. It was not in use at the time of the crash. The ambulance driver stated during the SCI interview that the patient was positioned on the cot on his left side with the backrest adjusted to the full-down position. The patient was secured by the shoulder, torso, and leg restraints.

Figure 8: The Stryker 6500 Power Pro XT patient cot

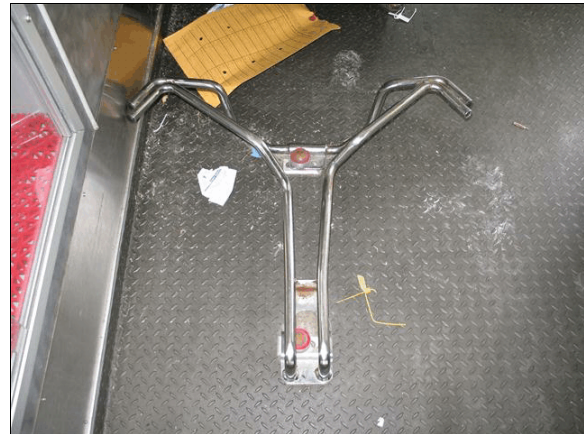
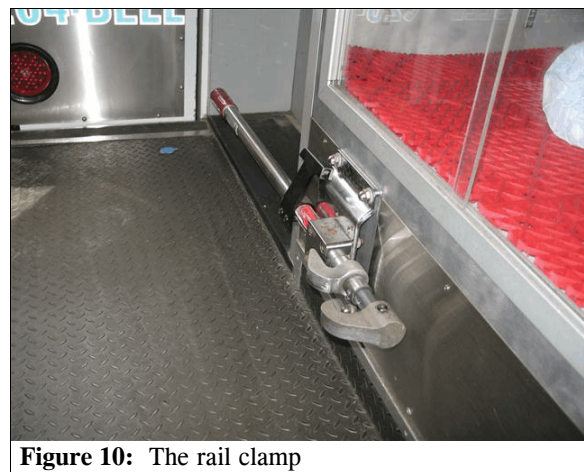
The cot was secured by the ambulance's antler bracket and rail clamp. The antler bracket secures the head of the cot by restraining the undercarriage using the wheel frames as anchor points. The rail clamp secured the frame of the cot. The cot remained secured throughout the crash and was not damaged. The antler bracket and rail clamp were not damaged (**Figures 9 and 10**).

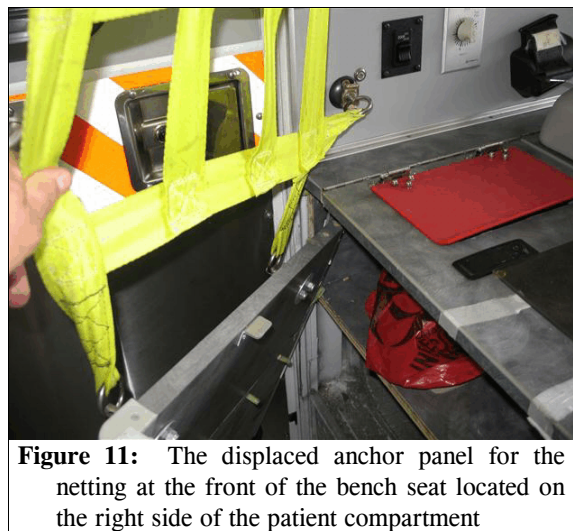
The unrestrained EMT was seated in the front seating position of the bench seat located along the right side of the patient compartment. At the time of the crash, he was leaning forward attempting to calm down the patient. The impact with the Honda displaced the EMT forward and to the left and he contacted the nylon net at the front end of the bench seat. The contact with the net separated the plywood header panel that the netting was anchored to from the base of the bench seat (**Figure 11**). The EMT sustained an abrasion on the right elbow from contacting the net. The EMT separated from the net and the on-board video showed that he continued forward and to the left and contacted the student EMT. The EMT sustained a lumbar strain from the contact.

Figure 11: The displaced anchor panel for the netting at the front of the bench seat located on the right side of the patient compartment
