On-Site Ambulance Crash Investigation
SCI Case Number DS13021
Vehicle: 2000 Ford F-350/Type I Ambulance
Location: Idaho
Crash Date: October 2013

14. Sponsoring Agency Code	
15. Supplemental Notes The focus of this investigation is the head-on crash of a 2000 Ford F-350 chassis with an American Emergency Vehicles (AEV) Type I ambulance body.

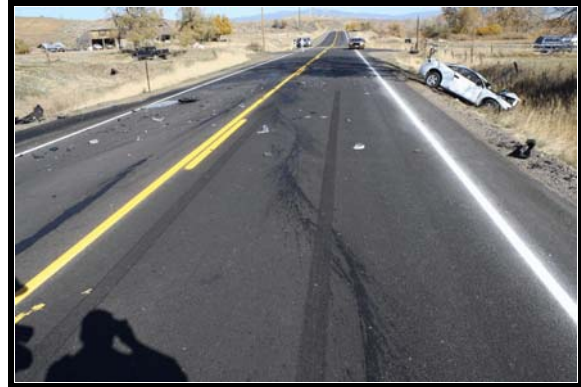
The Mitsubishi was displaced rearward and began a counterclockwise rotation. During rotation, the rear of the Mitsubishi impacted the left rear quarter panel of the Audi. The Mitsubishi then departed the east edge of the roadway and came to rest in a ditch facing southeast (**Figure 3**).

Figure 3. Final rest, looking north, 1998 Mitsubishi Eclipse (police photo)

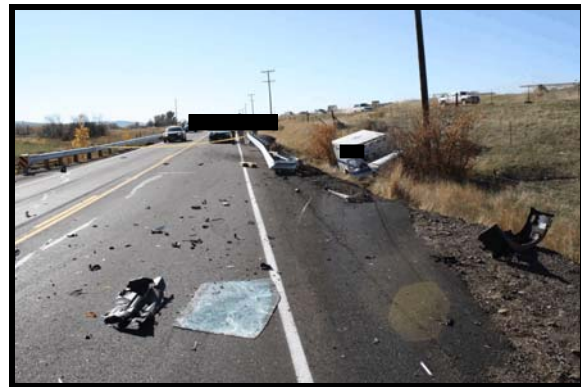
The ambulance was displaced to the right, departed the roadway, and impacted the energy-absorbing breakaway end treatment of a metal guardrail with its front plane (Event 3). The guardrail end collapsed and the ambulance traveled down an embankment. The left front of the ambulance impacted the ground (Event 4) and vehicle rotated in a counterclockwise direction. The ambulance came to rest in an upright orientation facing north (**Figure 4**).

Figure 4. Impact with guardrail end and final rest for 2000 Ford ambulance, looking south (police photo)

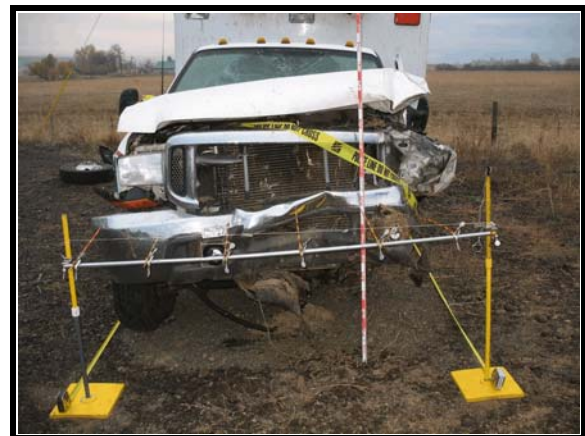
Damage to the exterior of the ambulance from the multiple event crash was present on the frontal and left planes. The ambulance sustained multiple impacts to the frontal plane (**Figure 5**). During the crash sequence the ambulance impacted the other vehicle, a guardrail end, and the ground. The direct damage from the guardrail and ground impact began at the left front bumper corner and extended approximately 113.0 cm (44.4 in) to the right. The damage from the vehicle-to-vehicle impact began at the left front bumper corner and extended approximately 12.0 cm (4.7 in) to right. The crush

Figure 5. Frontal damage, 2000 Ford F-350 ambulance

damage from the three impacts could not be separated and the crush profile is based on the final appearance of the damage. The Field L extended from bumper corner to bumper corner and measured 169.0 cm (44.4 in). Six crush measurements were taken at the bumper level as follows: $C_1 = 28.0$ cm (11.0 in), $C_2 = 18.0$ cm (7.0 in), $C_3 = 22.0$ cm (8.7 in), $C_4 = 12.0$ cm (4.7 in), $C_5 = 0$ cm, $C_6 = 0$ cm. The maximum crush was located at C_1 . The overall Truck Deformation Classification (TDC) for the frontal impacts was 12FYEW2. At impact with the Eclipse, the left front tire was damaged and the wheel was displaced from the vehicle. The rim was deformed and the sidewall cut (**Figure 6**). The direct damage from the impacts with the guardrail and ground extended as body surface abrasions and minor deformation along the lower edge of the left side of the cab. The guardrail damage continued along the left side of the ambulance module. There was damage caused by an unknown source to the right rear and upper right areas of the ambulance body.

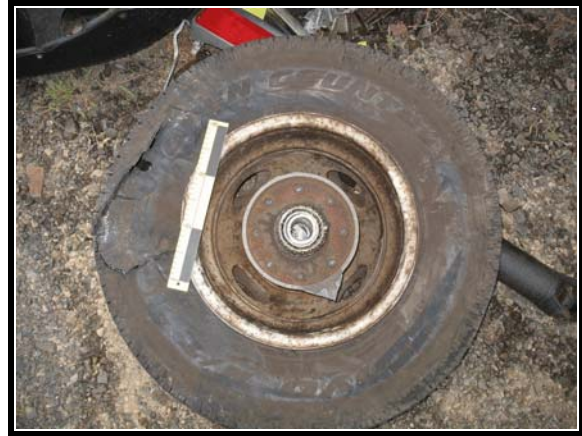
Figure 6. Inner aspect, left front tire

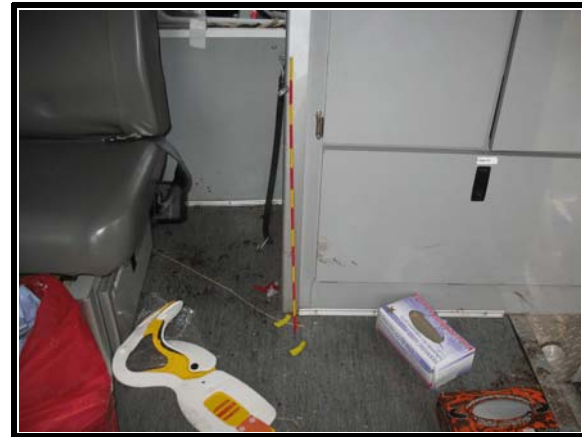
Minimal damage was sustained by the interior of the patient compartment module as a result of the crash. At the time of the SCI inspection, supplies and materials normally located in the module had been removed for use in another ambulance. Occupant contacts were documented to the left edge of a rear-facing cabinet located in the forward aspect of the module (**Figures 7-8**) and the cabinet doors.

Figure 7. Contact to cabinet, 2000 Ford F-350 ambulance

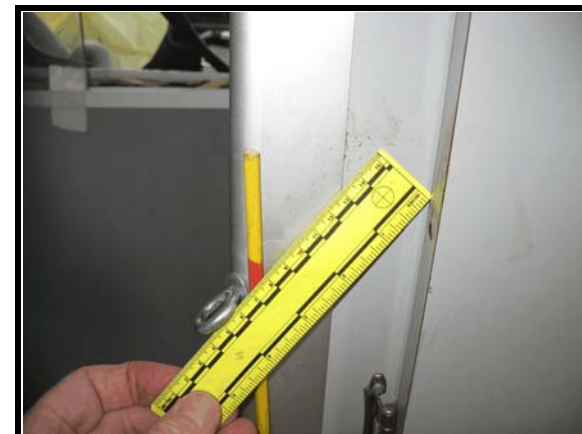
Figure 8. Contact to cabinet, 2000 Ford F-350 ambulance

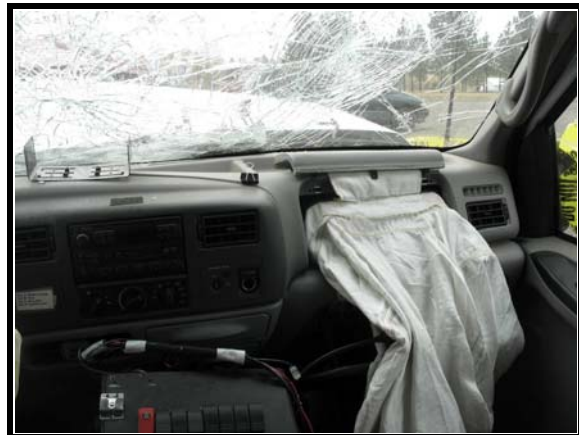
The Ford was equipped with two air bags for supplemental restraint. The driver's position steering wheel hub-mounted air bag deployed as a result of the front impact into the Mitsubishi (**Figure 9**). In its deflated state, the air bag was circular in shape with a seat-to-seam diameter of 64.0 cm (25.1 in). The air bag was configured with two circulate vent ports and a single internal tether. One area of occupant contact was documented on the air bag face. It was located at the bottom right quadrant and measured 4.0 x 11.0 cm (1.6 x 4.3 in). The mid-instrument panel mounted passenger air bag also deployed during the crash (**Figure 10**). In its deflated state, the air bag was rectangular in shape and measured 50.0 cm (19.6 in) in height and 64.0 cm (25.1 in) in width. It had a maximum excursion of 68.0 cm (26.7 in).

Figure 10. Passenger frontal air bag, 2000 Ford F-350 ambulance

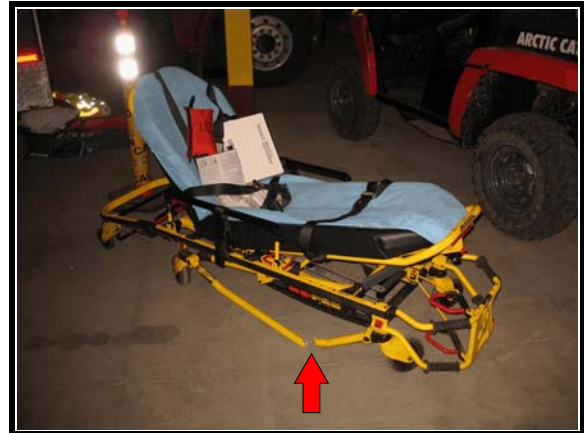
The patient cot was a Rugged MX-PRO Ambulance Cot that was manufactured by Stryker in June 2003 (**Figure 11**).

Figure 11. Stryker Rugged MX-PRO cot. Arrow highlights fractured lower rail.

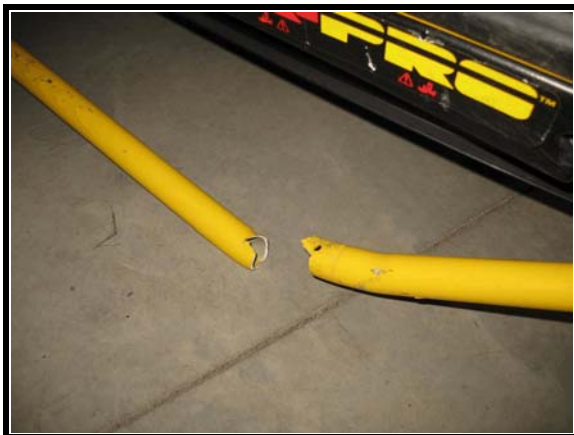
The serial number for the cot was 3006-39239. The cot was constructed of a tubular aluminum frame with circumferential weld joints and steel hardware fasteners. The X-frame supporting the mattress platform featured manual raise/lower capabilities and the mattress platform featured 0-73 degrees of backrest articulation. Its length was 203 cm (80 in) and the width was 58 cm (23 in). Labeling declared that the load capacity limit of the cot was a maximum of 227 kg (500 lbs). The cot was secured in place within the passenger compartment via a Stryker antler design floor-mount cot fastener system. The serial number was partially rubbed away by use. The last seven digits were 139579. The system consisted of a forward antler bracket and rearward locking-clamp mechanism. The antler bracket cradled the forward portion (location of the patient's head area) of the cot's frame, while the vertically-oriented locking mechanism clamped around a pin protruding from the cot's lower frame rail (**Figure 12**). Combined, these two components restricted the lateral and longitudinal movement of the cot. During the crash, the lower frame rail fractured (**Figure 13**). The fracture was located 31.0 cm (12.2 in) forward of the rear wheel at the point vertically oriented pin (**Figure 14**) clamps to the rail.

Figure 13. Fractured lower rail, Rugged MX-PRO Ambulance Cot

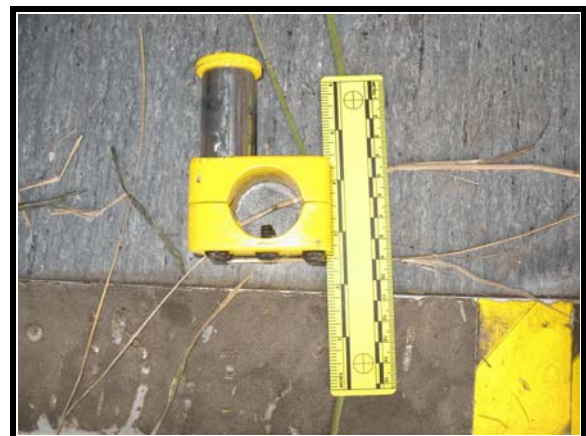
Figure 14. Locking pin separated from lower rail, Rugged MX-PRO Ambulance Cot

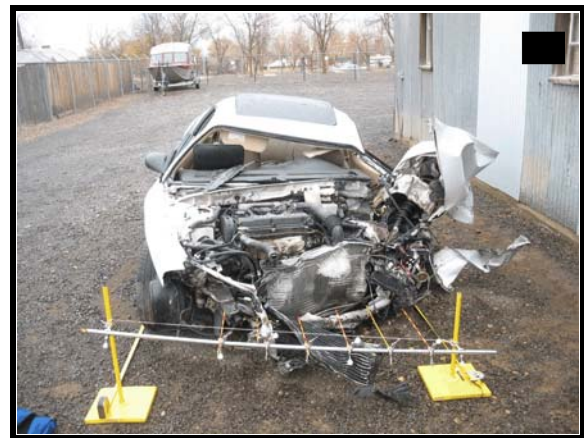
The Mitsubishi sustained severe damage to the front plane caused by the impact with the Ford ambulance in Event 1 (**Figures 17-18**). Direct damage began at the left corner and extended 78.0 cm (30.7 in) to the right. The Field L dimension was 97.0 cm (38.1 in). Six crush measurements were taken at the bumper level along the backing bar as follows: $C_1 = 61.0$ cm (24.0 in), $C_2 = 48.0$ cm (18.9 in), $C_3 = 29.0$ cm (11.4 in), $C_4 = 27.0$ cm (10.6 in), $C_5 = 30.0$ cm (11.8 in), $C_6 = 24.0$ cm (9.4 in). The maximum crush was located at C_1 . The Collision Deformation Classification (CDC) was 01FYEW3.

Figure 17. Frontal damage, 1998 Mitsubishi Eclipse

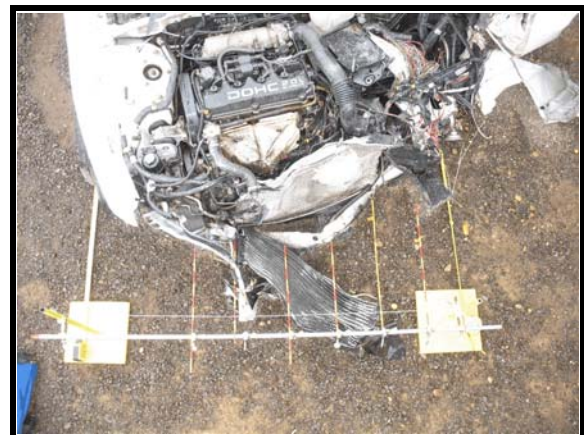
Figure 18. Crush profile, 1998 Mitsubishi Eclipse

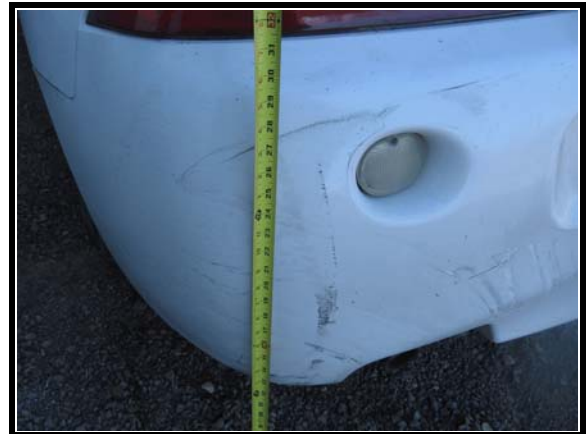
The Mitsubishi sustained minor rear plane damage during the impact with the Audi (**Figure 19**). The estimated CDC was 09BYLS1.

Figure 19. Rear plane contact, 1998 Mitsubishi Eclipse

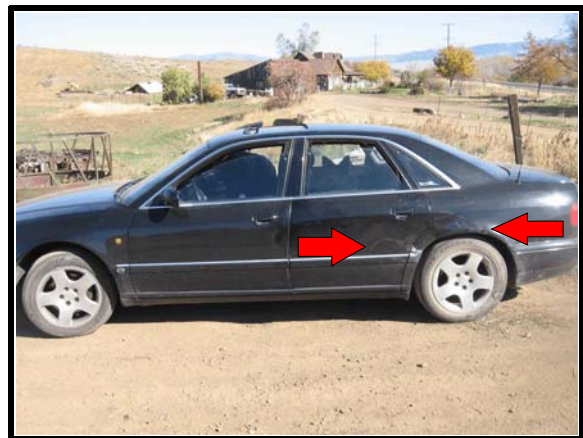
The Audi sustained minor sideswipe damage to the left rear door and wheel well area cause by the impact with the Mitsubishi in Event 2 (**Figure 20**). The estimated CDC was 11LPES1.

Figure 20. 1999 Audi A8 Quattro (police photo)
