### ON-SITE AMBULANCE CRASH INVESTIGATION

CASE NUMBER - IN14035

VEHICLE - 2010 FORD ECONOLINE E-350 TYPE II AMBULANCE

CRASH DATE - June 2014

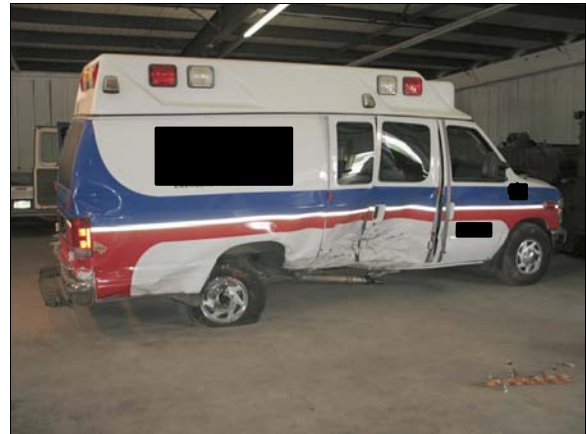
**Figure 1:** 2010 Ford Econoline Type II Ambulance

**Exterior Damage, Event 1:** The ambulance sustained right plane damage during the impact with the Toyota. The right rear doors, side panel, and rear wheel were directly damaged (**Figure 1**). The direct damage began 143 cm (56.3 in) rear of the right front axle and extended 235 cm (92.5 in) rearward. The Field L was 260 cm (102.4 in). The crush measurements were taken at the sill level and maximum residual crush was 30 cm (11.8 in) occurring at 26 cm (10.2 in) forward of C<sub>3</sub>. The crush values were: C<sub>1</sub> = 8 (3.1 in), C<sub>2</sub> = 6 cm (2.4 in), C<sub>3</sub> = 23 cm (9.1 in), C<sub>4</sub> = 29 cm (11.4 in), C<sub>5</sub> = 17 cm (6.7 in), C<sub>6</sub> = 7 cm (2.8 in). The sill height was 30 cm (11.8 in) and the height of the maximum crush was 40 cm (15.7 in). The Door/Sill Differential was 0. The vehicle's left side wheelbase was extended 4 cm (1.6 in) and the right side wheelbase was extended 19 cm (7.5 in).

**Damage Classification, Event 1:** The Collision Deformation Classification (CDC) for the impact with the Toyota was 01RPEW3 (30 degrees). The Damage algorithm of the WinSMASH program calculated the total Delta V as 9 km/h (5.6 mph). The longitudinal and lateral velocity changes were -8 km/h (-5 mph) and -5 km/h (-3.1 mph), respectively. These results appeared reasonable, based on the damage to the ambulance.

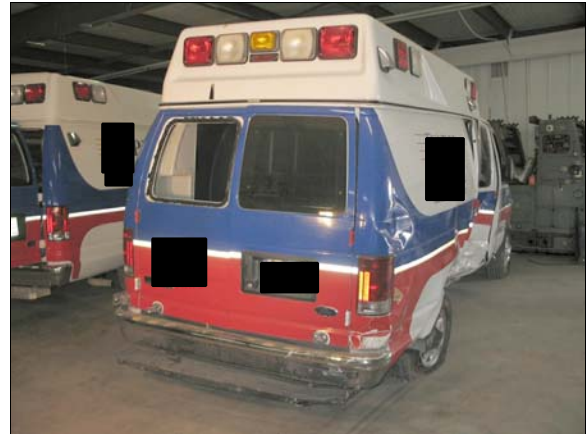
**Figure 5:** Right rear damage to ambulance

**Exterior Damage, Event 2:** The ambulance sustained back and right plane damage (**Figure 5**) during the impact with the Chevrolet. The back bumper and right rear side panel were directly damaged. There was no crush to the back bumper and no C-measurements were taken.

**Damage Classification, Event 2:** The CDC for the impact with the Chevrolet was 05BRAW2 (160 degrees). The CDC Only algorithm of the WinSMASH program calculated the total Delta V as 7 km/h (4.3 mph). The longitudinal and lateral velocity changes were 7 km/h (4.3 mph) and -2 km/h (-1.2 mph), respectively. The results should be considered borderline since they are based on CDC only.

**Exterior Damage, Event 3:** The ambulance sustained sideswipe damage to the right rear corner during impact with the Chevrolet. The direct damage to the ambulance could not be discerned since there was overlapping damage from event 2; however, the on-scene photos of the Chevrolet showed blue and red paint transfer on the Chevrolet's right plane, which was consistent with a sideswipe impact with the right rear corner of the ambulance (**Figure 5**).

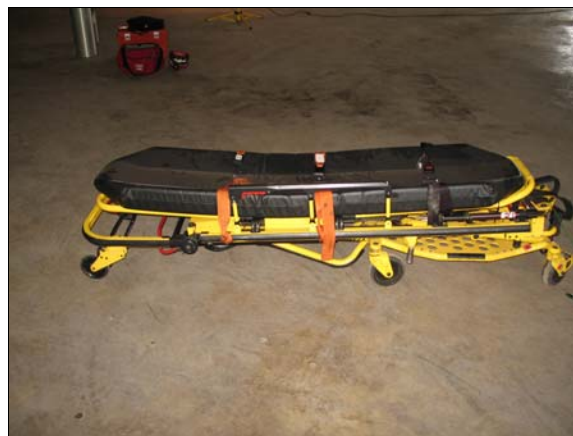
**Figure 6:** Stryker Medical Model 6092 EZ-Pro R4 ambulance cot

The cot that was used to transport the patient was a Stryker EMS Model 6092 EZ-PRO (**Figure 6**), serial number 04024xxxx. It was an H-frame design, and could carry a maximum of 295 kg (650 lbs). It was 211 cm (83 in) long and 58 cm (23 in) wide and had a height range of 30 cm (12 in) to 94

cm (37 in). The back rest could be adjusted from 0-73 degrees. The cot was equipped with torso, thigh, and lower leg restraints, all of which were tied to the frame of the cot. No shoulder straps were used to secure the patient. It is unknown if the ambulance service outfits their cots with shoulder straps. The torso and thigh restraints were manufactured by Morrison Medical Products, and the product number was #12000R. The manufacturer's tag on the lower leg restraint was illegible.

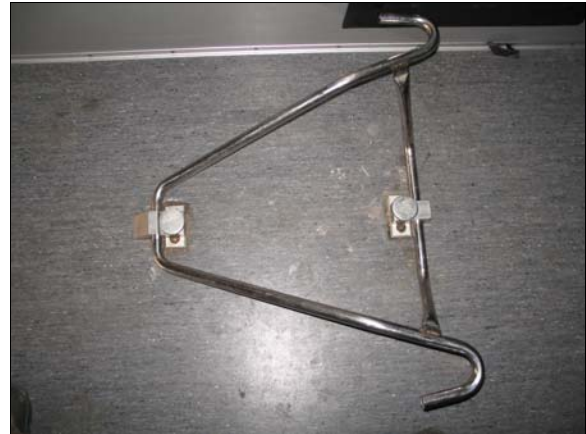
**Figure 7:** Antler bracket, assembled/bolted to floor by investigator

The cot was secured by the antler bracket and rail clamp (**Figures 7 and 8**). The antler bracket secured the head of the cot by restraining the undercarriage, using the wheel frames as anchor points. The rail clamp located at the back left of the patient compartment secured the cot to the floor. There were no manufacturer's labels or serial numbers on the rail clamp nor antler clamp. The patient was supine on the cot and was secured by the restraints at the chest and hip locations. The lower leg restraints were not in use since both of the patient's legs had been amputated above the knee. The recline angle of the back rest could not be determined. The ambulance service owner stated that the patient was found by emergency responders on the floor of the patient compartment, underneath the cot and the paramedic. It is unknown if the patient came out of the restraints during the crash.

The SCI inspection of the cot, antler bracket, and rail clamp focused on determining how the cot released from the rail clamp during the crash. There were no abnormalities to the antler bracket, the two anchor bolts, or the floor brackets. The bolts showed historical wear marks, primarily on the first seven threads, suggesting both bolts were not completely tightened against the floor bracket. The bolts held the antler bracket firmly when reassembled and fastened to the floor. The rail clamp was in working order when the cot was placed in the patient compartment and secured during the SCI inspection. The cot was shaken vigorously and the rail clamp held the cot in place. The rail clamp locking mechanism could be released by exerting light pressure on the back end of the rail clamp, pushing it forward. One pronounced and one light impression (**Figure 9**) of the end of the rail clamp was present in the vinyl of the back door

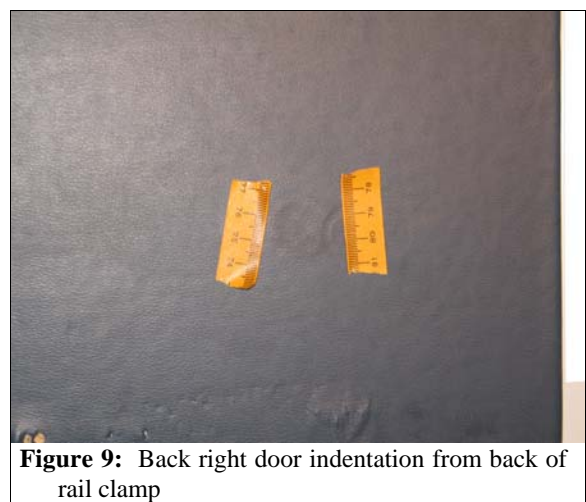
**Figure 9:** Back right door indentation from back of rail clamp

panel, indicating there had been contact between the end of the rail clamp and the door. The door was slammed a number of times during inspection and while there was minor contact between the door and the end of the rail clamp, the cot remained secured to the rail clamp. Inspection of the cot revealed its left adjustable side rail was broken off during the crash (**Figure 10**), the vertical attachment bar (which was held by the rail clamp) was slightly bent (**Figure 11**), and there were scuffs on the left side frame rail. The inspection findings of the rail clamp and the cot's vertical attachment bar suggested that crash forces during the back plane impact with the Chevrolet allowed the end of the rail clamp to contact the back door with sufficient force to create a pronounced impression of the end of the rail clamp in the vinyl and release of the cot from the rail clamp. The rail scuffs on the left rail of the cot indicated that it was then displaced to the right and contacted the right bench support.

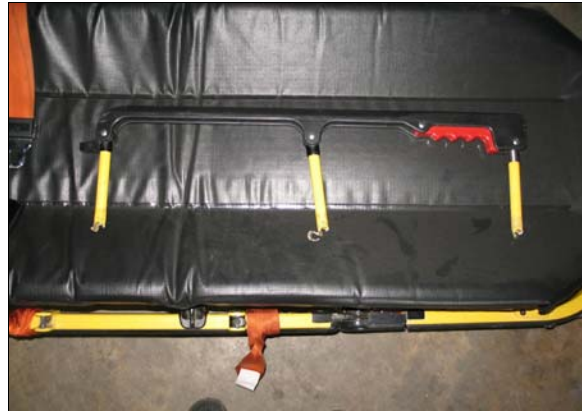
**Figure 10:** Broken left adjustable side rail

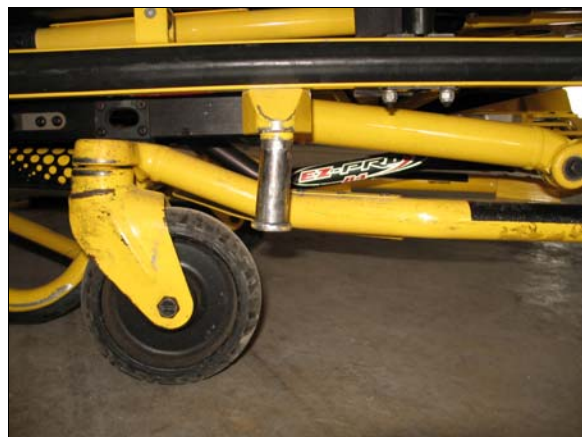
**Figure 11:** Vertical attachment bar (to rail clamp)

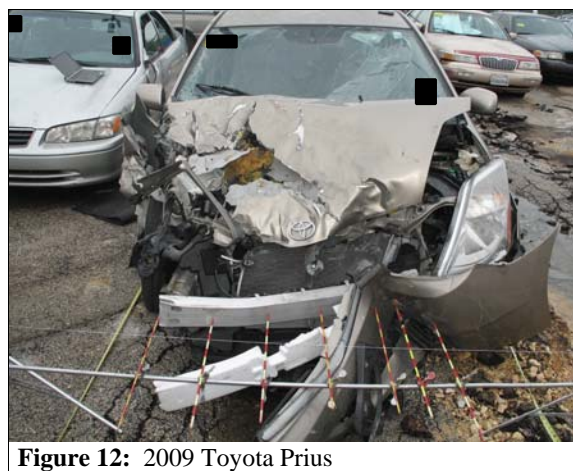
**Exterior Damage:** The Toyota sustained front plane damage during the impact with the ambulance. The front bumper, bumper fascia, grille, hood, right head lamp/turn signal assembly, and right fender were directly damaged (**Figure 12**). The direct damage extended 158 cm (62.2 in) across the entire front plane. The Field L was 106 cm (41.7 in). The crush measurements were taken at the front bumper bar and the maximum residual crush was 39 cm (15.4 in) occurring 12 cm (4.7 in) to the right of  $C_1$ . The crush values were:  $C_1 = 19$  (7.4 in),  $C_2 = 29$  (11.4 in),  $C_3 = 27$  (10.6 in),  $C_4 = 20$  (7.9 in),  $C_5 = 13$  (6.7 in),  $C_6 = 3$  (1.2 in). The vehicle's left side wheelbase was extended 1 cm (0.4 in), while the right side wheelbase was reduced 5 cm (2 in).

**Damage Classification:** The CDC for the impact with the Toyota was 10FDEW2 (310 degrees). The Damage algorithm of the WinSMASH program calculated the total Delta V as 30 km/h (18.6 mph). The longitudinal and lateral velocity changes were -19 km/h (-11.8 mph) and 23 km/h (14.3 mph). The results are borderline due to underride nature of the impact.

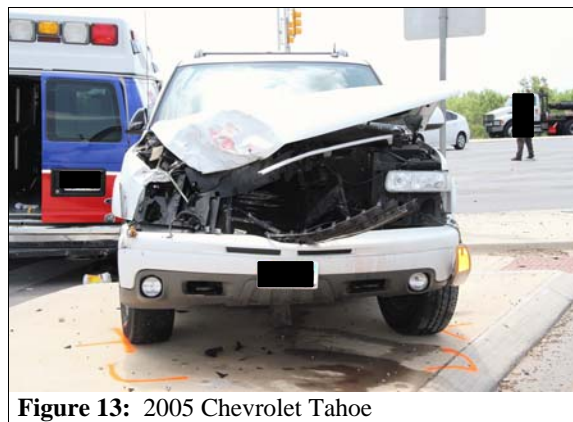
**Figure 13:** 2005 Chevrolet Tahoe

**Exterior Damage, event 2:** The Chevrolet sustained front plane damage from the impact with the ambulance. The front bumper, bumper fascia, right head lamp/turn signal assembly, left turn signal assembly, grille, hood, and right fender were directly damaged.

**Damage Classification, event 2:** The Chevrolet was not inspected. The CDC for the impact with the ambulance was 01FREW1 (20 degrees) based on the police photographs of the crash scene (**Figure 13**). The CDC Only algorithm of the WinSMASH program calculated the total Delta V as 12 km/h (7.5 mph). The longitudinal and lateral velocity changes were -11 km/h (-6.8 mph) and -4 km/h (-2.5 mph). The results are borderline since they are based on CDC only.

**Exterior Damage, event 3:** The Chevrolet sustained right plane damage from the sideswipe impact with the ambulance. The right doors were directly damaged.

**Damage Classification, event 3:** The CDC for the second impact with the ambulance was 12RPES1 (0 degrees), based on police photographs of the crash scene. The WinSMASH program was not used for this impact since sideswipes are out of scope for the program.
