# INDIANA UNIVERSITY

### ON-SITE AMBULANCE CRASH INVESTIGATION

CASE NUMBER - IN16013

VEHICLE - 2003 FORD ECONOLINE TYPE III AMBULANCE

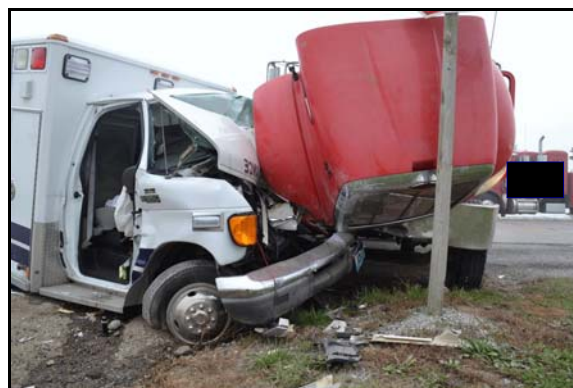
**Crash:** The front plane of the Ambulance impacted the right plane of the Peterbilt. The force direction was within the 11 o'clock sector to the Ambulance and both frontal air bags deployed. The WinSMASH program could not be used to calculate Delta V for either vehicle since an impact with a heavy trucks is out of scope for the program. The Barrier Equivalent Speed calculated by WinSMASH was 18 km/h (11 mph) and this result was considered to be low, based on the damage to the Ambulance. The police reconstruction report calculated Delta V for the Ambulance as a range between 25.7 km/h (16 mph) and 30.6 km/h (19 mph). The patient cot remained fastened in the antler bracket and rail clamps, but the patient slid forward and out of the patient cot restraints as a result of the impact. The vehicles remained in contact after the impact and were redirected in a northwesterly direction, approximately 4 m (13.1 ft). The Ambulance rotated clockwise approximately 20 degrees coming to final rest heading northwest. The Peterbilt rotated counterclockwise approximately 25 degrees, coming to final rest heading northwest (**Figure 4**).

**Figure 4:** Ambulance and Peterbilt at final rest

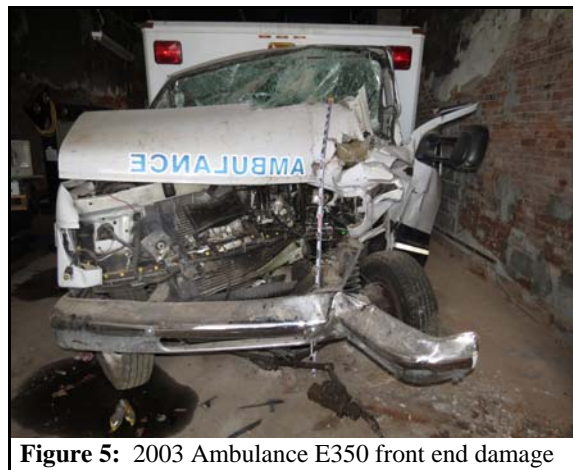
The Ambulance sustained front plane damage during the impact with the Peterbilt. The front bumper, grille, radiator, hood, left and right headlamp and turnlamp assemblies, and the left A-pillar were directly damaged (**Figure 5**). The direct damage began at the left end of the radiator support and extended 150 cm to the right. The undeformed end width was 176 cm (69.3 in) and the Field L was 140 cm (55.1 in). The crush measurements were taken on the lower radiator support and the front bumper and averaged where necessary, according to NASS vehicle crush measurement protocol. There was no crush to the front bumper. The maximum residual crush above the bumper was 64 cm (25.2 in), occurring at  $C_1$ . The averaged crush values were:  $C_1 = 32$  cm (12.6

**Figure 5:** 2003 Ambulance E350 front end damage

in),  $C_2 = 32$  cm (12.6 in),  $C_3 = 14$  cm (5.5 in),  $C_4 = 8$  cm (3.1 in),  $C_5 = 0$ ,  $C_6 = 0$ . The vehicle's left side wheelbase was reduced 16 cm (6.3 in) and the right side wheelbase was extended 8 cm (3.1 in).

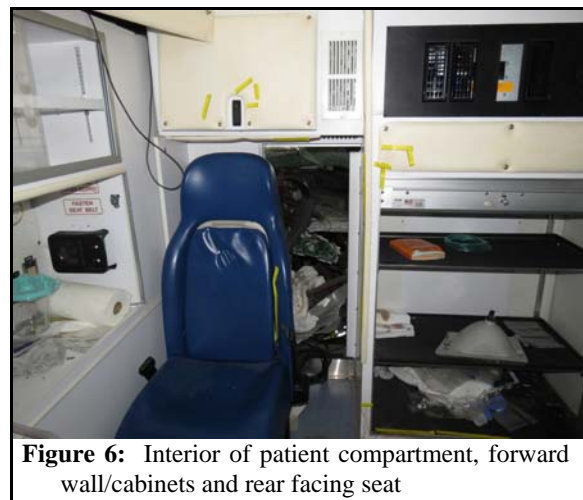
**Patient Compartment:** Inspection of the patient compartment revealed no damage from intrusion. The right side door and rear doors were undamaged and operational. Scuffs from occupant contact and blood stains were noted on the cabinet door padding (**Figure 6**) above the rear facing seat and on the right cabinet wall, from the floor to the top of the cabinet. Blood drips were also noted on the right door.

**Figure 6:** Interior of patient compartment, forward wall/cabinets and rear facing seat

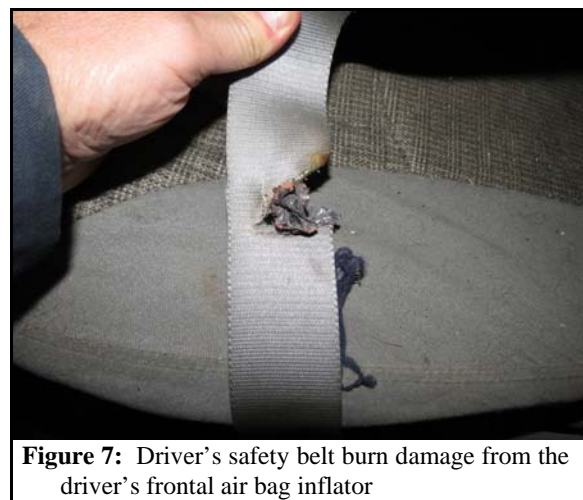
The driver was restrained by the lap and shoulder safety belt as indicated by the condition of the safety belt and an injury the driver sustained as follows: Inspection of the driver's safety belt assembly revealed that the shoulder portion of the belt webbing was melted (**Figure 7**) and would not fully retract into the B-pillar. This damage was caused by contact to the driver's frontal air bag inflator as indicated by a burn hole in the back side of the air bag and a 3<sup>rd</sup> degree burn located above the driver's left breast that her medical records stated was caused by contact with hot metal.

**Figure 7:** Driver's safety belt burn damage from the driver's frontal air bag inflator

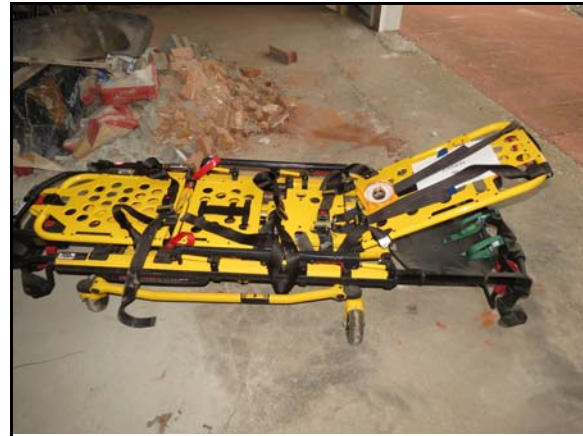
The cot that was used to transport the patient was a Stryker REF Model 6500 POWER-PRO (**Figure 8**), serial number 11114xxxx. It was an X-frame design, and could carry a maximum of 318 kg (700 lbs). It was 206 cm (81.1 in) in length and 58 cm (22.8 in) in width and had a height range of 36 cm (14.2 in) to 105 cm (41.3 in). The back rest could be adjusted from 0-73 degrees from horizontal. The cot was equipped with shoulder, torso, and thigh restraints. These restraints were nylon webbing straps, all of which were looped around the cot frame rail. They could slide along the frame rail to adjust for each patient.

**Figure 8:** Stryker 6500 Power Pro patient cot (padding removed)

The cot was secured by the antler bracket and rail clamp and remained secured throughout the crash. The antler bracket secured the head of the cot by restraining the undercarriage using the wheel frames as anchor points. The rail clamp was located at the back left of the patient compartment and secured the cot to the floor. SCI inspection discovered no abnormalities in the patient cot, its restraints, antler bracket, or rail clamp and all components were in good working condition.

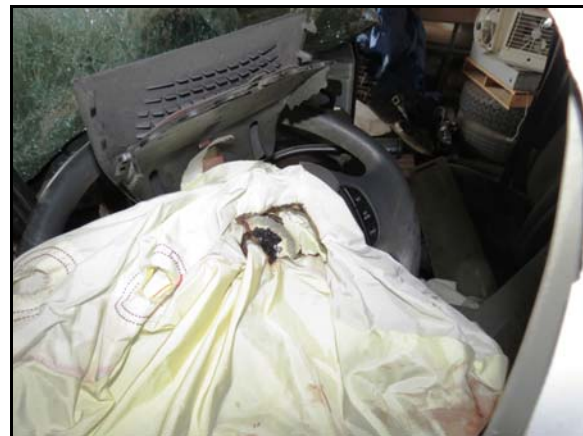
**Figure 9:** Back of driver's air bag burn damage from inflator

The back of the driver's frontal air bag had a 9 x 6 cm (3.5 x 2.4 in) burn hole (**Figure 9**) at the upper right side. This damage occurred when the air bag fabric was pressed between the driver and the inflator, due to the forward displacement of the driver and rearward displacement of the steering assembly during the crash. There was also a 0.5 cm (0.2 in) burn hole in the back left side of the air bag related to this occurrence.

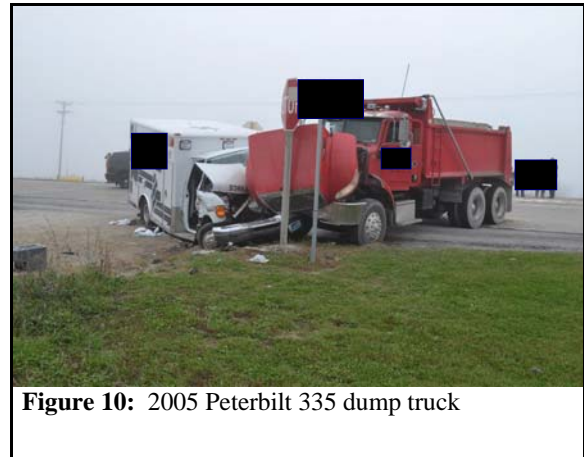
The Peterbilt sustained right and front plane damage, based on police on-scene images. The front bumper, engine cowl, and right front wheel were directly damaged.

**Figure 10:** 2005 Peterbilt 335 dump truck
