### ON-SITE AMBULANCE CRASH INVESTIGATION

CASE NUMBER - IN13021

LOCATION - NEBRASKA

VEHICLE - 1990 FORD E-350 TYPE III AMBULANCE

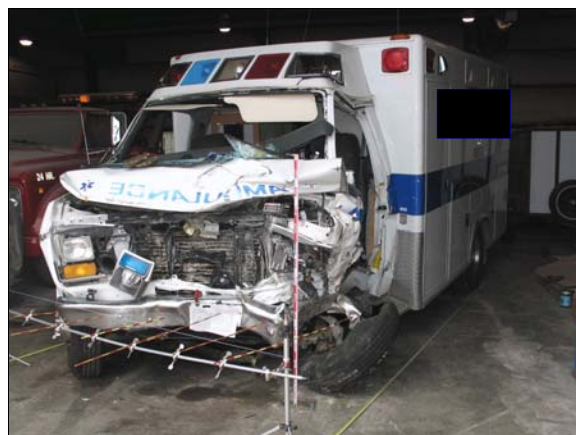
**Figure 4:** Ambulance frontal damage

**Exterior Damage, Event 1:** The ambulance sustained front plane damage during the impact with the Ford. The front bumper, grille, hood, left head lamp/turn signal assembly, left fender, and left front wheel were directly damaged. The direct damage began at the front left bumper corner and extended 160 cm (63 in) along the front plane. The Field L was 138 cm (54.3 in). The crush measurements were taken at the front bumper level and maximum residual crush was 111 cm (43.7 in) occurring at C1. The crush values were: C<sub>1</sub> = 111 cm (43.7 in), C<sub>2</sub> = 63 cm (24.8 in), C<sub>3</sub> = 57 cm (22.4 in), C<sub>4</sub> = 37 cm (14.6 in), C<sub>5</sub> = 14 cm (5.5 in), C<sub>6</sub> = 0 cm.

**Damage Classification:** The Collision Deformation Classification (CDC) was 12FDEW6 (10 degrees). The Damage algorithm of the WinSMASH program calculated the total Delta V as 32 km/h (19.9 mph). The longitudinal and lateral velocity changes were -32 km/h (-19.9 mph) and -6 km/h (3.7 mph). The results should be considered for informational purposes only since the ambulance was an altered vehicle and an accurate weight of the vehicle could not be determined.

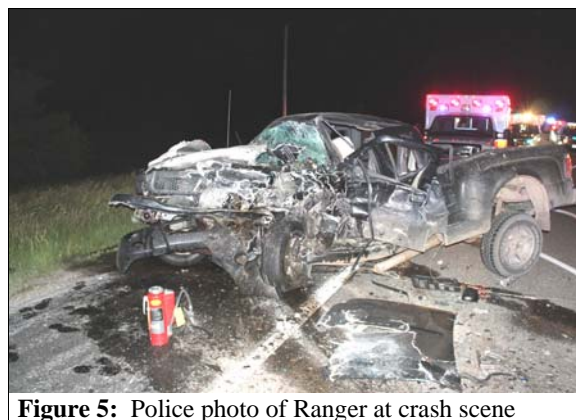
**Figure 5:** Police photo of Ranger at crash scene

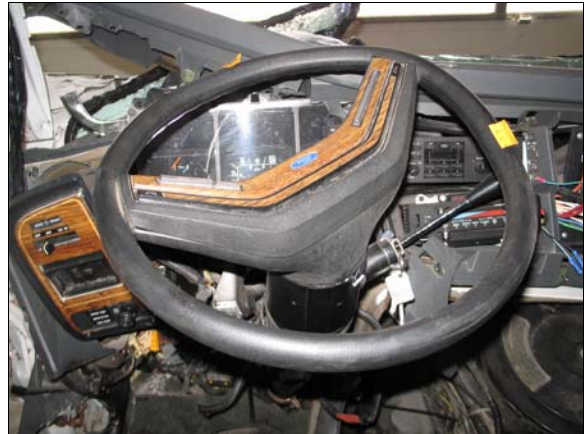
**Front Row:** The inspection of the front row revealed blood on the deformed lower left instrument panel from contact by the driver's knee. The upper half of the steering wheel rim (**Figure 6**) was deformed forward approximately 3 cm (1.2 in) from contact by the driver's chest, and the steering assembly was displaced upward.

**Figure 6:** The ambulance's deformed steering wheel rim

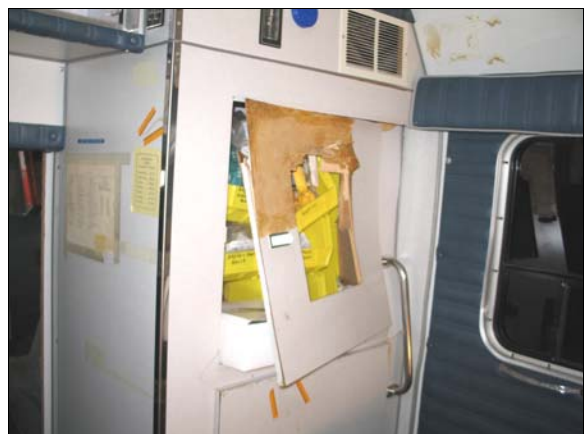
**Patient Compartment:** Inspection of the patient compartment revealed significant deformation of the supply cabinet located in the front right (**Figure 7**). There were scuff marks also present below the cabinet. The deformation and scuff marks were from contact by the male EMT, who was seated in position 6 at the front of the inward-facing bench seat, and from the patient at position 8<sup>1</sup>, who was supine on the cot. The class M oxygen cylinder located in the left front cabinet was undamaged and remained secured within the cabinet. A smaller class M oxygen cylinder found in the ambulance was also undamaged. Its location at the time of the crash is unknown. There was no damage to the visible oxygen lines. The upper left front wall intruded approximately 5 cm (2 in) into the patient compartment.

**Figure 7:** Damaged cabinet at front right of patient compartment

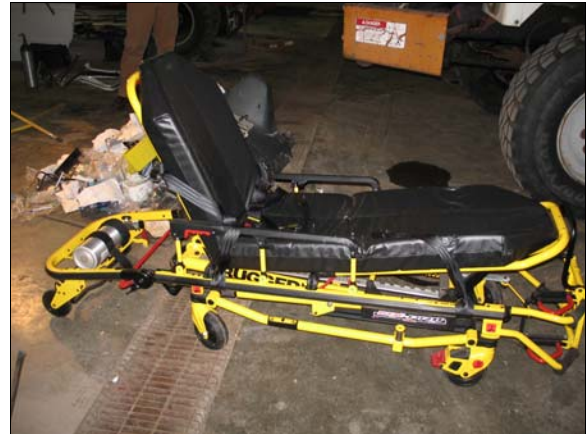
**Patient Cot:** The cot that was used to transport the patient was a Stryker EMS Model 6082 MX-PRO (Figure 8), serial number 050640318. It was an X-frame design, and could carry a maximum of 295 kg (650 lbs). It was 205 cm (80.5 in) in length and 58 cm (22.8 in) in width and could be set to seven different height positions. The back rest could be adjusted from 2-73 degrees from horizontal. The cot was equipped with torso, thigh, and lower leg restraints, all of which were tied to the frame of the cot. No discernable damage or contacts were noted on any of the restraints during SCI inspection. There were no shoulder restraints. There was a small oxygen tank secured to the cot at the head end. The tank was undamaged and there was no tubing or accessories attached at the time of SCI inspection.

**Figure 8:** Stryker EMS Model 6082 MX PRO patient cot

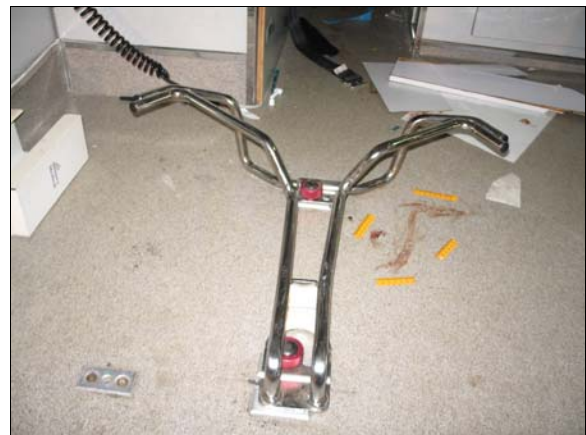
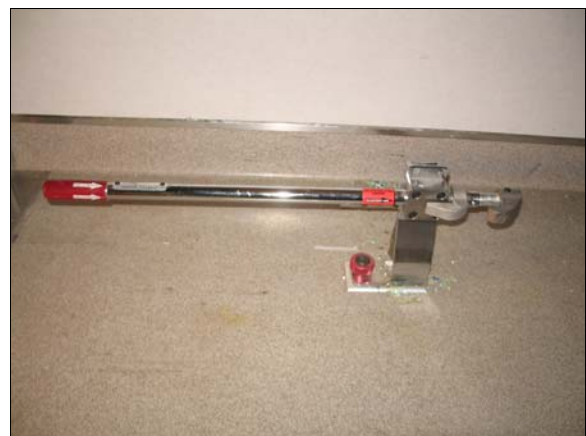
The cot was secured by the ambulance's antler bracket and rail clamp (Figures 9 and 10). The antler bracket secures the head of the cot by restraining the undercarriage using the wheel frames as anchor points. The rail clamp (Stryker Serial No. 050640756) secured the frame of the cot. Neither the antler bracket nor rail clamp were damaged. The cot was still secured to the antler bracket and rail clamp following the crash based on the SCI interview with an emergency responder. The cot was also undamaged with the exception of a broken plastic left arm rail, which was possibly contacted by the patient left arm, since he sustained left elbow and hand abrasions. The patient stated during the SCI interview that he was supine on the cot, fully reclined. He was secured by the restraints at the chest, hip, and lower legs, but no shoulder restraints were used. He also stated the hip restraint was somewhat loose since he was

**Figure 9:** Antler bracket mounted to floor of ambulance

**Figure 10:** Rail clamp on floor of ambulance

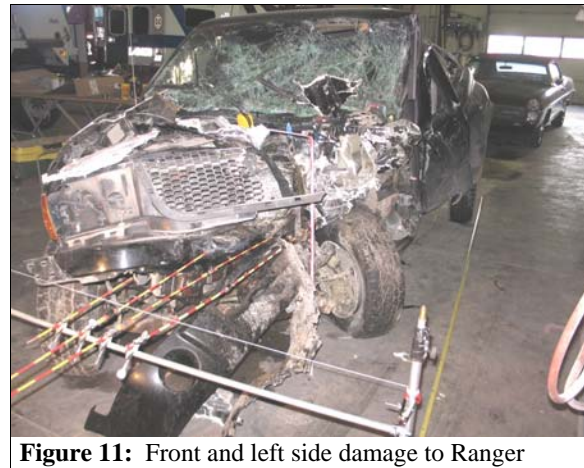
**Exterior Damage:** The Ranger sustained front plane damage during the impact with the ambulance. The front bumper, grille, hood, left head lamp/turn signal assembly, left fender, and left front wheel were directly damaged (**Figure 11**). The direct damage on the front plane began at the front left bumper corner and extended 140 cm (55.1 in) along the front plane. The Field L was 23 cm (9.1 in). Crush measurements were taken at the front bumper level and maximum residual crush was 160 cm (63 in) occurring at  $C_1$ . The vehicle's left side wheelbase was shortened 81 cm (31.8 in), while the right side wheelbase was extended 13 cm (5.1 in). The crush values were:  $C_1=160$  cm (63 in),  $C_2=97$  cm (38.2 in),  $C_3=48$  cm (18.9 in),  $C_4=8$  cm (3.1 in).

**Figure 11:** Front and left side damage to Ranger

**Damage Classification:** Collision Deformation Classification (CDC) for the impact with the ambulance was 12FDEW6 (0 degrees). The Damage algorithm of the WinSMASH program calculated the total Delta V as 110 km/h (68.4 mph). The longitudinal and lateral velocity changes were -110 km/h (-68.4 mph) and 0 km/h. The results should be considered for informational purposes only since the ambulance was an altered vehicle and an accurate weight of the vehicle could not be determined. Guidance from NHTSA indicates that WinSMASH generally over-estimates Delta V above 80 km/h (50 mph).
