SPECIAL CRASH INVESTIGATIONS

CASE NO: CR14002

ON-SITE AMBULANCE CRASH INVESTIGATION

VEHICLE: 2012 FORD E-350 CUTAWAY

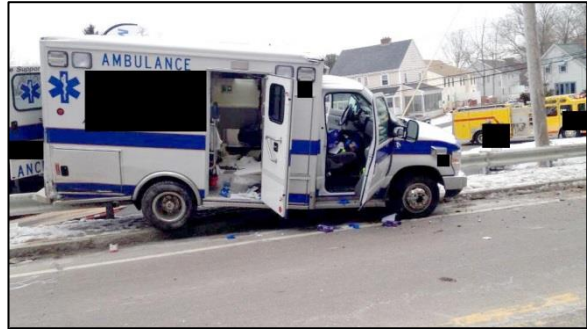
Figure 4: Right side view depicting the final rest position of the ambulance. (Image obtained from the police investigator).

The ambulance rolled one-quarter turn at which time the left fender struck the guardrail (Event 3) located along the right side of the collector road. Blue paint was transferred onto the guardrail in the region of the impact. At the third-quarter turn of the ambulance, the left front tire and suspension impacted the utility pole located immediately beyond the guardrail (Event 4). This impact was evidenced by a tire scuff and an abraded/gouged section on the face of the pole located approximately 1.5 m (5 ft) above the ground. This impact decelerated and interrupted the rollover of the ambulance. The ambulance completed four-quarter turns and came to rest straddling the guardrail facing southeast 31 m (102 ft) from the initial impact. The vehicle's final rest position is depicted in the on-scene police photo **Figure 4**.

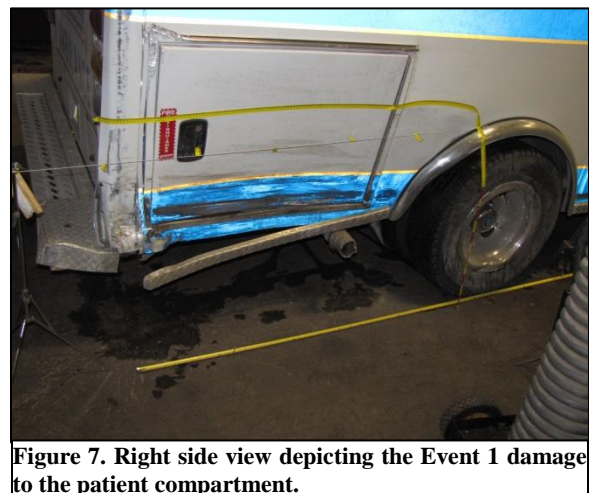
The SCI inspection of the ambulance identified multiple regions of impact and rollover damage which were directly related to the multiple events of this crash. The Mercedes' impact to the right plane of the ambulance aft of the rear axle (Event 1) resulted in a combined region of direct and induced damage that measured 139 cm (54.5 in) (**Figure 7**). The direct contact damage began 18 cm (7 in) aft of the rear axle on the 9 to 10 o'clock sector of the rear wheel.

Figure 7. Right side view depicting the Event 1 damage to the patient compartment.

The aluminum wheel cover at that location was deformed over a 13 cm (5 in) length. The direct contact damage to the patient compartment began immediately above and adjacent to the aft aspect of the wheel and extended rearward to the rear corner of the compartment. The residual crush profile, measured at the 51 cm (20 in) bumper elevation of the Mercedes, was as follows: C1 = 6 cm (2.5 in), C2 = 5 cm (2.0 in), C3 = 9 cm (3.5 in), C4 = 8 cm (3.0 in), C5 = 5 cm (2.0 in), C6 = 0. A non-structural aluminum step/bumper that was attached to, and extended from, the back plane of the patient compartment was deformed at the right corner. The Collision Deformation Classification (CDC) assigned to this damage pattern was of the 02RZEW1. A WinSMASH analysis of this impact was not possible, as the impact involved the patient compartment and was beyond the algorithm's scope.

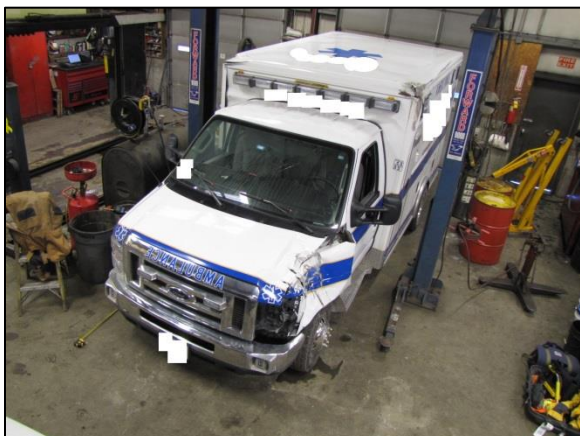
The Event 2 rollover damage consisted of localized crush and abrasions to the four corners of the patient compartment (**Figure 8**). The longitudinal side rails, at the junctions of the side and top planes were abraded. The forward wall of the patient compartment deformed vertically down an estimated 5 cm (2 in) and was buckled above the occupant compartment of the cab. The aluminum corner post at the forward right corner of the patient compartment was partially separated. The equivalent CDC assigned to the rollover damage was 00TDDO2.

Figure 8: Overhead front left view of the ambulance depicting the rollover damage to the patient compartment.

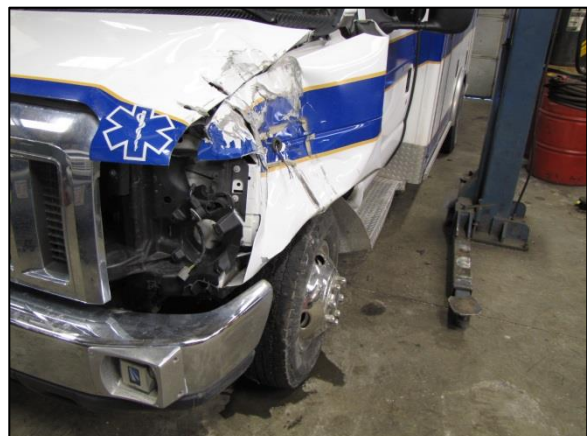
A third zone of damage was noted at the left front fender of the ambulance. The fender was deformed over a 61 cm (24 in) wide region from its non-horizontal impact with the guardrail during the first-quarter turn of the rollover (Event 3). The nature of this damage pattern was consistent with guardrail contact (**Figure 9**). The fender deformed rearward 17 cm (6.5 in) and buckled outward 18 cm (7 in). The residual deformation was located 8 cm (3 in) forward of the left front axle and extended forward. The downward crush of the fender measured 14 cm (5.5 in) at its mid-point. The CDC of this damage was 00LFMW2. The CDC of the undercarriage impact (Event 4) was 00UFLN1. There was no identifiable damage to the undercarriage.

Figure 9: Left front oblique view depicting the Event 3 guardrail damage to the ambulance.

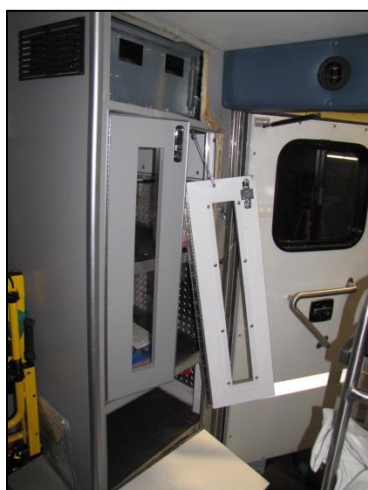
The interior damage within the patient compartment consisted primarily of the fracturing the cabinetry at the forward right aspect of the compartment and the displacement of the heater/air conditioner unit located at its upper aspect (**Figure 11**). This damage probably occurred during ground impact at the second to third-quarter turn of the rollover. This cabinet measured 66 cm x 53 cm x 168 cm (26 in x 21 in x 66 in) width x depth x height and was constructed of 19 mm (3/4 in) plywood. The right French-type door of the cabinet had separated. During the rollover, the displacement of its interior contents contacted the door and separated wood screw fasteners that secured the piano hinge of the door to the plywood construction of the cabinet. The heater/air conditioner unit originally fastened into the upper aspect of the cabinet was dislodged. The formed sheet metal vent cover was also displaced free and had become an interior loose object.

Figure 11: View of the fractured cabinet at the forward right side of the patient compartment of the ambulance

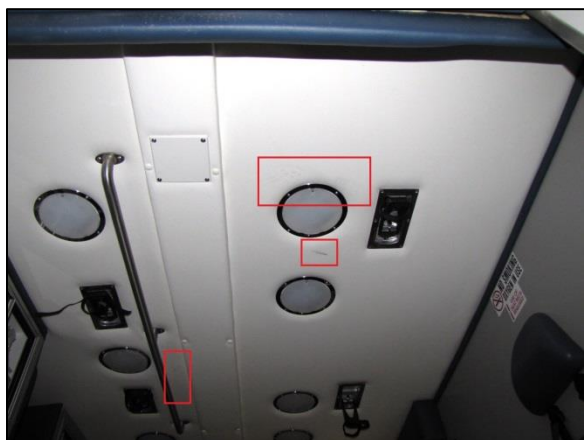
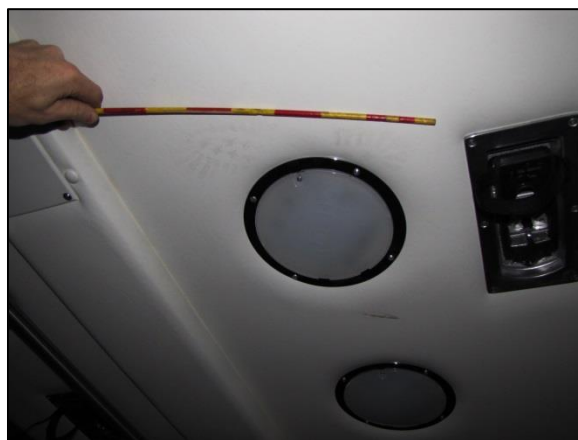
Several points of occupant contact were observed on the roof of the patient compartment (**Figures 13 and 14**). These contact points were attributed to the unrestrained Paramedic. Three small scuffs marks, each measuring less than 5 cm (2 in) in length, were observed on the roof above the CPR seat. The marks were located between the longitudinal grab bar and the padded center area of roof. A left footprint was observed on the roof adjacent to the aft-most recessed light fixture. Dimensionally, the footprint was centered 56 cm (22 in) forward of the back wall, 69 cm (27 in) from the right wall and 102 cm (40 in) from the left wall. A 6 cm (2.5 in) laterally oriented scuff was located 89 cm (35 in) from the back wall, 66 cm (26 in) from the right wall and 104 cm (41 in) from the left wall.

Figure 13: View of the roof of the patient compartment from the back plane looking forward. The locations of the scuff marks and foot print are highlighted in red.

Figure 14: Close-up view of the foot print on the roof of the patient compartment.

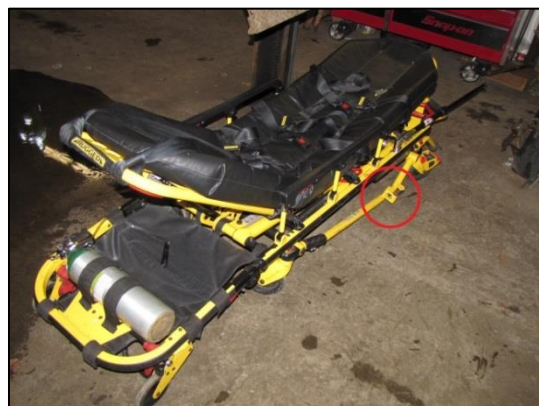
A Stryker cot, Model Number: 6082 MX-PRO R3 (Figure XX); Serial Number: 080540919, was used to transport the patient involved in this crash (**Figure 15**). This cot was constructed of powder-coated, cast aluminum tubing and was designed for a maximum patient weight of 295 kg (650 lb). The lower frame of the cot incorporated a scissor design which allowed for height adjustment. The overall dimensions of the cot measured 203 cm (80 in) in length and 58 cm (23 in) in width. The cushion measured 185 cm x 46 cm (73 in x 18 in). The angle of the back rest was set via a pneumatic adjustment. The patient was being transported in a semi-Fowler's position with the back rest elevated 35 degrees above horizontal. The lower portion of the cot was elevated 15 degrees referenced to horizontal.

Figure 15: View of the right side of the Stryker cot and fractured longitudinal rail at the locking pin.

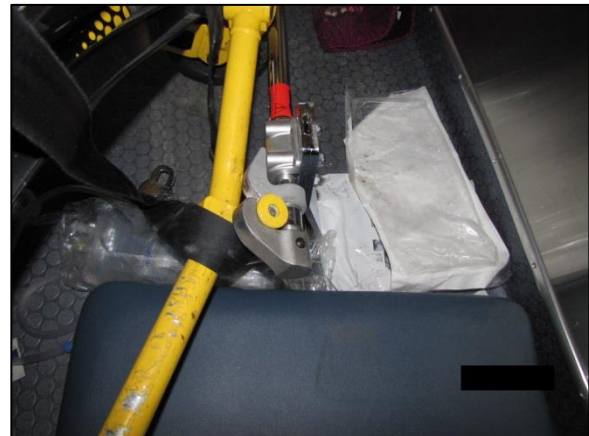
The right rear aspect of the cot was secured by a floor-mounted rail clamp. The rail clamp was a Stryker Model 6370 Cot Fastening System; Serial No. 121241439. This rail clamp was the manufacturer's recommended fastener. The spring-loaded clamp was mounted to a 15 cm (6 in) tall steel bracket assembly secured to the floor of the ambulance by two 10 mm (3/8 in) cap screws. A locking pin that was attached to the lower right tubular frame of the cot, adjacent to the right rear wheel, was secured in the jaw of the clamp for transport. At initial inspection, the clamp mechanism was jammed in the locked position (**Figure 17**). The jaw of the clamp was forced open during the SCI inspection in order to release the cot. During the crash, the rail clamp was loaded and deformed which restricted the internal movement of the clamp and impeded its operation.

Figure 17: View of the jammed rail clamp and cot locking pin within the patient compartment.

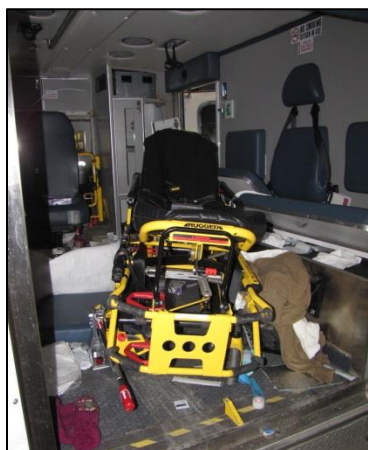
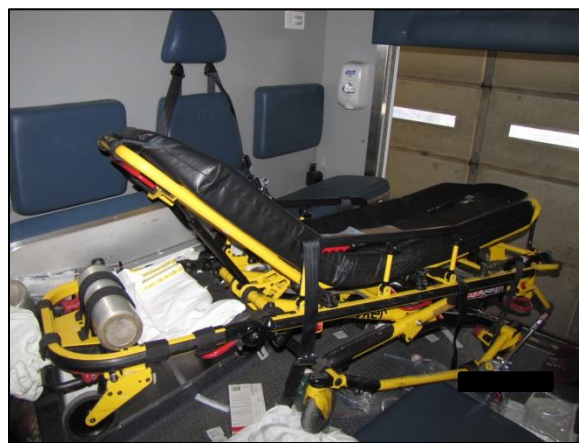
cot disengaged from its position within the antler bracket. The forward aspect of the cot pitched toward the ceiling. The non-horizontal rollover forces caused the cot to yaw about the locking pin at the floor rail clamp toward the right side of the ambulance. As the cot yawed, the applied bending moment caused the longitudinal rail at the right side of the cot to fracture and deformed the rail clamp. The cot came to rest in an elevated position its front left wheel inside the opened squad bench as the ambulance returned to an upright orientation (**Figures 18 and 19**).

Figure 18: Image depicting the post-crash position of the cot looking forward through the rear doors of the ambulance.

Figure 19: Lateral image depicting the post-crash position of the cot within the ambulance.

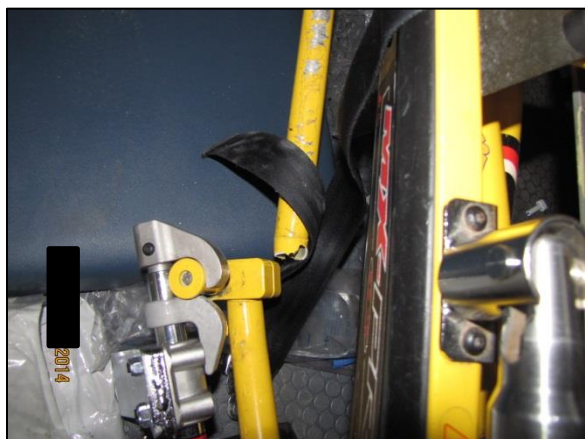
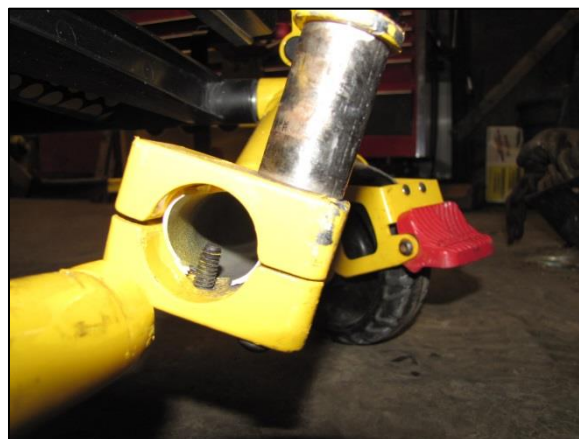
The locking pin was positioned on the cot's longitudinal tubular frame rail 24 cm (9.5 in) forward of the right rear wheel and was fastened to the cot frame via two half-moon shaped components secured together to form a friction clamp. The locking pin was positioned along the longitudinal rail by a drilled hole and a threaded fastener that passed through the bottom side of the friction clamp assembly and into the longitudinal rail. The cast tube sheared through the drilled positioning hole due to the overload force (**Figures 20 and 21**).

Figure 20: View of the fractured frame rail, locking pin and jammed rail clamp prior to the removal of the cot from the patient compartment.

Figure 21: Close-up view of the fractured frame rail and locking pin after its removal from the patient compartment.

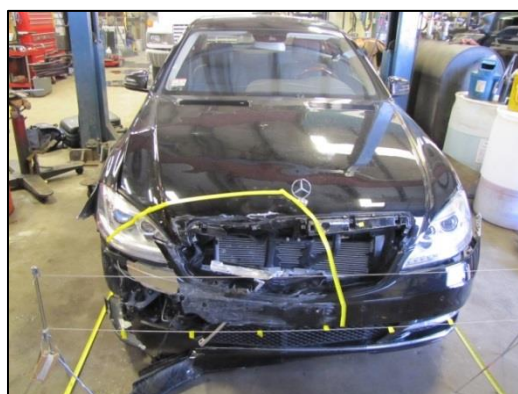
Figure 22: Front view of the Mercedes depicting the impact damage.

The front plane of the Mercedes sustained moderate damage which was related to the intersection crash with the ambulance. The combined width of the direct and induced damage extended across the entire 157 cm (62 in) end width of the vehicle. The direct contact damage began 19 cm (7.5 in) left of center and extended 98 cm (38.5 in) to the right corner of the front bumper. The residual crush profile was measured to the aluminum reinforcement bar and was as follows: C1 = 0, C2 = 6 cm (2.4 in), C3 = 10 cm (4.0 in), C4 = 14 cm (5.5 in), C5 = 14 cm (5.5 in), C6 = 16 cm (6.3 in). The right wheelbase was reduced 1 cm (0.5 in). The left wheelbase measurement was unchanged from the vehicle's specifications. All doors remained closed during the crash and were operational based on the post-crash inspection. There was no damage to the windshield, backlight or glazing of the side windows. The CDC assigned to this damage pattern was 12FZEW1. The force of the impact caused the driver air bag to deploy. The driver's safety belt pretensioner was actuated.
