ON-SITE AMBULANCE CRASH INVESTIGATION

SCI CASE NO: CR13021

VEHICLE: 2012 CHEVROLET G4500 CUTAWAY

AMBULANCE: AMERICAN EMERGENCY VEHICLES TRAUMA HAWK TYPE III

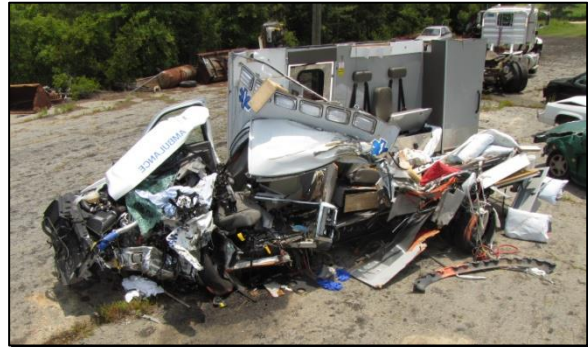
This on-site investigation focused on the frontal crash of a 2012 Chevrolet G4500 Type III ambulance (**Figure 1**) and the injury source(s) for the fatally injured 44-year-old female driver, and the 56-year-old male Emergency Medical Technician (EMT) and 65-year-old male patient who were occupying the patient compartment of the vehicle. The front plane of the ambulance struck an opposite-direction tractor semi-trailer that had entered the ambulance's travel path.

Figure 1: Overhead left front oblique view of the ambulance.

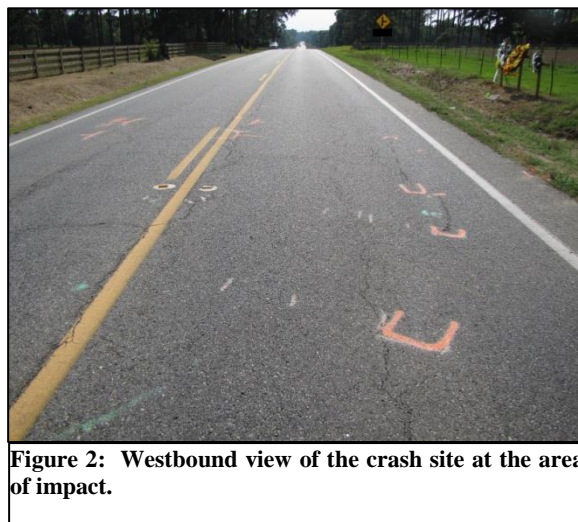
This two-vehicle crash occurred on an east/west asphalt two-lane road (**Figure 2**) that was located in a rural setting. At the time of the crash, it was dark with an overcast sky. It had been raining and the road surface was wet. In the area of the crash, the road was straight and predominately level. The total width of the road measured 7.0 m (22.9 ft) and was comprised of two 3.5 m (11.4 ft) lanes. The travel lanes were delineated by a white fog lines and solid/broken centerlines that represented a passing zone for eastbound traffic. The asphalt road shoulders measured 0.8 m (2.6 ft). The grass roadside beyond the shoulders tapered into drainage ditches that paralleled both the north and south sides of the road. The ditches were approximately 0.6 m (2 ft) in depth. A residential driveway, located west of the area of the impact, intersected the road from the south. The speed limit in the area of the crash was 89 km/h (55 mph).

Figure 2: Westbound view of the crash site at the area of impact.

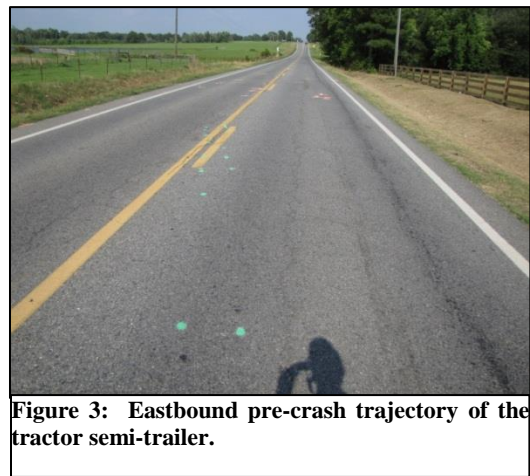
Eastbound traffic consisted of a non-contact 2011 Chevrolet Malibu driven by a 25-year-old female followed by the 2001 International tractor and semi-trailer driven by a 59-year-old male. The International was hauling an empty 14 m (45 ft) hopper-bottom semi-trailer. As the opposite direction traffic approached the ambulance, the driver of the non-contact vehicle applied the brakes and steered right to yield to the emergency vehicle. The driver of the International tractor realized he was overtaking the non-contact vehicle and locked the brakes in avoidance. When the tractor driver realized that he would not be able to stop the unit, he attempted to pass the non-contact vehicle. He steered the tractor to the left and the left side tires of the tractor crossed the centerline (**Figure 3**).

Figure 3: Eastbound pre-crash trajectory of the tractor semi-trailer.

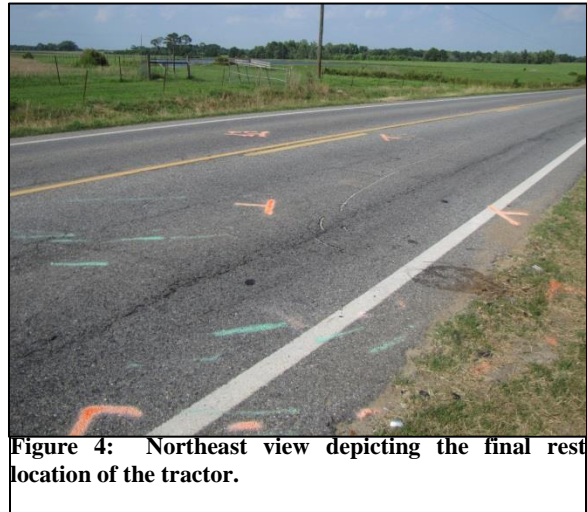
The impact force from the ambulance was located near the articulation point of the tractor semi-trailer. The force of the impact resulted in a CCW rotation of the tractor and a clockwise rotation of the semi-trailer, as this vehicle separated from the impact. As the tractor slid to the east, it rotated approximately 55 degrees CCW and came to rest straddling the centerline of the road (**Figure 4**) approximately 6 m (21 ft) east the impact. The trailer rotated approximately 25 degrees CW. At final rest, the left tires of the trailer's rear axle were on the centerline of the road. Based on the impact configuration and the distance from the area of impact to the final rest of the tractor semi-trailer, the impact speed of the tractor semi-trailer was approximately 32-48 km/h (20 to 30 mph).

Figure 4: Northeast view depicting the final rest location of the tractor.

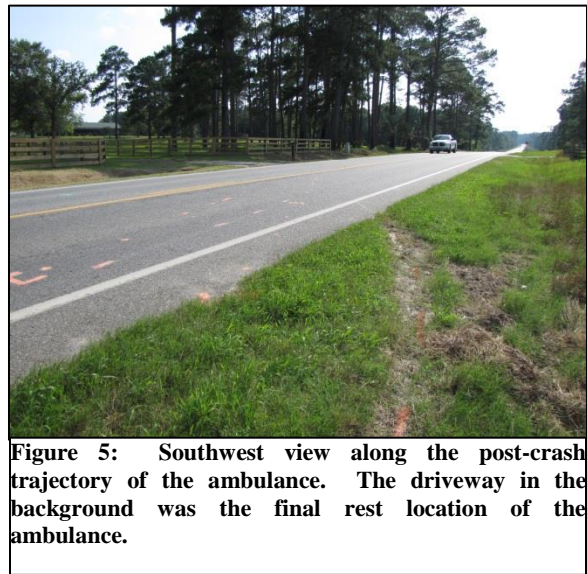
The ambulance was deflected to the right and separated from the impact with a counterclockwise (CCW) rotation. The right tires of the vehicle departed the north road edge evidenced by arcing tire marks along the roadside and through the ditch. The off-tracking of the ambulance was approximately 20 degrees CCW relative to its original travel direction. A road sign located 33 m (107 ft) from the initial impact was struck by the right corner of the rear step (Event 2) and taken down during the ambulance's post-crash travel. The ambulance continued along its arcing trajectory, returned to the westbound lane (**Figure 5**), crossed the

Figure 5: Southwest view along the post-crash trajectory of the ambulance. The driveway in the background was the final rest location of the ambulance.

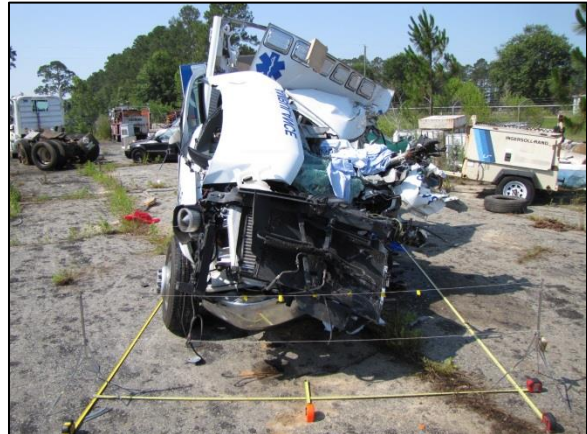
The front and left planes of the Chevrolet sustained severe damage as a result of the offset impact. The direct contact damage began 21 cm (8.3 in) left of center and extended 68 cm (26.7 in) left to the left front corner. The combined width of the direct and induced damage extended across the entire 178 cm (70 in) frontal end width (**Figure 8**). The residual crush, measured along the front bumper, was as follows: C1 = 89 cm (35.0 in), C2 = 72 cm (28.5 in), C3 = 46 cm (18.0 in), C4 = 31 cm (12.2 in), C5 = 17 cm (6.5 in), C6 = 0. The offset impact force buckled the left frame and left structures of the van chassis

Figure 8: Front view of the ambulance.

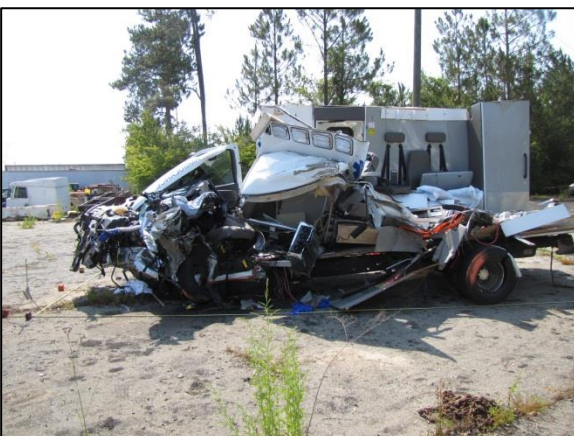
(**Figure 9**). The left structure of the engine compartment and left front wheel assembly were compressed into the left cowl structure and lower A-pillar. The right frame rail was deformed to the left 38 cm (14.8 in). The right upper A-pillar separated from the cowl at the beltline as the left structure of cab (greenhouse) impacted the left corner of the trailer. The left aspect of the windshield header exhibited 36 cm (14 in) of direct contact which began at the corner and extended right (**Figure 10**). The left roof side rail was crushed to a vertical depth of 23 cm (9 in). For reference, the comparison measurement of the undeformed roof side rail was 91 cm (36 in). The roof structure rotated counterclockwise approximately 80 degrees during its deformation. The base of the left B-pillar separated from the frame of the chassis and was deflected to a near-horizontal orientation. The right B-pillar deformed laterally to the left. The deflection at the top of the right B-pillar measured 86 cm (34 in).

Figure 9: Overall left view of the ambulance.

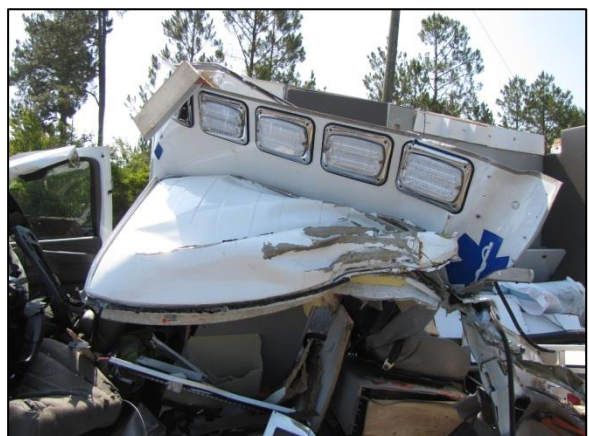
Figure 10: Close view depicting the direct contact damage and the crush of the ambulance roof.

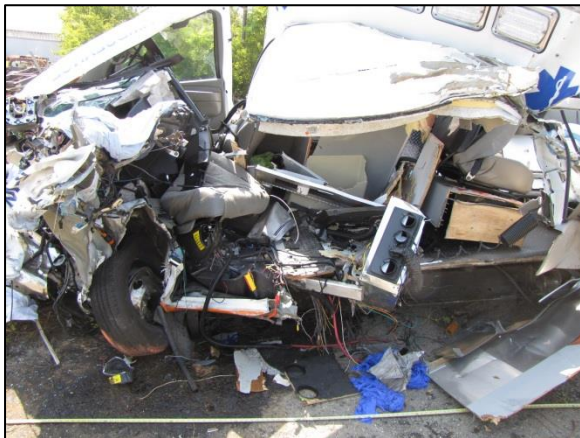
The forward interior compartment of the Chevrolet sustained severe damage with a complete loss of integrity that was directly attributed to the exterior crash forces (**Figure 11**). The left instrument panel, left bolster and left toe pan intruded to the forward aspect of the driver seat cushion. The steering column was separated from the instrument panel and the column was rotated 90 degrees CW relative to its original location. The steering wheel rim had separated from the top of the column and was missing. The driver seat track position was unknown. Its position had been altered during the removal of the ACM. The seat back was separated from the seat frame and removed by the first responders during the extrication activities.

Figure 11: Left lateral view depicting the cab intrusion.

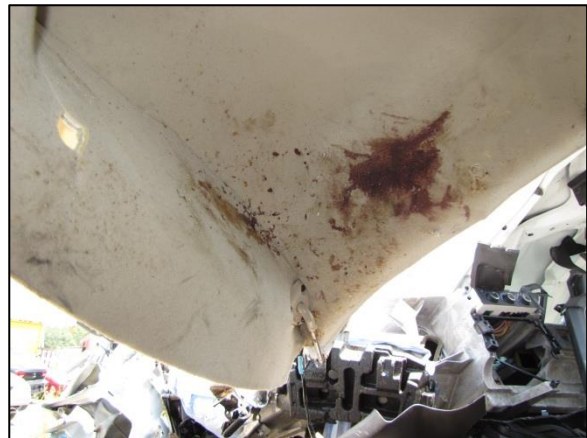
A driver head contact was identified during the interior inspection (**Figure 12**). The contact was located at the forward right aspect of the roof and measured 30 cm x 18 cm (12 in x 7 in) in overall dimension. The center of the contact was located 30 cm (12 in) aft of the windshield header and 13 cm (5 in) left of the right roof side rail.

Figure 12: Image depicting the head contact at the front right corner of the roof.

The force of the impact overloaded and buckled the left structures of the chassis. The left interior components intruded into the driver space. The left front corner of the ambulance roof impacted the left corner of the semi-trailer. This engagement compressed the left roof side rail to a residual depth of 23 cm (9 in) and caused the roof structure to rotate CCW as the support pillars separated. The driver's head impacted the front right aspect of the roof and was the probable source of her head trauma.

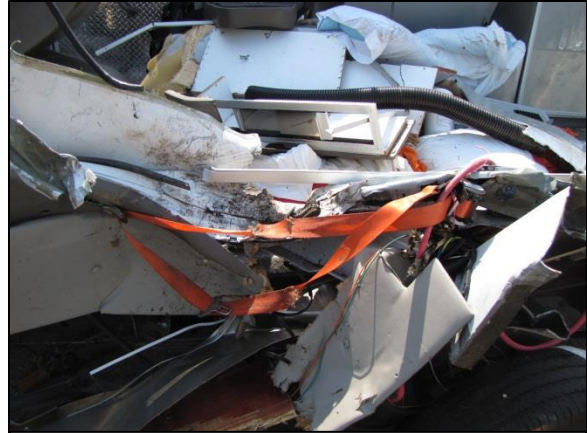
The left B-pillar was oriented in a horizontal position due to its separation from the sill. The base of the pillar and the retractor were located adjacent to the left rear axle. The (orange-colored) safety belt webbing was in a stowed position (**Figure 13**). The exposed webbing was partially cut in several places from contact with edges of the deformed sheet metal during the crash sequence. The webbing was stowed on the retractor spool. Examination of the latch plate was unremarkable for crash-related physical evidence (i.e. loading abrasions). The surface of the D-ring was not abraded. Based on the observations of the SCI inspection, the driver of the ambulance was not restrained by the safety belt at the time of the crash. The unrestrained status of the driver was consistent with the imaged EDR data.

Figure 13: View of the deformed left B-pillar and stowed driver safety belt (orange-colored webbing).

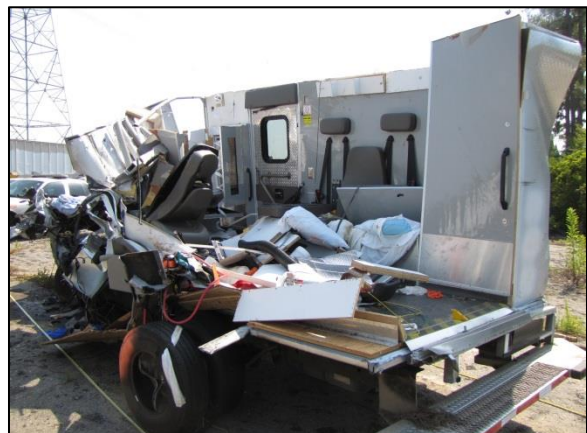
The AEV Trauma Hawk Type III patient compartment sustained catastrophic damage as a result of the impact (**Figure 14**). The left, back and top planes separated from the vehicle during the crash and were dispersed throughout the crash site. The forward wall of the compartment hinged at the right corner with rearward displacement at the left and center aspects. Comparative (longitudinal) measurements of the patient compartment indicated that the residual location of the left front corner was 99 cm (39 in) aft of its original position. The rear facing jump seat was deflected rearward and displaced from its box-mount. All the left cabinetry was dislodged.

Figure 14: Left rear oblique view of the patient compartment.

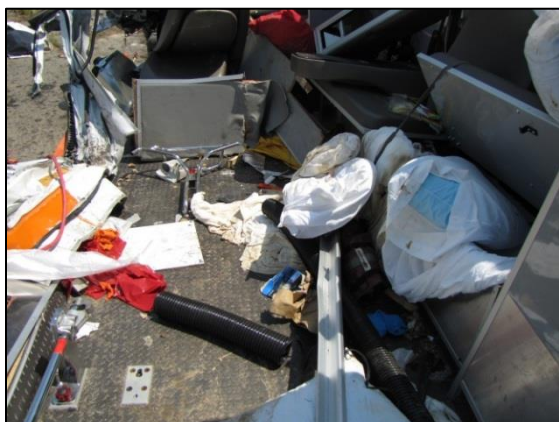
Physical inspection of the antler bracket positioned on the floor at the forward aspect of the cot was unremarkable. It was not damaged (**Figure 15**). The Stryker rail clamp system was intact and operational (**Figure 16**). At inspection, the locking jaw opened and closed as designed. The rail clamp was identified as Model No. 6370 and Serial No. 120841138.

Figure 15: View of the patient compartment floor, rail clamp and the antler bracket.

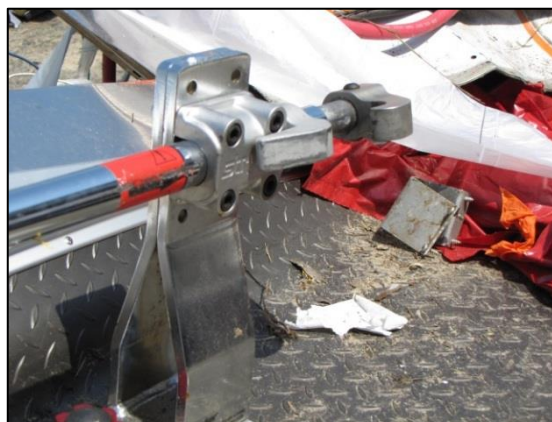
Figure 16: Close-up view of the rail clamp.

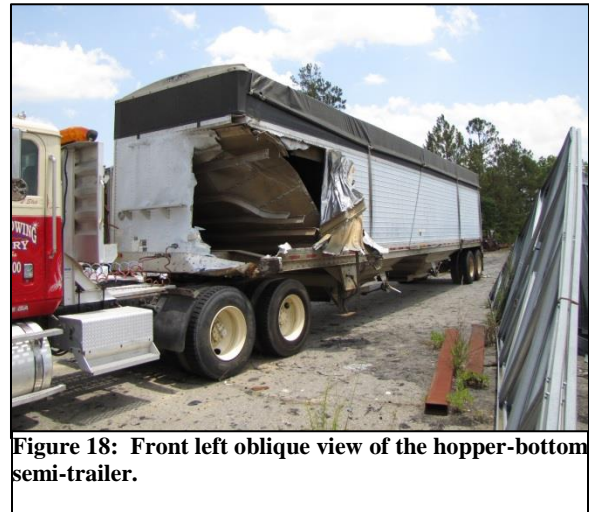
The left front corner of the trailer was holed due to its impact with the ambulance (**Figure 18**). The trailer's front plane at the floor elevation exhibited 48 cm (19 in) of direct contact damage. This direct contact began at the corner and extended to the right. The aluminum wall of the trailer sheared in the area of this direct contact and tore resulting in a 183 cm by 79 cm (72 in by 31 in), height by width, opening at the front plane. This opening extended along the left plane 2.2 m (7 ft) as the side wall buckled/deformed rearward. For reference, the floor of the trailer was located 119 cm (47 in) above the ground. The TDC assigned to the damage pattern of the tractor semi-trailer was 12LKEW4.

Figure 18: Front left oblique view of the hopper-bottom semi-trailer.
