ON-SITE AMBULANCE CRASH INVESTIGATION

CASE NUMBER - IN14004

VEHICLE - 2012 FORD E-450 TYPE III AMBULANCE

CRASH DATE - January 2014

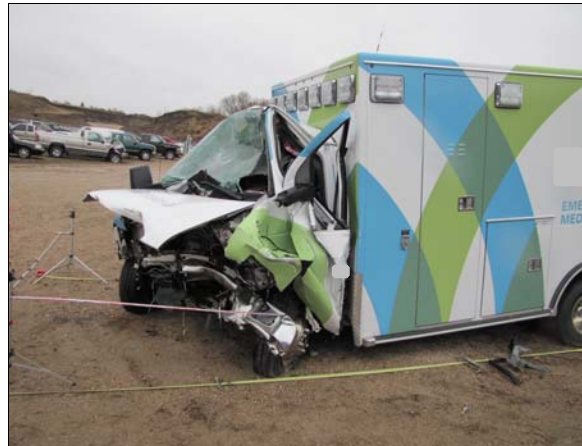
Figure 1: The damaged 2012 Ford E-450 Type III ambulance

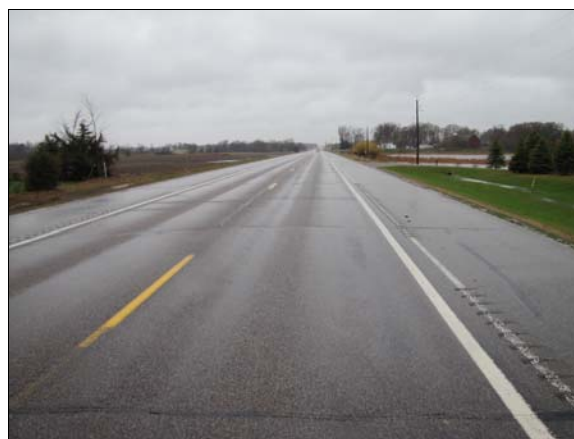
Figure 2: Westbound approach of the ambulance

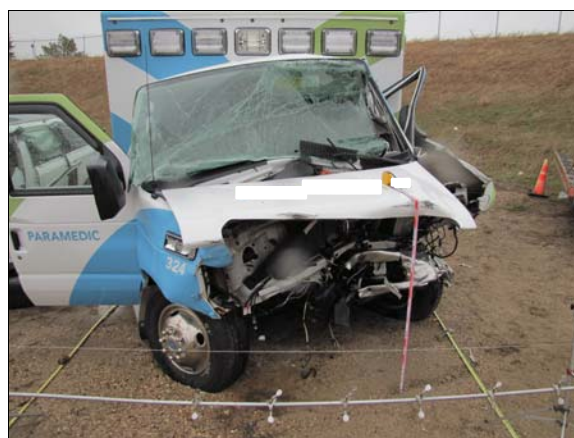
Crash: The front plane of the ambulance (**Figure 3**) was impacted by the front plane of the Lincoln (**Figure 4**). The impact occurred approximately in the center of the roadway (**Figure 5**). The force direction on the ambulance was within the 12 o'clock sector, and the impact resulted in deployment of the driver's frontal air bag and actuation of his safety belt pretensioner. The patient cot separated from the rail clamp and antler bracket and the cot overturned. The patient was displaced on the cot and partially out of the restraints, but remained on the cot. The force direction on the Lincoln was also within the 12 o'clock sector and the impact resulted in actuation of the driver's safety belt pretensioner and a stage two deployment of the driver's frontal air bag. The driver's seat-mounted side impact air bag and both inflatable curtain (IC) air bags also deployed.

Figure 3: Damage to the front plane of the ambulance from the impact with the front plane of the Lincoln

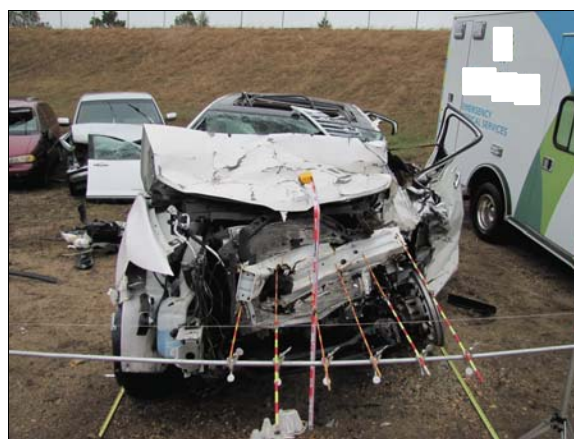
Figure 4: Damage to the front plane of the Lincoln

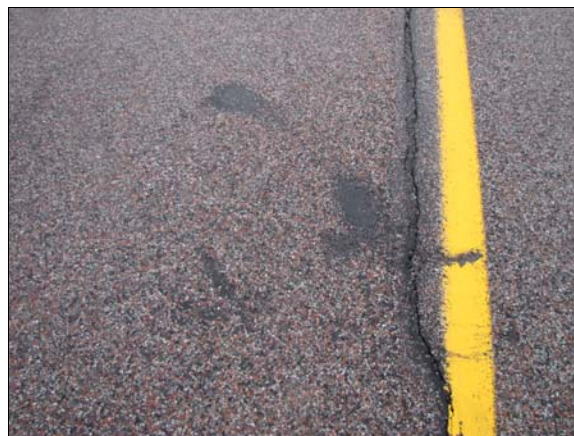
Figure 5: View west at impact gouge marks on the center line and in the eastbound lane

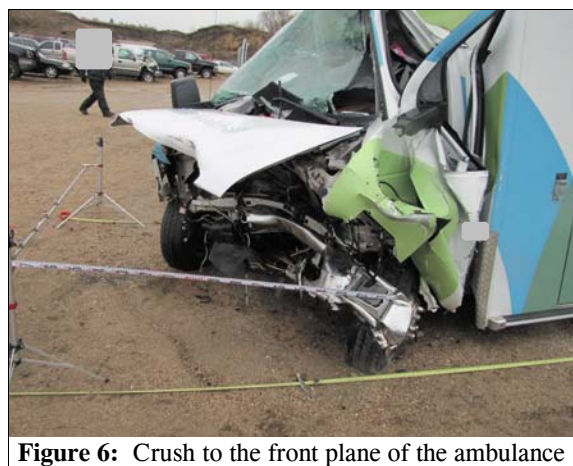
The ambulance sustained damage to the front plane during the impact with the front plane of the Lincoln. The front bumper, grille, hood, both headlamp/turn signal assemblies, left fender, and front portion of the right fender were directly damaged. The direct damage began at the left corner of the front bumper and extended 176 cm (69.3 in) across the front plane. The Field L was 147 cm (57.9 in). Crush measurements were taken at the bumper level and the maximum residual crush was 154 cm (60.6 in) occurring at C₁ (**Figure 6**). The crush values were: C₁ = 157 cm (61.8 in), C₂ = 135 cm (53.1 in), C₃ = 127 cm (50 in), C₄ = 83 cm (32.7 in), C₅ = 60 cm (23.6 in), C₆ = 40 cm (15.7 in).

Figure 6: Crush to the front plane of the ambulance

The Collision Deformation Classification (CDC) was 12FDEW6 (10 degrees). The WinSMASH program could not be used to calculate Delta V since the ambulance was a medium/heavy vehicle type and impacts involving such vehicles are out of scope for the program. The severity of the damage was severe.

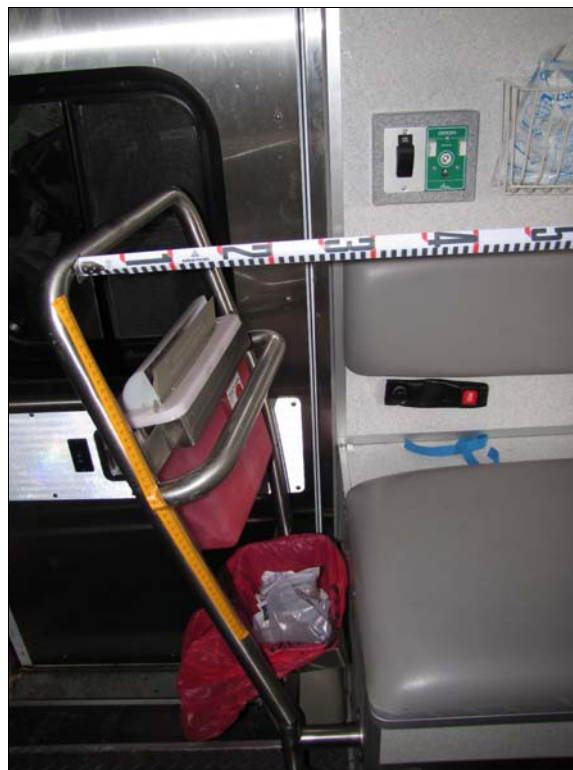
Patient Compartment: There was no intrusion of the patient compartment. The stainless steel railing at the front of the right inward-facing bench seat (**Figure 7**) was bent forward 22 cm (8.7 in) from contact by the paramedic's torso. Blood transfer and scuff marks from contact by the paramedic's head were located on the front edge of the top shelf of the storage cabinet (**Figure 8**) located forward of the right inward-facing bench seat. The edge of the middle shelf was also dented and scuffed from contact by the paramedic's torso. No other components in the patient compartment were damaged or exhibited discernable evidence of occupant contact.

Figure 7: Displaced railing at front of the right inward-facing bench seat from contact by the paramedic

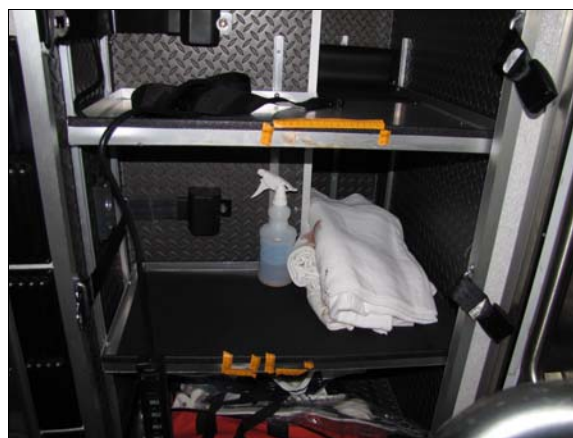
Figure 8: Occupant contact marks from the paramedic located on the storage shelf forward of the right inward-facing bench seat

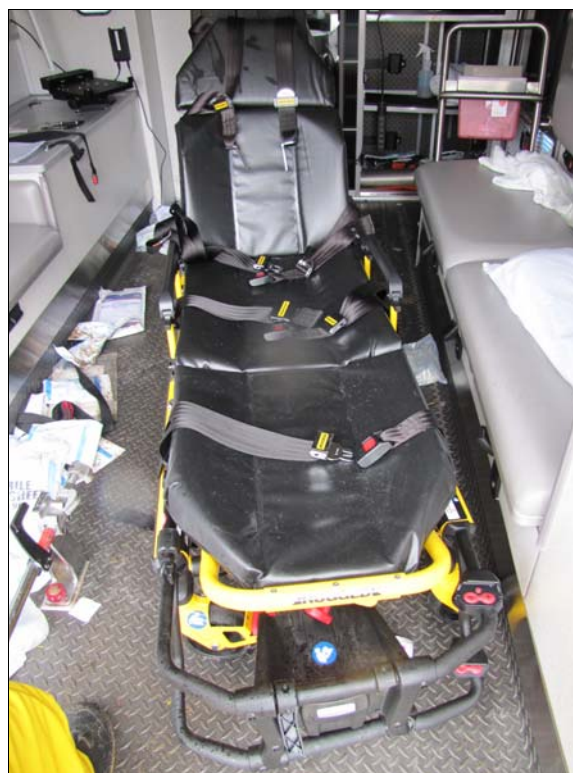
The patient was restrained on a Stryker 6506 Power-Pro XT patient cot (Serial Number: 13084xxxx, date of manufacture: August 2013, **Figure 9**). The cot was an X-frame design and the manufacturer's specifications stated the standard length, width, weight, and weight rating were 206 cm (81 in), 58 cm (23 in), 57 kg (125 lbs), 318kg (700 lbs), respectively. The cot was equipped with shoulder harness straps and restraints for the chest, thighs, and lower legs. Each restraint was labeled "Rugged," and the model numbers on the buckles of the lower leg, thigh, and chest restraints were ASCP 2B130401, ASCP 2B130301, and 2B070702, respectively. The number 1C1301 was present on the latch plate of the lower leg restraint, chest restraint, and shoulder harnesses. The patient was restrained by the shoulder harness, chest, thigh, and lower leg restraints, and the back rest was reclined 31 degrees aft of vertical.

Figure 9: The Stryker 6506 Power-Pro XT patient cot

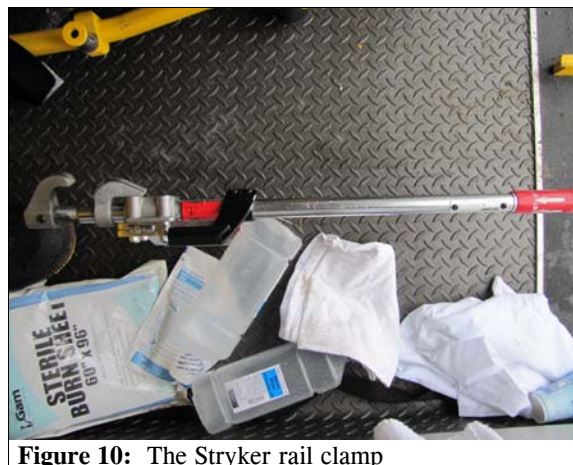
The cot was secured to the floor of the ambulance by the rail clamp and the front wheels were secured by an antler bracket. The rail clamp (**Figure 10**) was manufactured by Stryker and the serial number was 12034xxxx. The rail clamp was not damaged in the crash. The rail clamp floor anchor was slightly loose, but was not deformed. The loose status of the anchor did not appear to be crash related. The rail clamp striker on the right frame rail of the cot was not damaged and the right frame rail was not deformed. The antler bracket was also not damaged. Heavy scuff marks were present on the front wheel brackets of the cot from contacting the antler bracket during the crash.

The patient cot separated from the rail clamp during the crash and the cot was displaced out of position and overturned. The driver stated during the interview that he clearly heard the sound of the rail clamp snapping closed when he and the paramedic loaded the patient in the ambulance. The lack of damage to the rail clamp, rail clamp striker, and right frame rail of the cot suggested that the rail clamp released from the striker during the crash. The severity of the crash and possibly the upward pitch of the back of the ambulance during the impact were most likely the primary factors contributing to the release of the rail clamp from the striker. The heavy scuff marks on the front wheel brackets of the cot indicated that the front wheels contacted the antler bracket and probably resulted in the foot end of the cot pitching upward contributing to the overturn of the cot during the crash.

Figure 10: The Stryker rail clamp

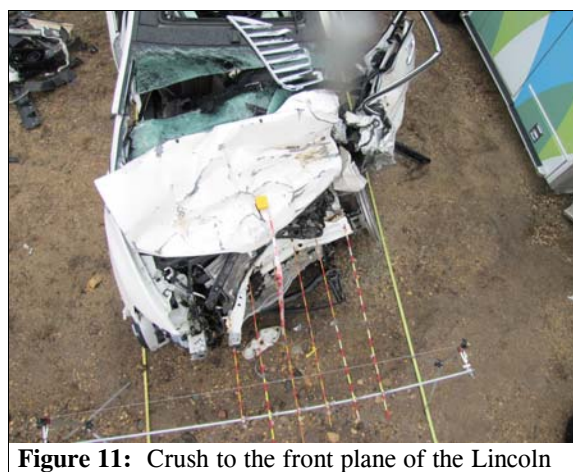
The Lincoln sustained damage to the front and left planes during the impact with the front plane of the ambulance. The front bumper, grille, hood, both headlamp/turn signal assemblies, left fender, and left front door were directly damaged. The direct damage began at the left corner of the front bumper and extended 149 cm (58.7 in) across the front plane. The Field L was 79 cm (31.1 in). The crush measurements were taken on the bumper bar and the maximum residual crush was 80 cm (31.5 in) occurring at C₃ (**Figure 11**). The crush values were: C₁ = 63 cm (24.8 in), C₂ = 70 cm (27.6 in), C₃ = 80 cm (31.5 in), C₄ = 74 cm (29.1 in) C₅ = 50 cm (19.7 in), C₆ = 2 cm (0.8 in).

The CDC was 12FDEW4 (0 degrees). The WinSMASH could not be used to calculate Delta V since the ambulance was out of scope for the program for the program. However, WinSMASH was used to calculate a Barrier Equivalent Velocity (BES) of 64 km/h (39.8 mph). The severity of the damage was severe.
