SPECIAL CRASH INVESTIGATIONS

CASE NO.: CR15019

ON-SITE AMBULANCE CRASH INVESTIGATION

VEHICLE: 2008 FORD E350

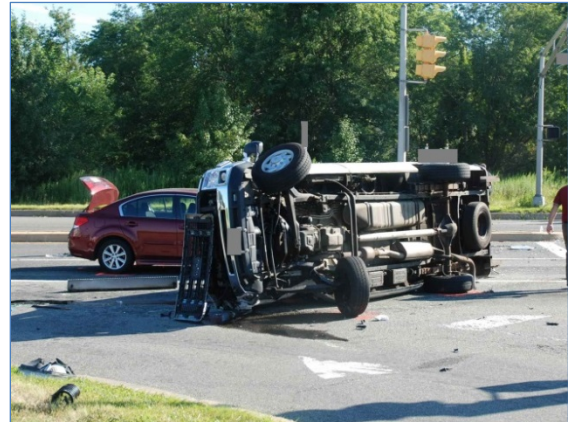
Figure 1: Overturned ambulance at final rest (*image obtained from the investigating law enforcement agency*).

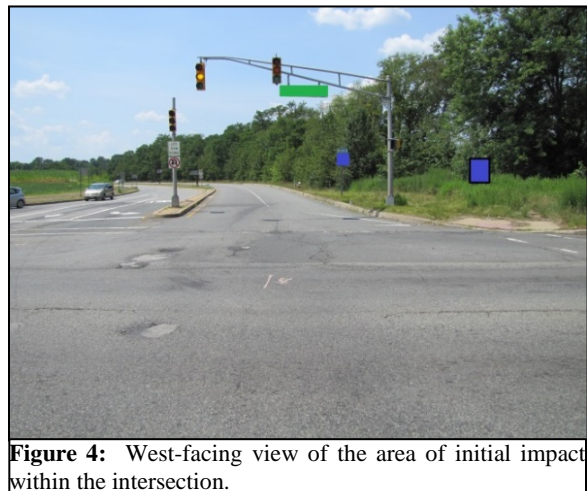
The first crash event occurred within the intersection (**Figure 4**) as the front plane of the Toyota impacted the forward aspect of the ambulance's right plane in a near right-angle orientation. Associated crash forces were within the 2 o'clock sector for the ambulance and 11 o'clock sector for the Toyota. Impact engagement induced a rapid CCW rotation to the ambulance and a rapid clockwise (CW) rotation to the Toyota. The ambulance's trajectory was redirected to the southwest, while the Toyota's trajectory was redirected westward. Damage was sustained by the ambulance's right front wheel/axle, right front door, and right front fender. The right front window glazing was disintegrated by the impact forces.

Figure 4: West-facing view of the area of initial impact within the intersection.

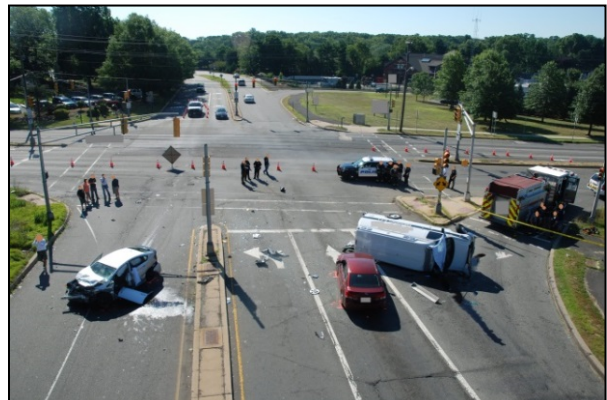
The final crash event occurred as the rear aspect of the ambulance's top plane impacted the front of the stationary Subaru (Event 4). These forces were non-horizontal in nature for the ambulance, but within the 12 o'clock sector for the Subaru. Engagement between the vehicles displaced and rotated the Subaru approximately 2.0 m (6.6 ft) rearward and 15 degrees CW from its stationary position, where it came to final rest in the eastbound lane, facing east. The ambulance came to final rest with its top plane in contact with the front plane of the Subaru, facing southwest. At this final rest position, the head, upper extremities, and upper torso of the partially ejected front right occupant were entrapped beneath the over-turned ambulance. **Figure 5** depicts an on-scene overhead view of the ambulance, Toyota, and Subaru at final rest.

Figure 5: East-looking overhead view of the crash site and the involved vehicles at final rest (image provided by the investigating law enforcement agency).

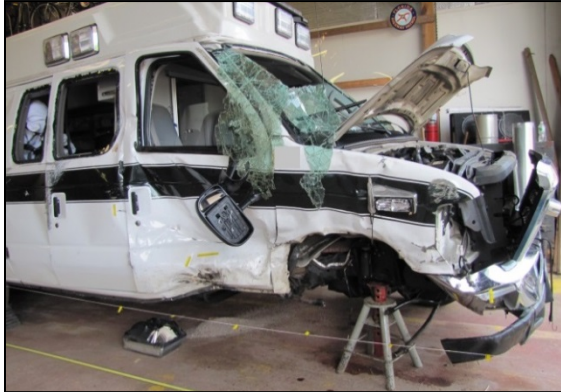
Figure 7: View of the Event 1 damage profile to the ambulance, as viewed from the approximate angle of the impact force.

Direct contact damage associative to the first impact event with the front plane of the Toyota began 31 cm (12.2 in) aft of the right front bumper corner and extended 155 cm (61.0 in) rearward. The direct and induced damage width measured 212 cm (83.5 in), beginning 14 cm (5.5 in) aft of the right front bumper corner and extending rearward. A residual crush profile was documented at sill level using the half-width method (**Figure 7**). This crush profile produced the following resultant measurements: C1 = 1 cm (0.4 in), C2 = 28 cm (11.0 in), C3 = 27 cm (10.6

in), C4 = 51 cm (20.1 in), C5 = 43 cm (16.9 in), C6 = 17 cm (6.7 in). Maximum crush was observed at the C4 measurement location. The Collision Deformation Classification (CDC) assigned to the ambulance for the Event 1 impact with the Toyota was 02RYEW3. Due to the ambulance's weight and characteristics, the vehicle type was beyond the scope of the WinSMASH model. However, the Damage Algorithm of the model was used to calculate a reconstruction of the crash for analysis purposes. The calculated delta-V of the ambulance for the Event 1 impact was 18 km/h (11.2 mph), with longitudinal and lateral components of -9 km/h (-5.6 mph) and -16 km/h (-9.9 mph), respectively. The Barrier Equivalent Speed (BES) was 27 km/h (17 mph). These results appeared underestimated.

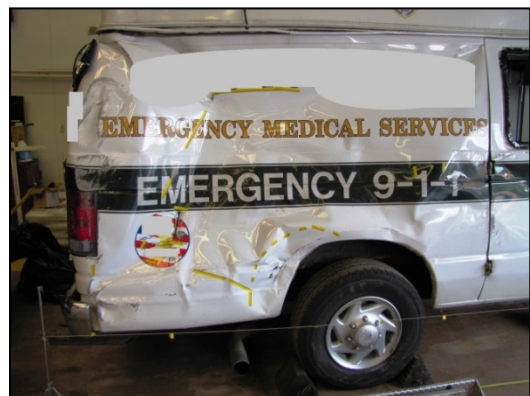
Distinct side-slap damage was visible on the ambulance's right plane. The profile of the rear aspect of the Toyota's left plane was sharply outlined on the ambulance's right plane (**Figure 8**). Within the damage pattern was lateral deformation to the right plane of the ambulance, with surface scratches and abrasions in the painted surface. An I-shaped perforation into the body panel was located within the right rear quarter panel area, attributable to the side profile of the Toyota's rear bumper beam.

Figure 8: Right plane view of the ambulance and the resultant side-slap (Event 2) damage profile.

A circular tire mark, attributable to the Toyota's rotating left rear tire, was visible on the right rear quarter panel area of the ambulance immediately rearward of the right rear axle position. Direct contact damage associative to the side-slap event began 29 cm (11.4 in) forward of the right rear axle position and extended 147 cm (57.9 in) rearward. The direct and induced damage width measured 187 cm (73.6 in), beginning 45 cm (17.7 in) forward of the right rear axle position and extending rearward. A residual crush profile was documented at upper door level using the half-width method. This crush profile produced the following resultant measurements: C1 = 4 cm (1.6 in), C2 = 15 cm (5.9 in), C3 = 26 cm (10.2 in), C4 = 20 cm (7.9 in), C5 = 15 cm (5.9 in), C6 = 6 cm (2.4 in). Maximum crush was observed at the C3 measurement location. The CDC assigned to the ambulance for the Event 2 side-slap with the Toyota was 03RBAW3.

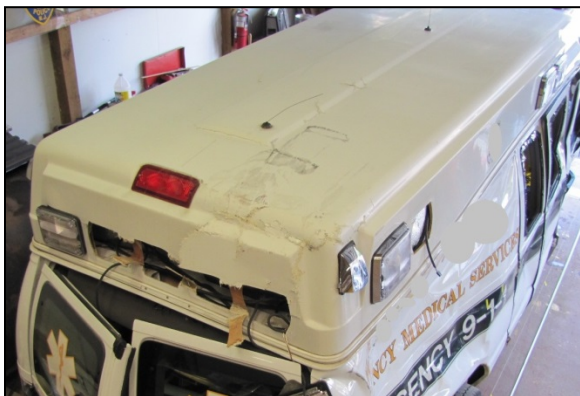
Figure 9: Right rear oblique overhead view of the ambulance's top plane and the Event 4 damage.

Damage associative to the fourth impact event with the front plane of the Subaru was located on the top plane of the ambulance, to the raised fiberglass roof structure. This included fracture of the fiberglass right of centerline, at the rear aspect of the roof. In conjunction with the fractured fiberglass, multiple emergency warning lights at the upper aspect of the rear plane were displaced from their housing within the fiberglass structure. There was also a pattern of abrasions to the painted surface of the fiberglass, with black

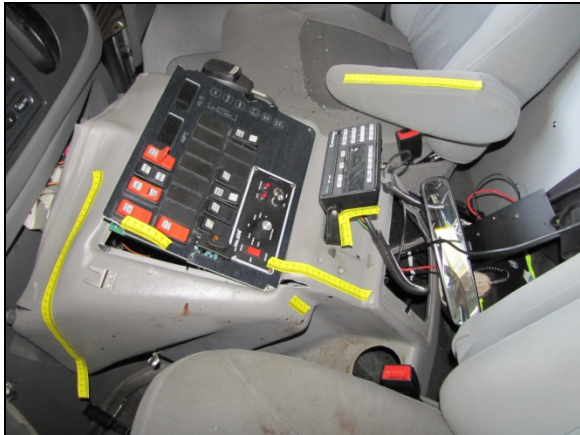
The cab of the ambulance was inspected for occupant contact, intrusion, and crash related damage. Occupant contact evidence was located throughout the cab's interior, and highlighted the unrestrained occupants' kinematic responses to the crash forces. Contact evidence attributable to the driver was observed to the center console, roof, partition between the cab and patient compartment, and armrest of the right front seat. The center console was deformed and multiple operational switches were displaced and/or damaged by loading from the driver's right flank and right lower extremity (**Figure 10**). A bracket mounted to the console that served as the securement for a two-way mobile communications radio was bent to the right. Scuffs to the roof from contact by the driver's head were also visible. On the clear polymer panel of the partition separating the cab from the patient compartment was a scuff oriented from the lower left corner toward the upper right corner (**Figure 11**). This was attributed to contact from the driver's back. Lastly, the right armrest on the left aspect of the front right seat back was deformed to the right. It is probable that this resulted from contact with the displaced driver's right flank.

Figure 10: Interior damage to the center console within the ambulance's cab attributable to driver contact.

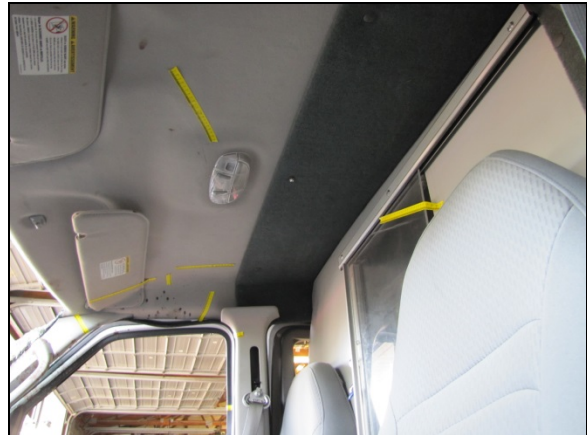
Figure 11: Driver contact to the roof and rear partition within the ambulance's cab.

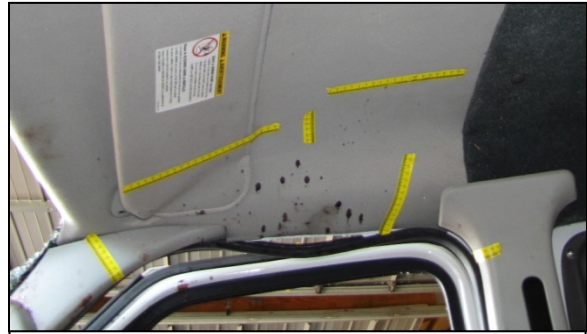
Blood transfer, splatter, and smears were visible on the right roof side rail and right upper A-pillar (**Figure 12**). On the exterior of the ambulance and extending in an angular fashion from the right front glazing opening toward the lower aspect of the right rear loading doors was blood, hair, and body tissue. This resulted from contact by the partially ejected front right occupant with the ambulance and roadway surface as the vehicle slid on its right plane from the rollover until final rest.

Figure 12: Front right occupant contact evidence to the roof, A-pillar, B-pillar, and right roof side rail within the cab of the ambulance.

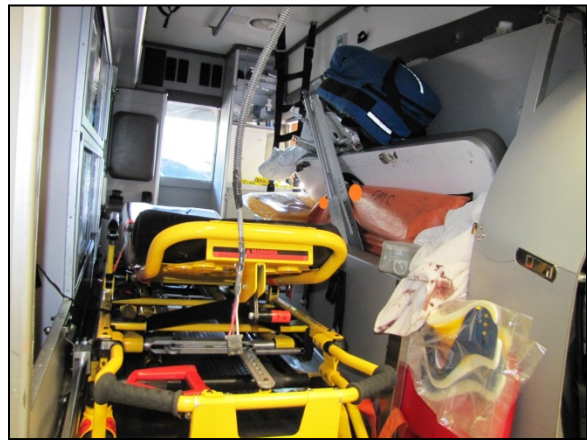
Secondary damage, associated to the crash sequence, was sustained by the interior of the patient compartment. This included separation of the cabinetry and storage compartments on the right plane, inclusive of the three-passenger left-facing bench seat and on-board oxygen storage tank (located within a compartment at the right rear corner). Left wall cabinetry and storage remained largely intact and undamaged. Unsecured medical equipment and supplies were strewn about the patient compartment's interior (**Figure 13**).

Figure 13: Forward-facing view of the patient compartment's interior at the time of the SCI investigation.

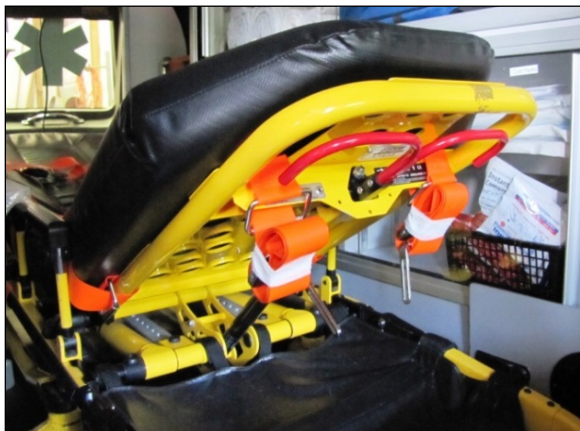
Figure 15: Shoulder straps of the Stryker cot bound tightly behind the back of the cot.

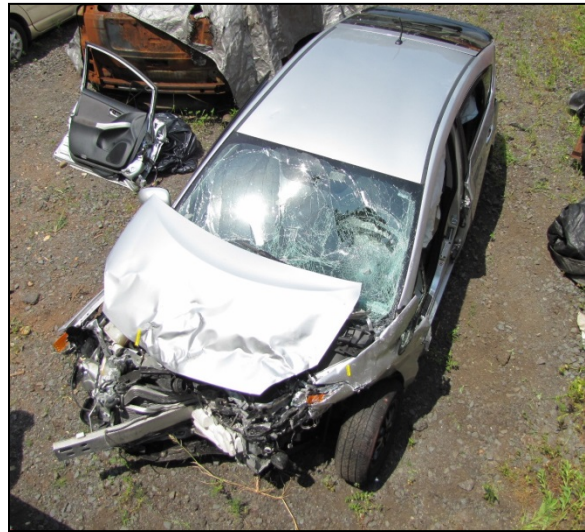
Damage to the Toyota was present on both the front and left planes, attributable to the first and second crash events with the ambulance. Within the front damage profile was longitudinal and lateral deformation to the bumper beam, hood, left front fender, and under-hood components (**Figure 17**). The front bumper fascia and grille were separated from the Toyota. Direct contact damage began at the left front bumper corner and extended 109 cm (42.9 in) to a point located 22 cm (8.7 in) right of the vehicle's centerline. The right aspect of the bumper beam was separated from its mounting location at the end of the right frame rail. However, the beam's center aspect and the area within the direct contact damage were embedded within the radiator and surrounding components. The left aspect of the beam remained mounted to the left frame rail. Therefore, even though the residual crush profile was documented to the partially separated front bumper beam, the damage measurements remain valid.

Figure 17: Overhead view of the Toyota's front plane damage pattern.

The Field-L utilized spanned the damaged bumper beam's 96 cm (37.8 in) deformed width, and produced the following resultant measurements: C1 = 27 cm (10.6 in), C2 = 41 cm (16.1 in), C3 = 52 cm (20.5 in), C4 = 32 cm (12.6 in), C5 = 10 cm (3.9 in), and C6 = 0 cm (0 in). Maximum crush was observed at the C3 measurement location. The CDC assigned to the Toyota for the Event 1 impact with the ambulance was 10FYEW3.

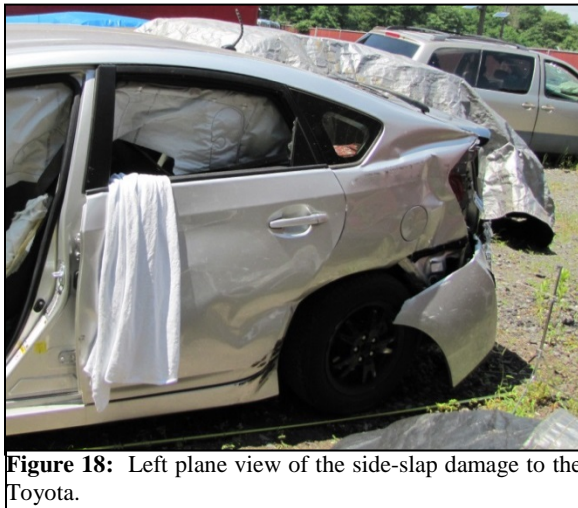
Side-slap damage was located on the rear aspect of the Toyota's left plane. Remnants of transfer from the vinyl graphics on the right side plane of the ambulance were distinctly visible on the left rear quarter panel and C-pillar area of the Toyota. Lateral deformation was present on the left rear door, left rear quarter panel, hatchback, and rear bumper. The left taillight assembly was disintegrated. At the left rear bumper corner, an outward perforation to the bumper fascia attributable to the end profile of the bumper beam was visible. This aligned with the penetration observed on the right side plane of the ambulance.

Figure 18: Left plane view of the side-slap damage to the Toyota.

Direct contact damage associative to the side-slap event (**Figure 18**) measured 178 cm (70.1 in), beginning at the left rear bumper corner and extending forward. A residual crush profile was documented using a Field-L width of the same dimension, which produced the following resultant measurements: C1 = 15 cm (5.9 in), C2 = 13 cm (5.1 in), C3 = 10 cm (3.9 in), C4 = 10 cm (3.9 in), C5 = 6 cm (2.4 in), C6 = 0 cm (0 in). Maximum crush was observed at the C1 measurement location. The CDC assigned to the Toyota was 09LZAW2.

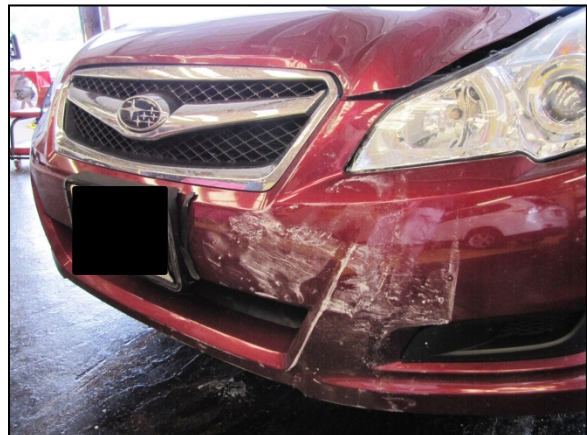
Damage to the exterior of the Subaru associative to the focus crash was minimal, limited to minor body surface damage to the vehicle's front plane. Relative to the fourth crash event with the top plane of the ambulance, damage involved only the bumper fascia, grill, and hood of the Subaru. This consisted of the fracture of the black polymer license plate frame and surface abrasions and scratches to the bumper fascia (**Figure 20**). The grille was slightly deformed, and the leading edge of the hood was displaced slightly rearward on the left aspect. Direct contact measured 82 cm (32.3 in) wide, starting at the left front bumper corner and ending 16 cm (6.7 in) right of the vehicle's centerline.

Figure 20: View of the Event 4 damage to the front plane of the Subaru.

There was no visible deformation (crush) to the vehicle associative to the crash. The CDC assigned to the Subaru for the Event 4 damage was 11FYEW1. No WinSMASH calculations could be performed due to the minor severity of the impact and insufficient residual damage.
