On-Site Ambulance Crash Investigation

SCI Case Number DS14016

Vehicle: 2013 Leader Type II Mercedes-Benz Sprinter Ambulance

Crash Date: April 2014

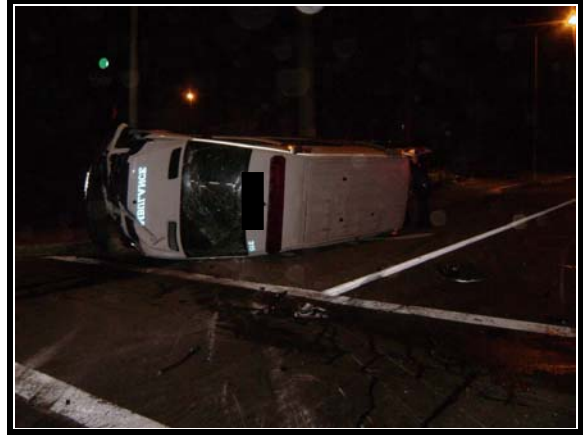
displaced to the south and rotated in a clockwise direction before coming to rest facing west in the south leg of the intersection. The ambulance rotated clockwise, tripped, and rolled one quarter-turn onto its left side (Event 2). The vehicle continued rotating on its left side until coming to rest facing north in the right turn lane in the south leg of the intersection (**Figure 4**).

Figure 4. 2013 Mercedes-Benz Sprinter ambulance, looking south (on scene photo)

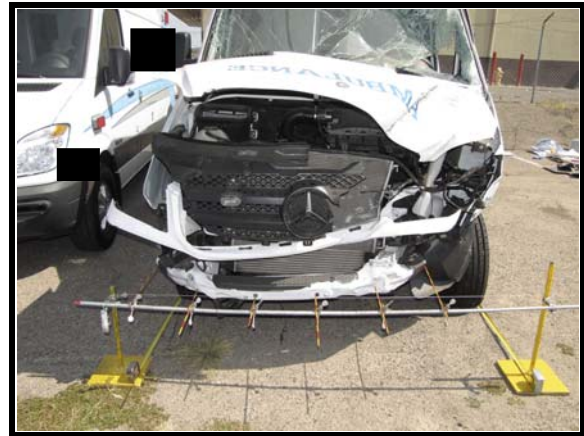
The ambulance sustained moderate damage to the front plane during the impact with the Lincoln (Event 1). The direct damage began at the left bumper corner and extended 76.0 cm (29.9 in) laterally to the right (**Figure 6**). The Field L extended from bumper corner to bumper corner and measured 144.0 cm (56.6 in). Six crush measurements were taken at the bumper backing bar level as follows: $C_1 = 5.0$ cm (1.9 in), $C_2 = 2.0$ cm (0.8 in), $C_3 = 3.0$ cm (1.2 in), $C_4 = 1.0$ cm (0.4 in), $C_5 = 0$ cm, $C_6 = 4.0$ cm (1.6 in). The maximum crush was located at C_1 . The backing bar/frame rails were shifted 20.0 cm (7.9 in) to the right. The Collision Deformation Classification (CDC) was 71FYEW1.

Figure 6. 2013 Mercedes-Benz Sprinter ambulance, frontal damage

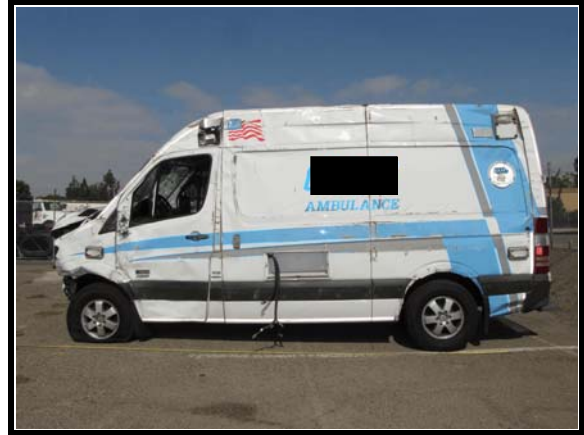
The ambulance sustained minor damage to the left plane during the one-quarter rollover (Event 1). The direct damage began at the rear of the patient compartment and extended 258.0 cm (101.5 in)

forward (**Figure 7**). The vertical damage extended from the sill to the roof. The maximum crush was located 13.0 cm (5.1 in) below the roof line and 46.0 cm (18.1 in) forward of the rear of vehicle and measured 8.0 cm (3.1in). The CDC was 00LDAO2.

Figure 7. 2013 Mercedes-Benz Sprint ambulance, left side damage

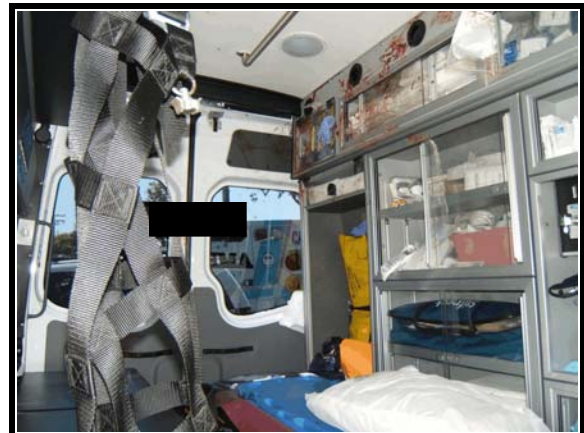
The interior of the cab and patient compartment had been stripped prior to the SCI inspection. Several interior images were obtained from the ambulance company by SCI. There was a large area of blood located at the aft end of the upper cabinetry along the left side (**Figure 8**).

Figure 8. Interior, 2013 Mercedes-Benz Sprinter (ambulance company photo)

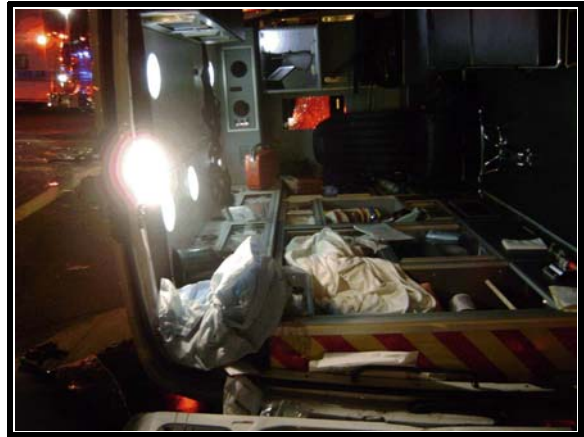
Figure 11. Patient compartment, 2013 Mercedes-Benz Sprinter ambulance (on-scene photo)

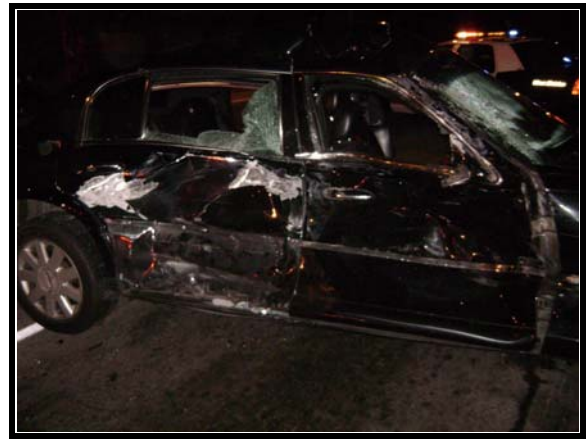
The Lincoln sustained moderate damage to the right side (**Figure 12**). The estimated CDC was 02RPAW2. It was towed from the scene due to damage.

Figure 12. 2005 Lincoln Town Car, right side damage (on scene photo)
