**ON-SITE AMBULANCE CRASH INVESTIGATION**

**SCI CASE NO: CR13004**

**VEHICLE: 1999 FORD E-350 CHASSIS**

**AMBULANCE BODY: AMERICAN EMERGENCY VEHICLES TYPE II**

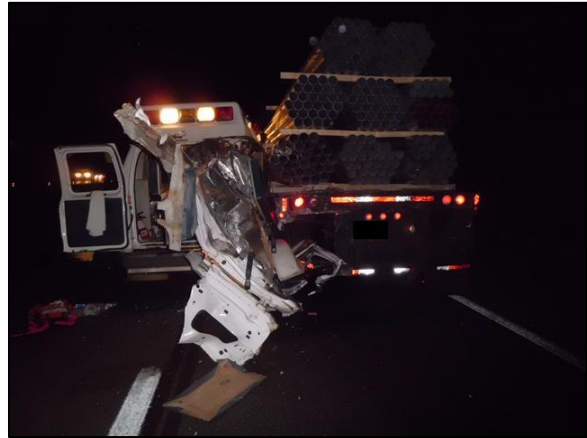
**Figure 2: On-scene image of the vehicles at final rest. (Image supplied by the police investigator.)**

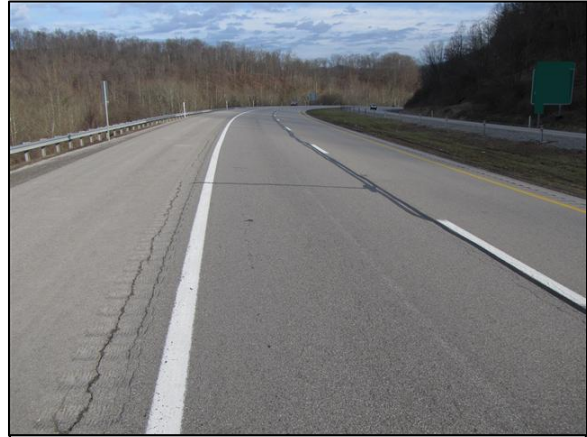
**Figure 3:** Look back along the southbound lanes of the interstate at the crash site.

In this region of West Virginia, the topography is mountainous and the interstate highway is winding with long grades (positive and negative). Leading into the area of the crash, there was a positive 5% grade for approximately 2.4 km (1.5 miles). Over that distance there was a moderate radius right curve and then a straight section approximately 0.8 km (0.5 miles) long that led into the left curve described above. Loaded heavy trucks labored, at a reduced speed due to the length of the grade, to reach the mountain crest, based on the SCI investigator's observations during the scene inspection. The hillcrest was located approximately 1.2 km (0.75 mile) south of the crash site.

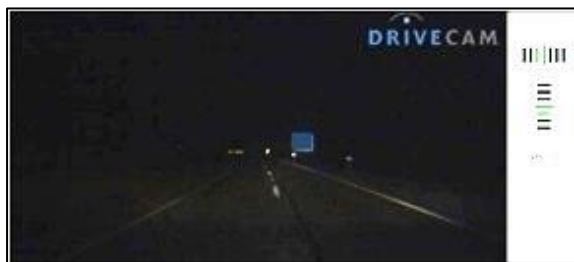
Based on a review of the Drive Cam™ video, the ambulance drifted from the right lane and straddled the centerline approximately 8.5 seconds prior to the crash. **Figure 4** is frame capture from the Drive Cam™ 7.0 seconds prior to the impact. The vehicle returned to the right lane approximately 4.5 seconds prior to the impact and continued to negotiate the left curve. The tractor/loaded flatbed trailer was visible throughout the video sequence and the distance between the vehicles was closing. The slowly-moving tractor/trailer's taillights were illuminated. **Figure 5** is a frame capture 0.75 seconds prior to impact. As the ambulance approached the back plane of the flatbed trailer, the paramedic driver recognized the slower moving vehicle and initiated a left avoidance maneuver (counterclockwise steering) approximately 0.5 seconds prior to the crash. The late steering maneuver by the ambulance driver resulted in a narrow overlap of the structure of the vehicles. The Fleetmatics™-reported speed of the ambulance was 106 km/h (66 mph).

Figure 4: Drive Cam™ video capture from the ambulance 7.0 seconds prior to impact.

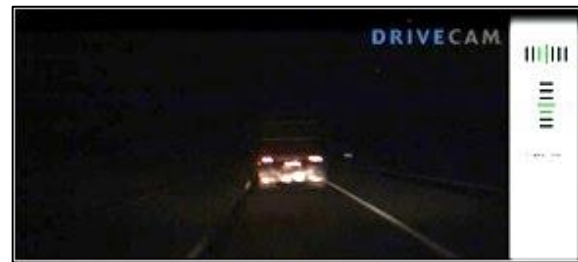
Figure 5: Drive Cam™ video capture 0.75 seconds prior to impact.

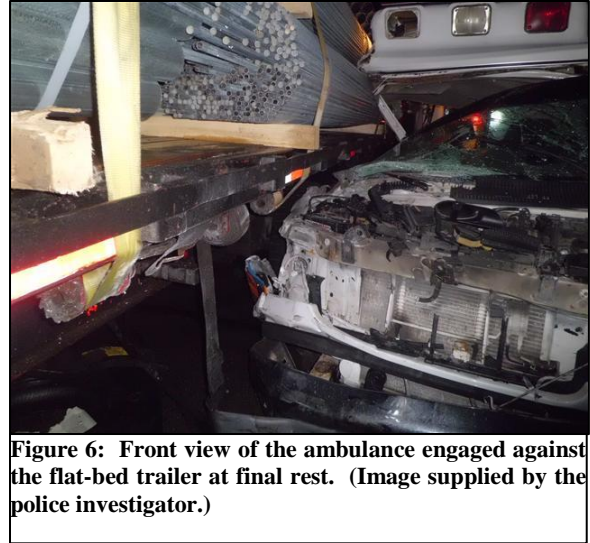
The front right corner of the ambulance impacted the back left corner of the loaded flatbed trailer. The direct contact damage to the ambulance's front bumper was located to the right of the frame rail. The relatively soft structures of the front profile of the ambulance engaged the

rigid structure of the trailer's back profile. The frontal air bags in the ambulance deployed and the front seat safety belt pretensioners actuated. The left aspect of the trailer's rear impact guard deflected forward. As the right plane of the ambulance engaged against the trailer's load, the side structure completely separated. The right interior components of the patient compartment fractured and were deposited onto the roadway. The side structure of the ambulance deformed, folding rearward, hinging at the right D-pillar. The ambulance remained in contact with the trailer as it decelerated. The Freightliner driver applied the brakes and came to a controlled stop in the right lane of the interstate. At final rest the ambulance remained engaged against the left side of the flatbed trailer and its load (**Figure 6**). A Crash Diagram is included at the end of this technical report on Page 15.

**Figure 6: Front view of the ambulance engaged against the flat-bed trailer at final rest. (Image supplied by the police investigator.)**

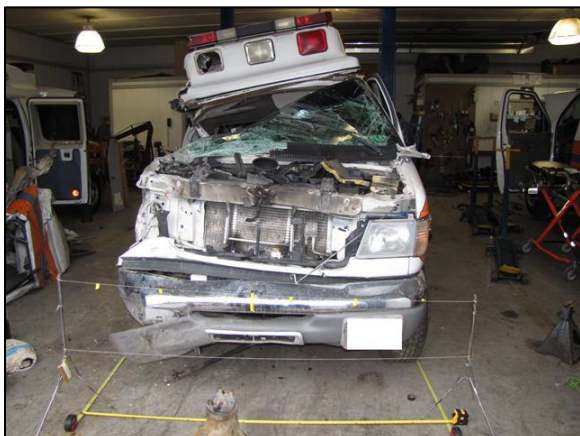
The front plane of the Ford (**Figure 8**) sustained corner impact damage and its right plane engaged the back plane of the trailer (**Figure 9**) during the impact. The direct contact to the front plane began 60 cm (23.5 in) right of center and extended to the right corner of the front bumper. The length of the direct contact measured 24 cm (9.5 in). The impact damage was located to the right of the right frame rail. There was no noted deformation of the vehicle's frame. The residual crush measured along the front bumper had the following profile: C1 = 0, C2 = 0, C3 = 0, C4 = 0, C5 = 0, C6 = 17 cm (6.7 in). The residual crush at the right corner of the upper radiator support measured 33 cm (13.0 in).

**Figure 8: Front view of the ambulance.**

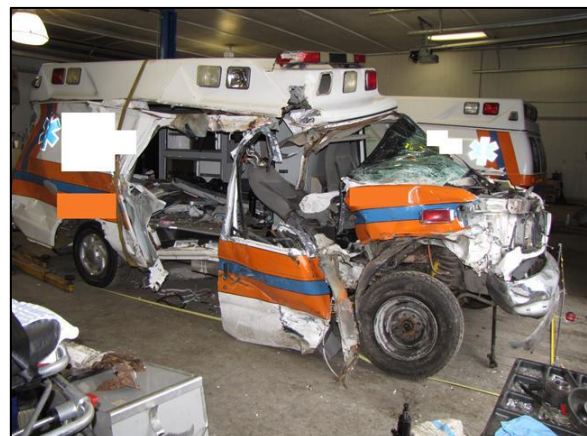
As the higher speed ambulance engaged the trailer, the sheet metal of the right plane sheared (tore) along the entire length of the vehicle. Examination of the exposed vehicle structure found that the spot welds from assembly were intact and that the sheet metal surrounding the welds tore. The sheet metal tore away due to overload. The right fender separated from the inner structure. The front right brake rotor fractured from impact with the trailer and the wheel assembly separated. The right wheel base was reduced 17 cm (6.8 in). The A-pillar hinge and right front door separated as a unit. The B- and C-pillars separated at the roof side rail and sill. The separated right wall folded/hinged rearward at the D-pillar and extended rearward beyond the vehicle at final rest. The fiberglass raised roof of the ambulance was separated from the roof side rails and the end-plane headers around its entire perimeter. The Collision Deformation Classification (CDC) assigned to this damage pattern was 12FRAE9. Analysis of this crash by the WinSMASH program was not possible. Heavy truck collisions and corner impact configurations (outside the vehicle's frame/stiffness) were beyond the scope of the program.

**Figure 9: Right side view of the ambulance.**

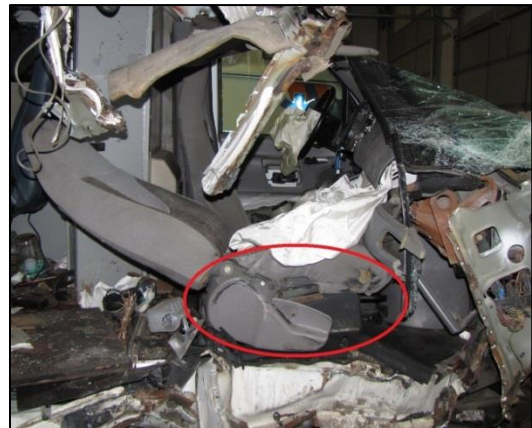
The box-mounted front right passenger seat track was jammed. Based on the observations of the SCI inspection, the seat was adjusted in a mid-to-rear track position similar to the driver seat. At the time of the SCI inspection, the seat back was reclined to a measured angle of 55 degrees (**Figure 10**). The seat's recline mechanism was inspected and it was determined to be operational. The seat back moved freely throughout its range of motion and the ratchet-mechanism of adjustment locked the seat back in various positions. There was evidence of direct contact on the exposed right surface of the seat, trim panel and recline mechanism to the sidewall of the semi-trailer's rear tire, highlighted by the red ellipse in **Figure 10**. Scuffing abrasions and melted rubber fragments were observed on the right surface of the seat cushion and on the trim panel, respectively. It was determined that during the vehicle-to-vehicle interaction of the crash, the recline mechanism was contacted by the sidewall of the trailer's tire, thus releasing the seat back and allowing the seat back to fully recline. The height of the damage was consistent with the height of the trailer tire. Also, the on-scene police images indicted that at final rest the trailer tire was adjacent to the passenger seat. The seat back was not forced rearward into the reclined position by occupant loading.

**Figure 10: Right view depicting reclined position of the front right seat and the intrusion and deformation at that location. Note, the scuffing and abrasions to the seat cushion and trim highlighted by the red ellipse.**

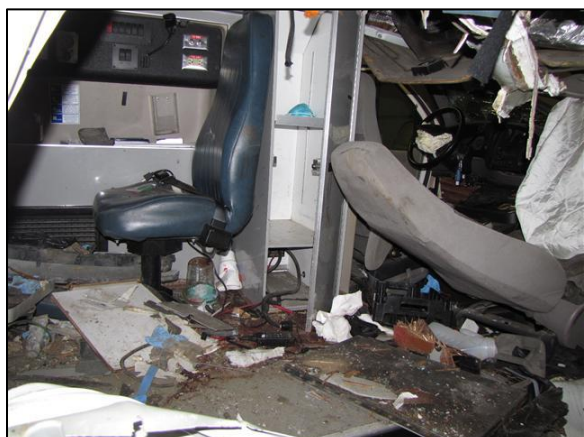
The patient compartment was not occupied at the time of the crash. The plywood cabinetry and interior components of the right side of the vehicle were directly involved in the overlapping crash. The vertical cabinet located immediately behind the front right passenger seat fractured at floor level and was displaced (**Figure 11**). The three-passenger bench seat was displaced onto the roadway. The Ferno cot remained secured by the floor-mounted rail clamp and was not damaged. **Figure 12** is a rearward oblique interior view depicting the patient compartment damage taken during the SCI inspection.

**Figure 11:** Right interior view depicting the fractured/separated cabinet immediately behind the front right seat.

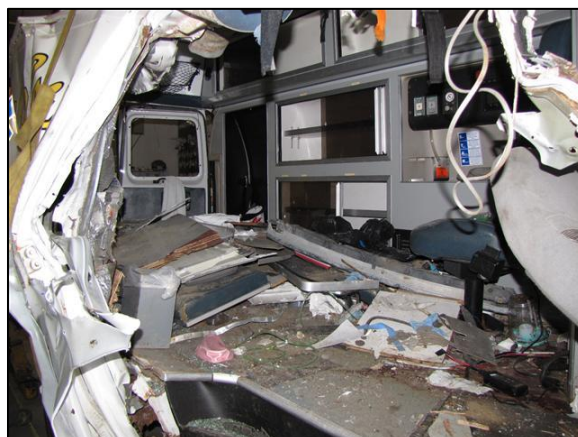
**Figure 12:** Right oblique view depicting the patient compartment damage.

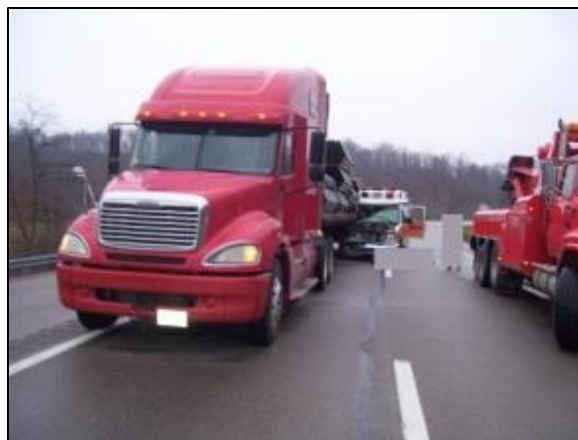
**Figure 14: Front left oblique view of the Freightliner at the crash site. (Image supplied by the police investigator.)**
