# A LoRa Mystery 1 - Phantom Packets

## **A LoRa mystery 2 – Phantom packets but deeper**

## **Phantom Packets 3 - Is this the reason ?**

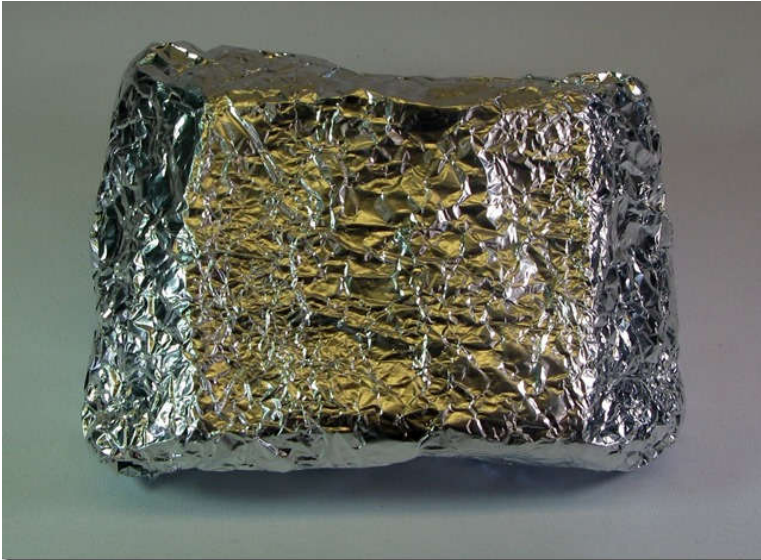
With the receiver now wrapped in foil and consequently very well screened I was still receiving phantom packets and with the similar RSSI and SNR values as before. Perhaps the phantom packets were a result of electro magnetic interference (EMI) coming from the receiver itself, but if so how could the CRCs be valid ?

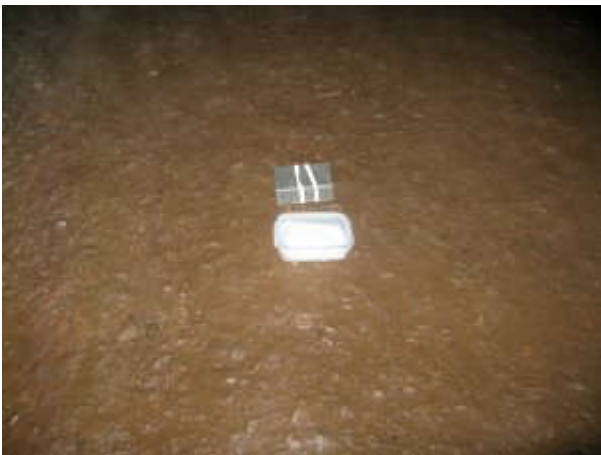
With the two receivers on the floor I could still hear the beeps indicating phantom packets at the same rate as I had been getting in my workshop and local field. Looking at the logs the receivers produced later it was clear that the signal strengths in the workshop were the same as I was seeing deep underground and a very long way from any LoRa transmitters.

## Log

*ReqIrqFlags 0x50*

*CRC and Header OK*

*SNR,-11dB,RSSI,-114dBm,Length,153*

*Packet data 9E,62,C8,7C,55,B2,6F,E1,40,8A,F8,D4,B1,99,0C,33,EA,E1,58,  
(packet data truncated)*

*Valid Packets 7 CRC Errors 2 Header Errors 0*
