# EXXONMOBIL BATON ROUGE REFINERY BLAST, US (2016)

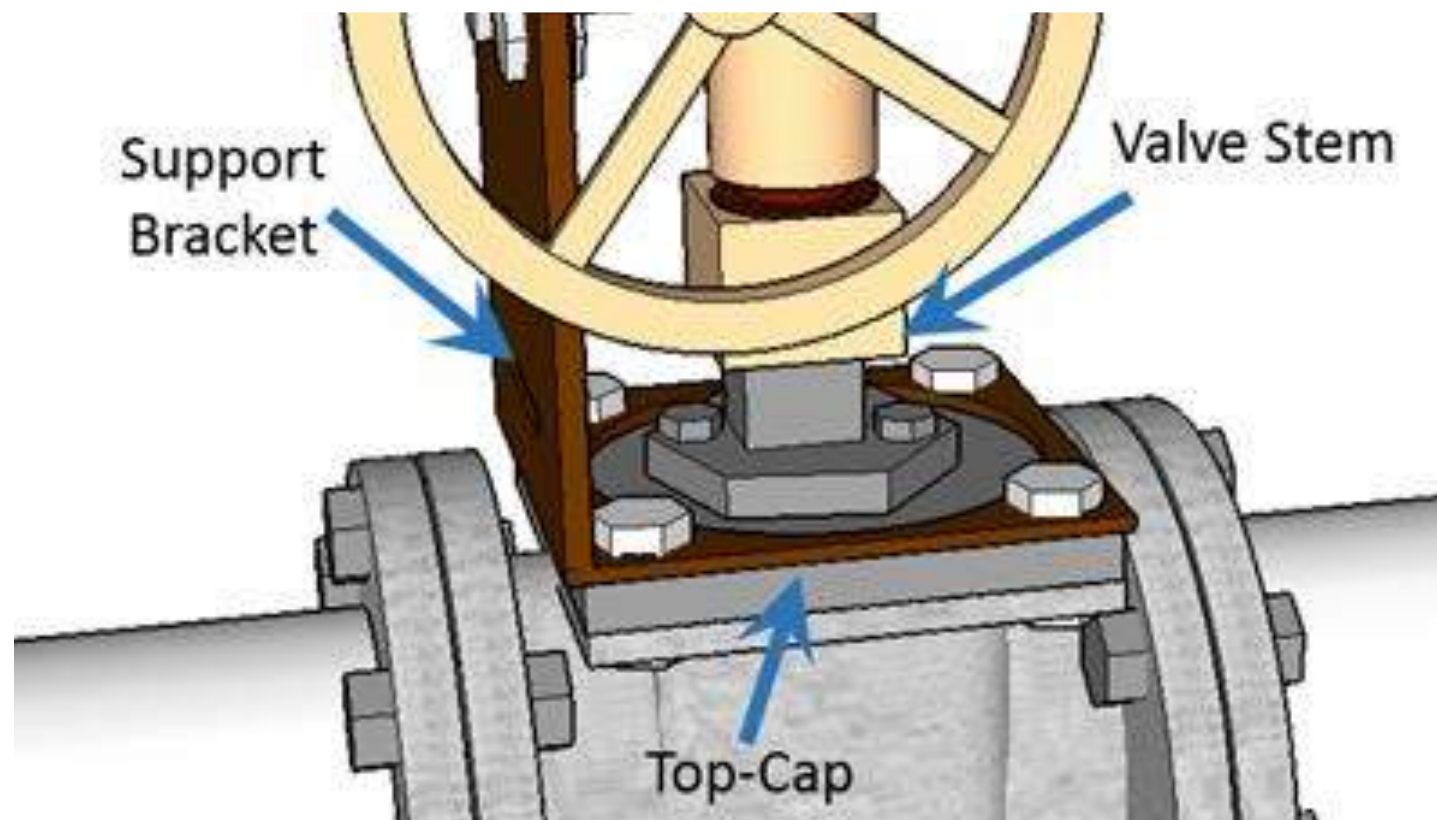
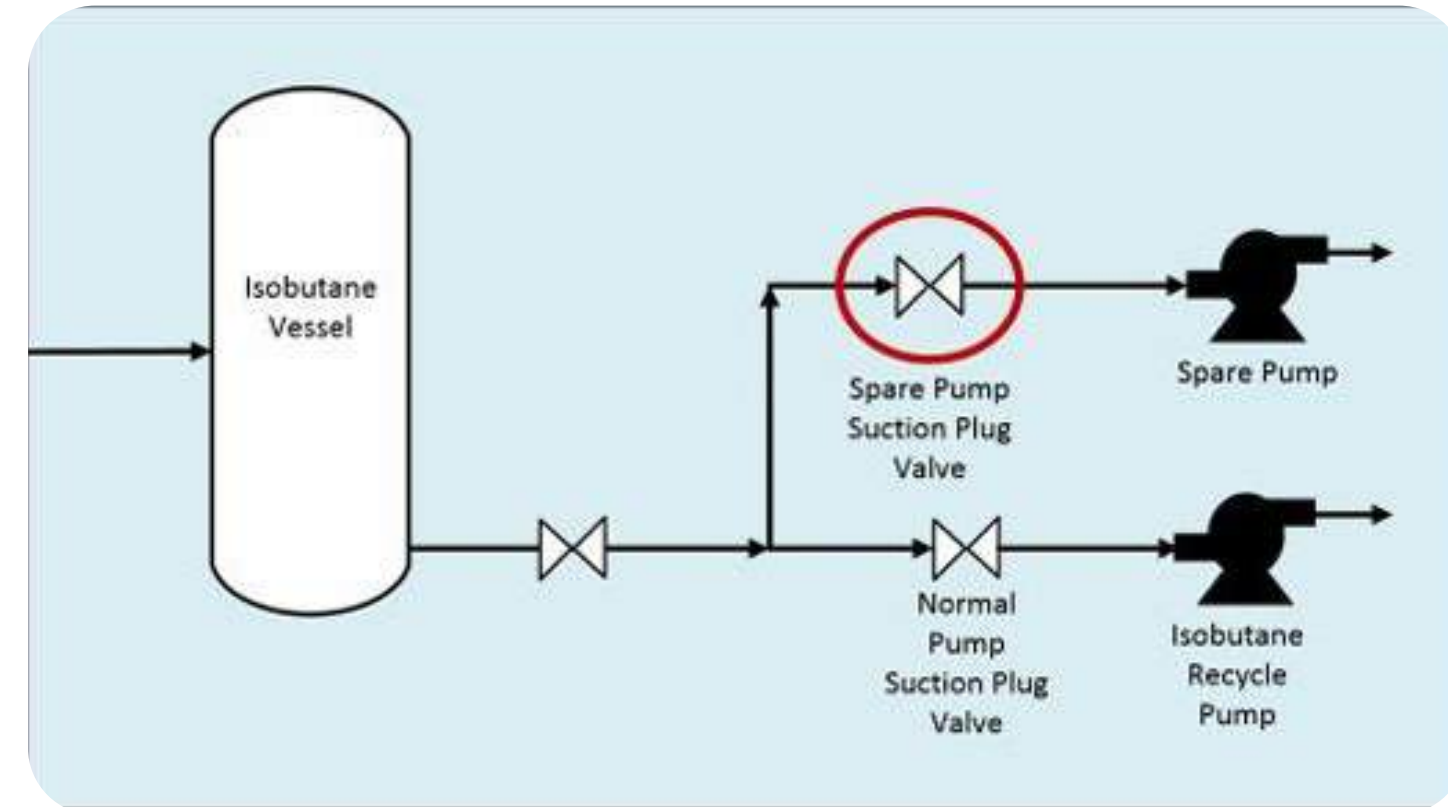
- On the afternoon of November 22, 2016, two Baton Rouge refinery alkylation unit operators were preparing isobutane equipment for maintenance.
- As part of this preparation, the operators needed to adjust valves to put a spare isobutane pump into service.
- To switch the pumps, the operators needed to open the inlet (suction) plug valve to the spare pump.
- The refinery used a type of valve known as a quarter-turn plug valve for many applications in the alkylation unit, including the inlet valves to these isobutane pumps.

- One of the operators removed the gearbox assembly so he could turn the valve stem with a pipe wrench to open the valve.
- Removing a malfunctioning gearbox from a plug valve is an accepted practice for alkylation unit operators.
- To remove the gearbox, the operator removed the four vertical bolts that connected the gearbox support bracket to the valve body.
- These four bolts, however, also secured the top-cap – a pressure-retaining component – to the valve body.
- The two horizontal bolts that could safely remove the gearbox from the support bracket remained in place.

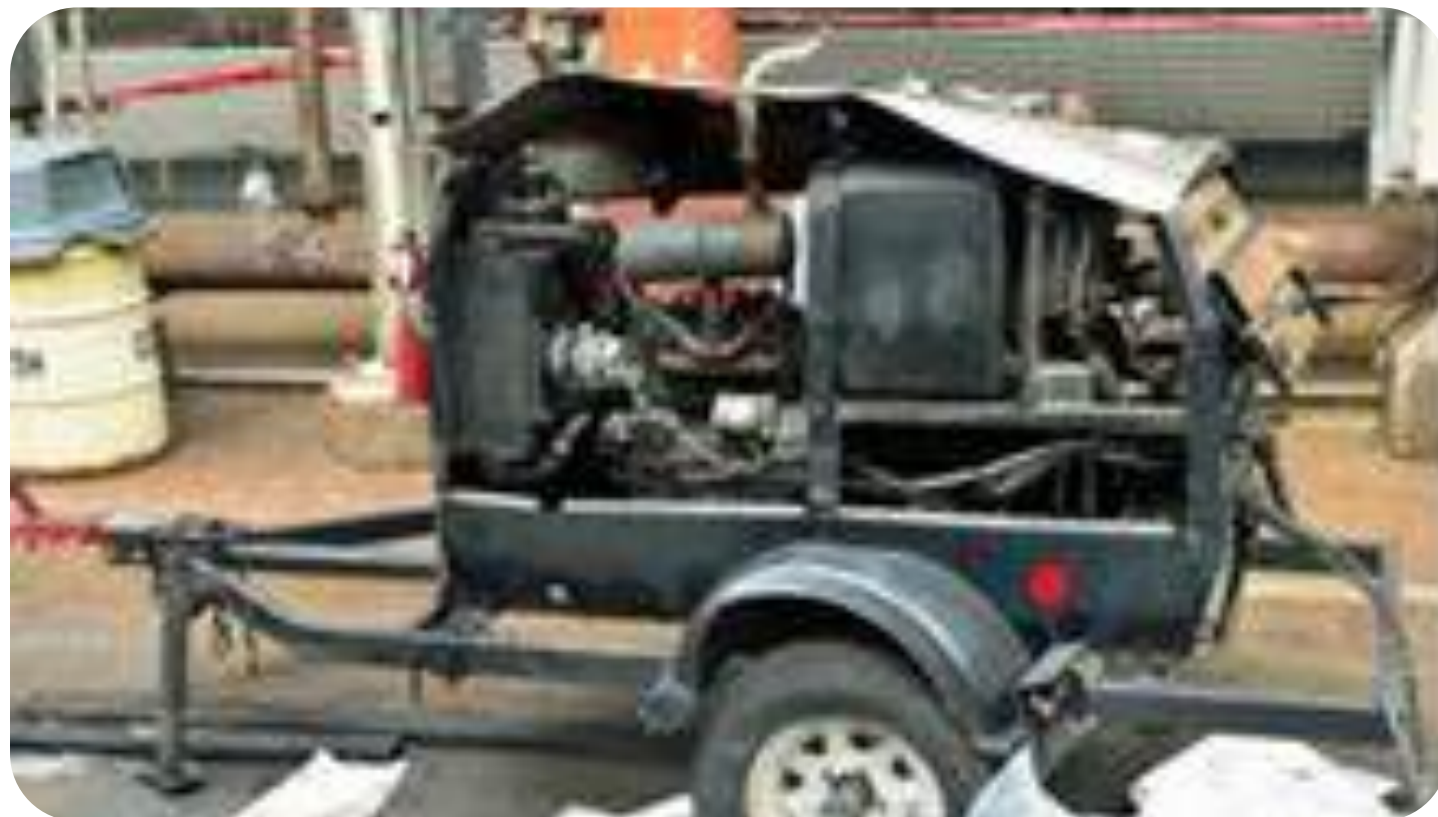
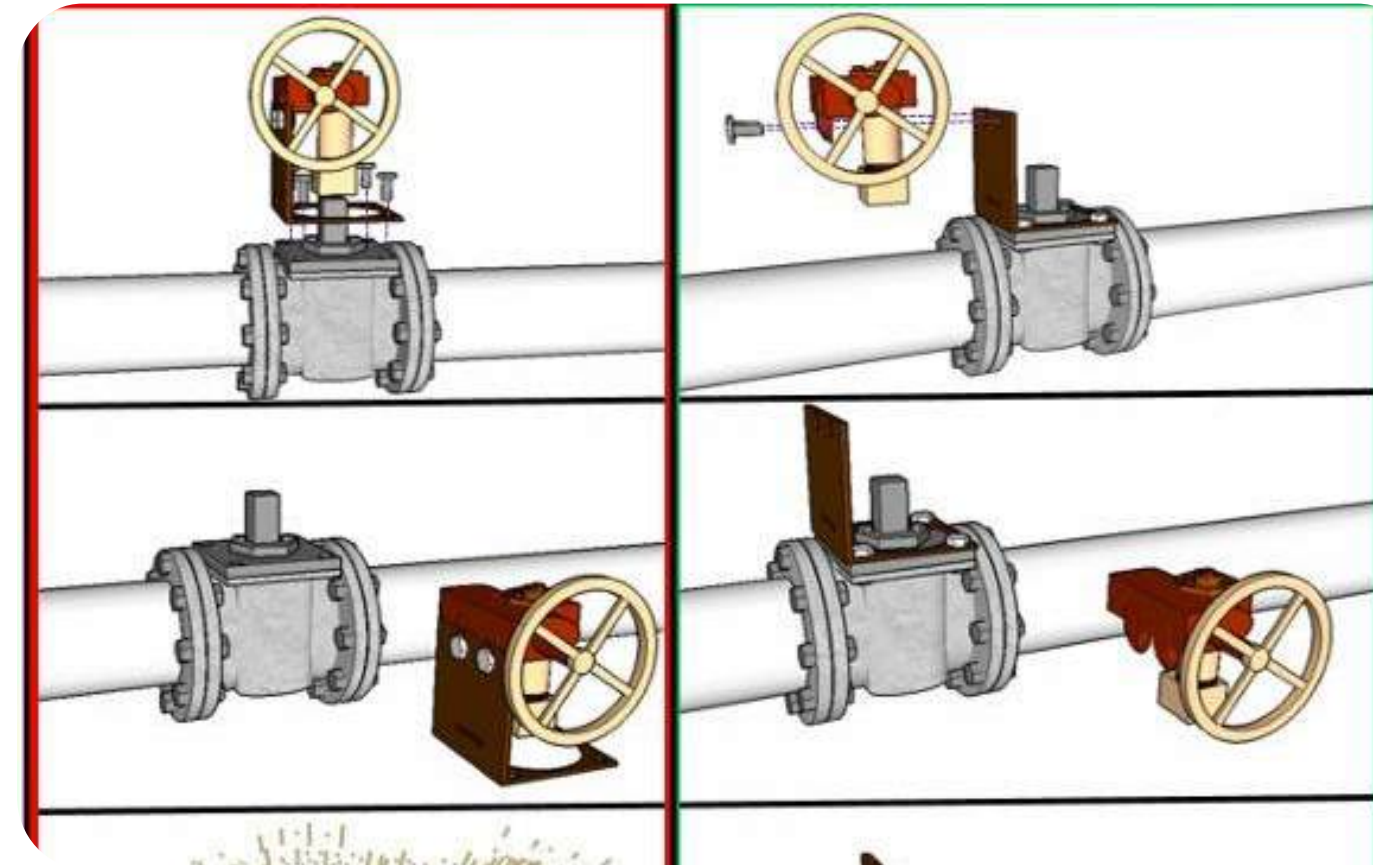
- **One of the operators then opened the valve by rotating the valve stem with a pipe wrench.**
- **With the four bolts removed from the top-cap, critical valve components were no longer held together. When the operator turned the valve stem, the plug valve loosened and came apart.**
- **Pressurized isobutane<sup>14</sup> escaped from the valve body, forming a flammable white vapor cloud. Following the release, the operators shouted to others in the area, warning them of the immediate danger and ordering them to evacuate.**
- **One of the operators alerted the board operator of the emergency by radio and told him to shut down the unit.**

- **ExxonMobil estimated that 2,000 pounds of isobutane released into the atmosphere.**
  - **Based on surveillance video, an energized welding machine located roughly 70 feet away likely ignited the vapor cloud.**
  - **The resulting fire seriously injured one ExxonMobil employee and three contractors working in the vicinity of the release.**
  - **15 Emergency responders isolated the release and extinguished the fire about 25 minutes after the initial ignition.**
-

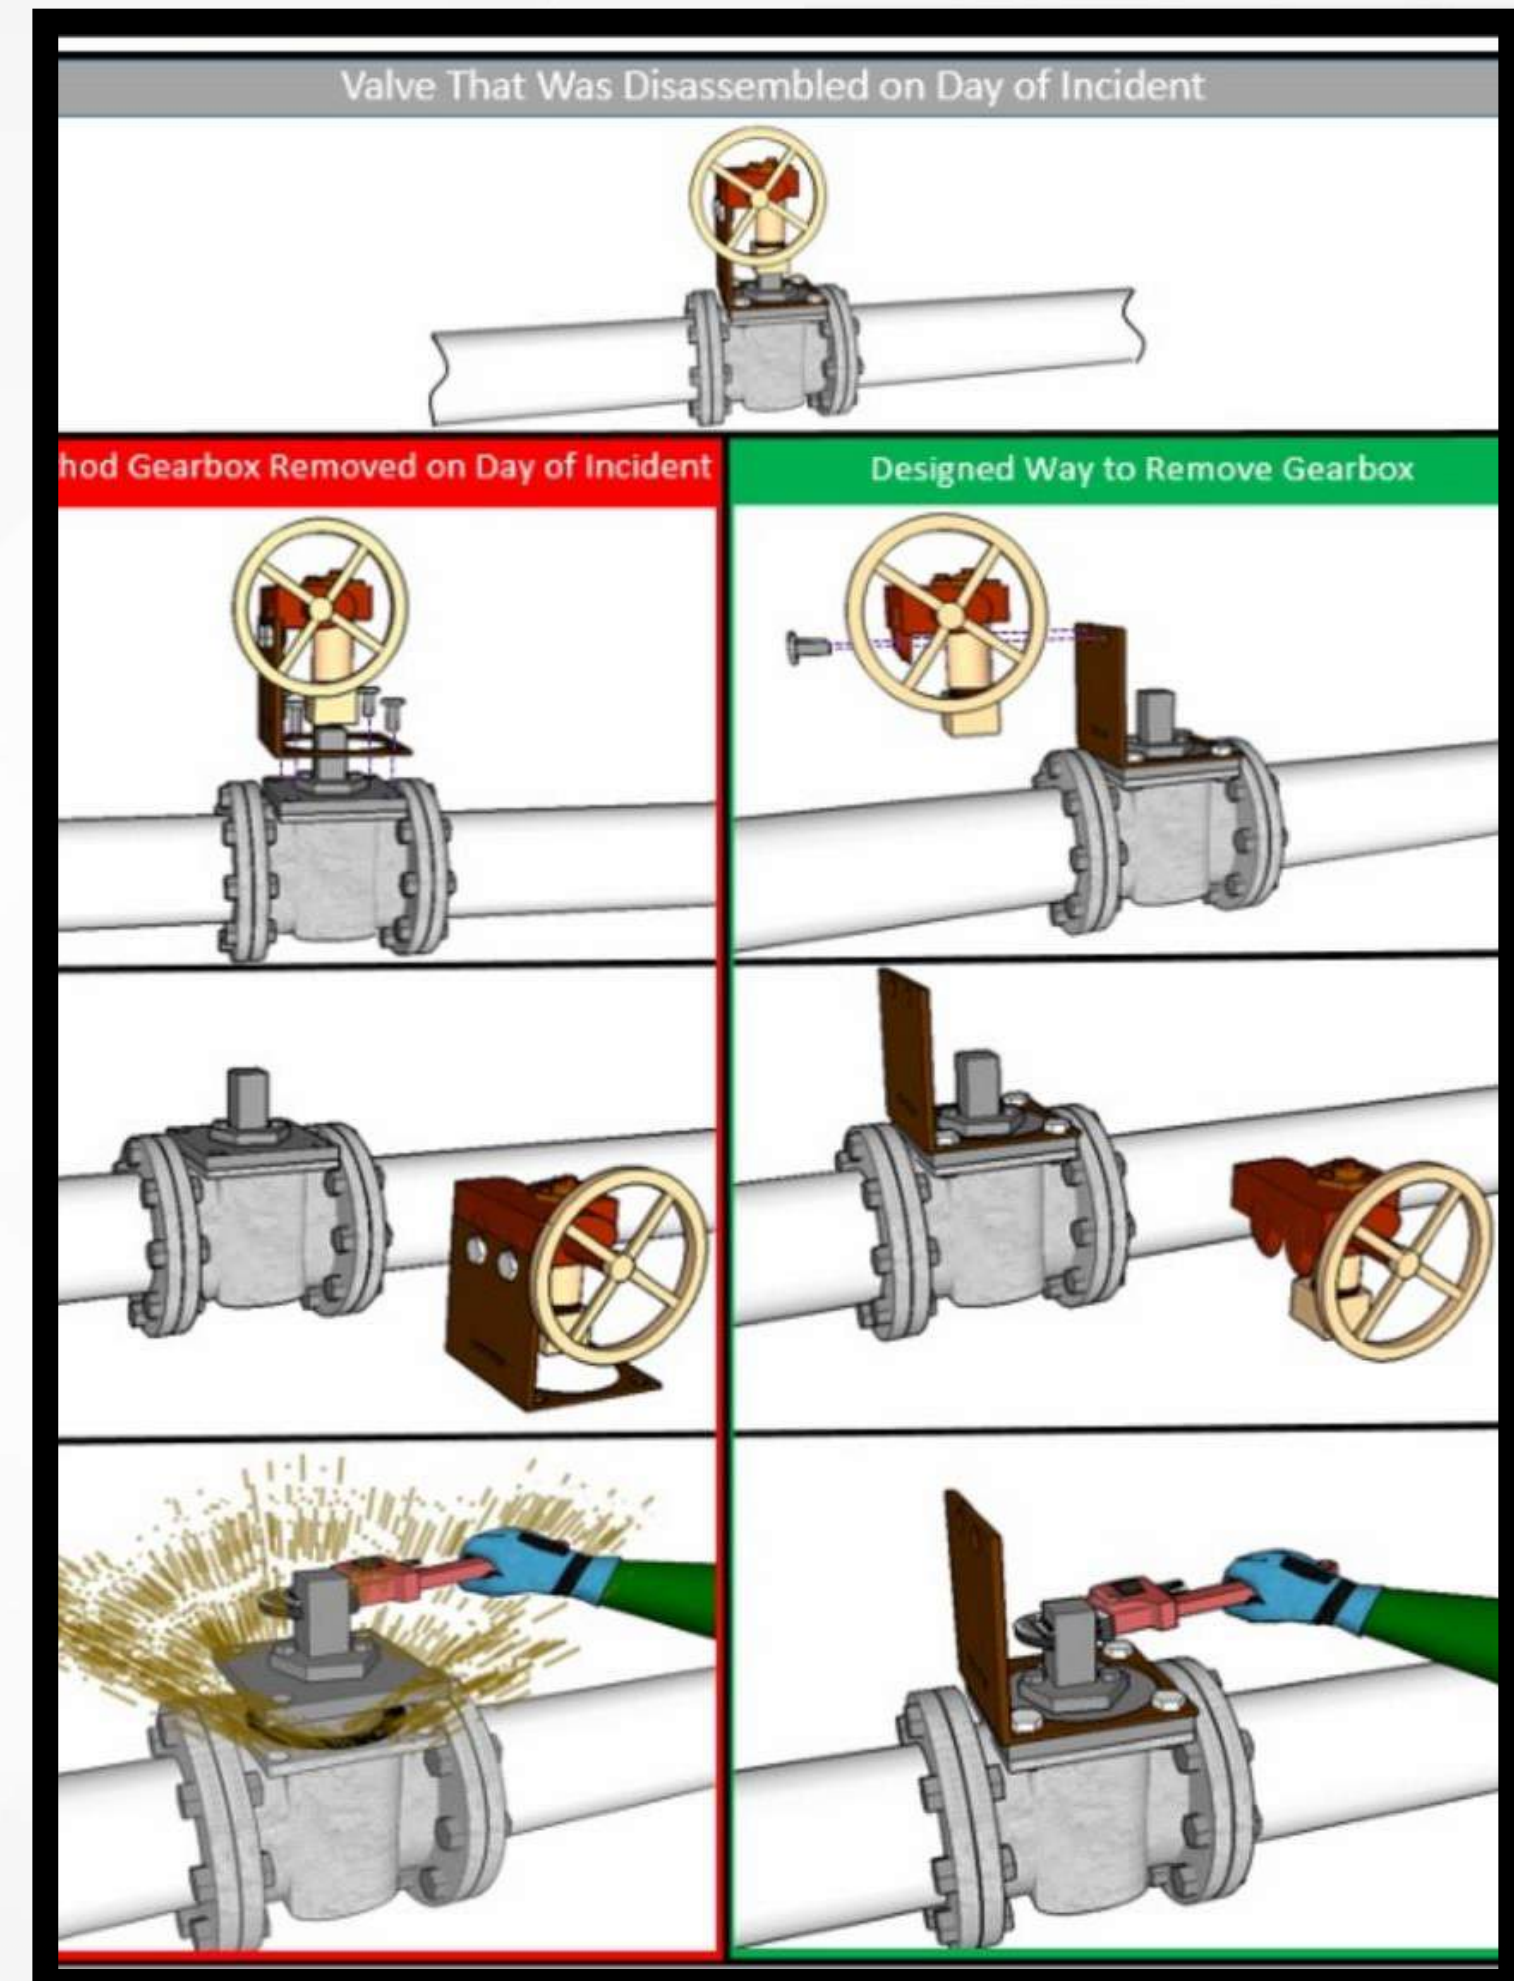
- Gearbox support brackets on 15 plug valves located in the Baton Rouge refinery's alkylation unit were attached using the same four vertical bolts that secure the pressure retaining top-cap to the valve body.
- This gearbox (a 30-plus year-old design), however, could be removed by taking off the two horizontal bolts without disturbing the critical top-cap bolts.
- The gearbox involved in the incident conformed to this part of the standard because it could be removed without removing any pressure-retaining parts.
- The operator could have removed the two horizontal bolts that connect the support bracket directly to the gearbox, rather than the four vertical bolts that secure the support bracket to the pressure-retaining top-cap.
- But the operator did not remove these two horizontal bolts; instead, he removed the four vertical bolts, which he believed to be the correct bolts to remove.

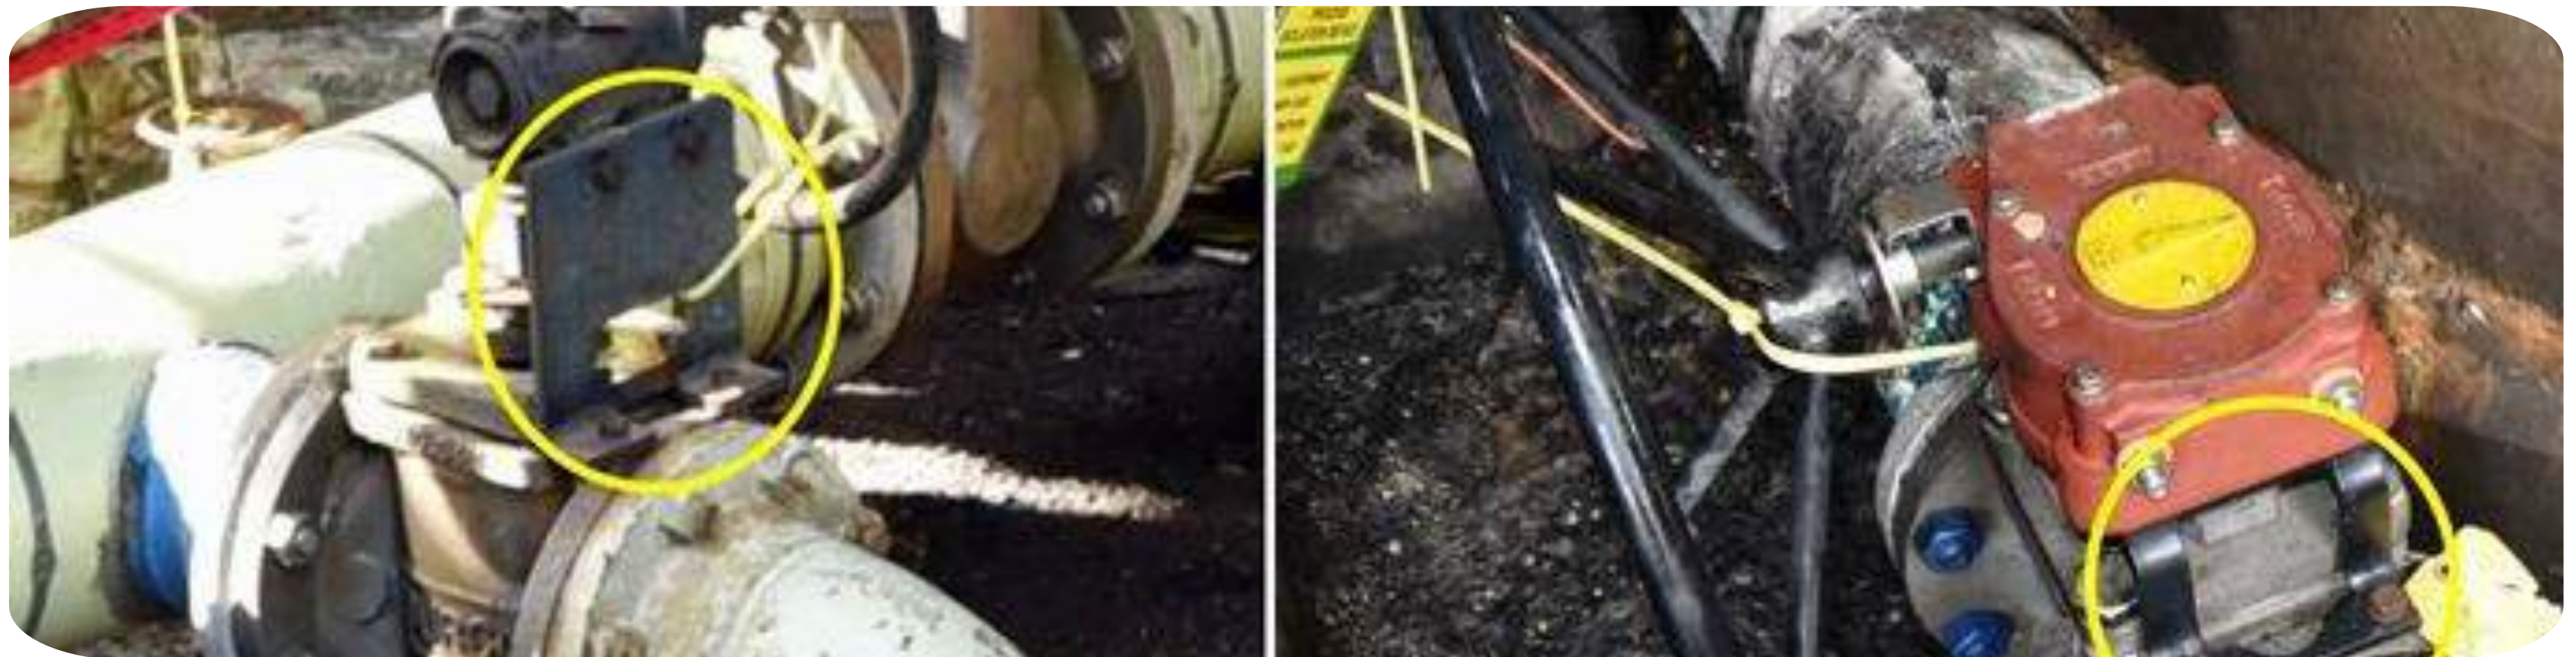
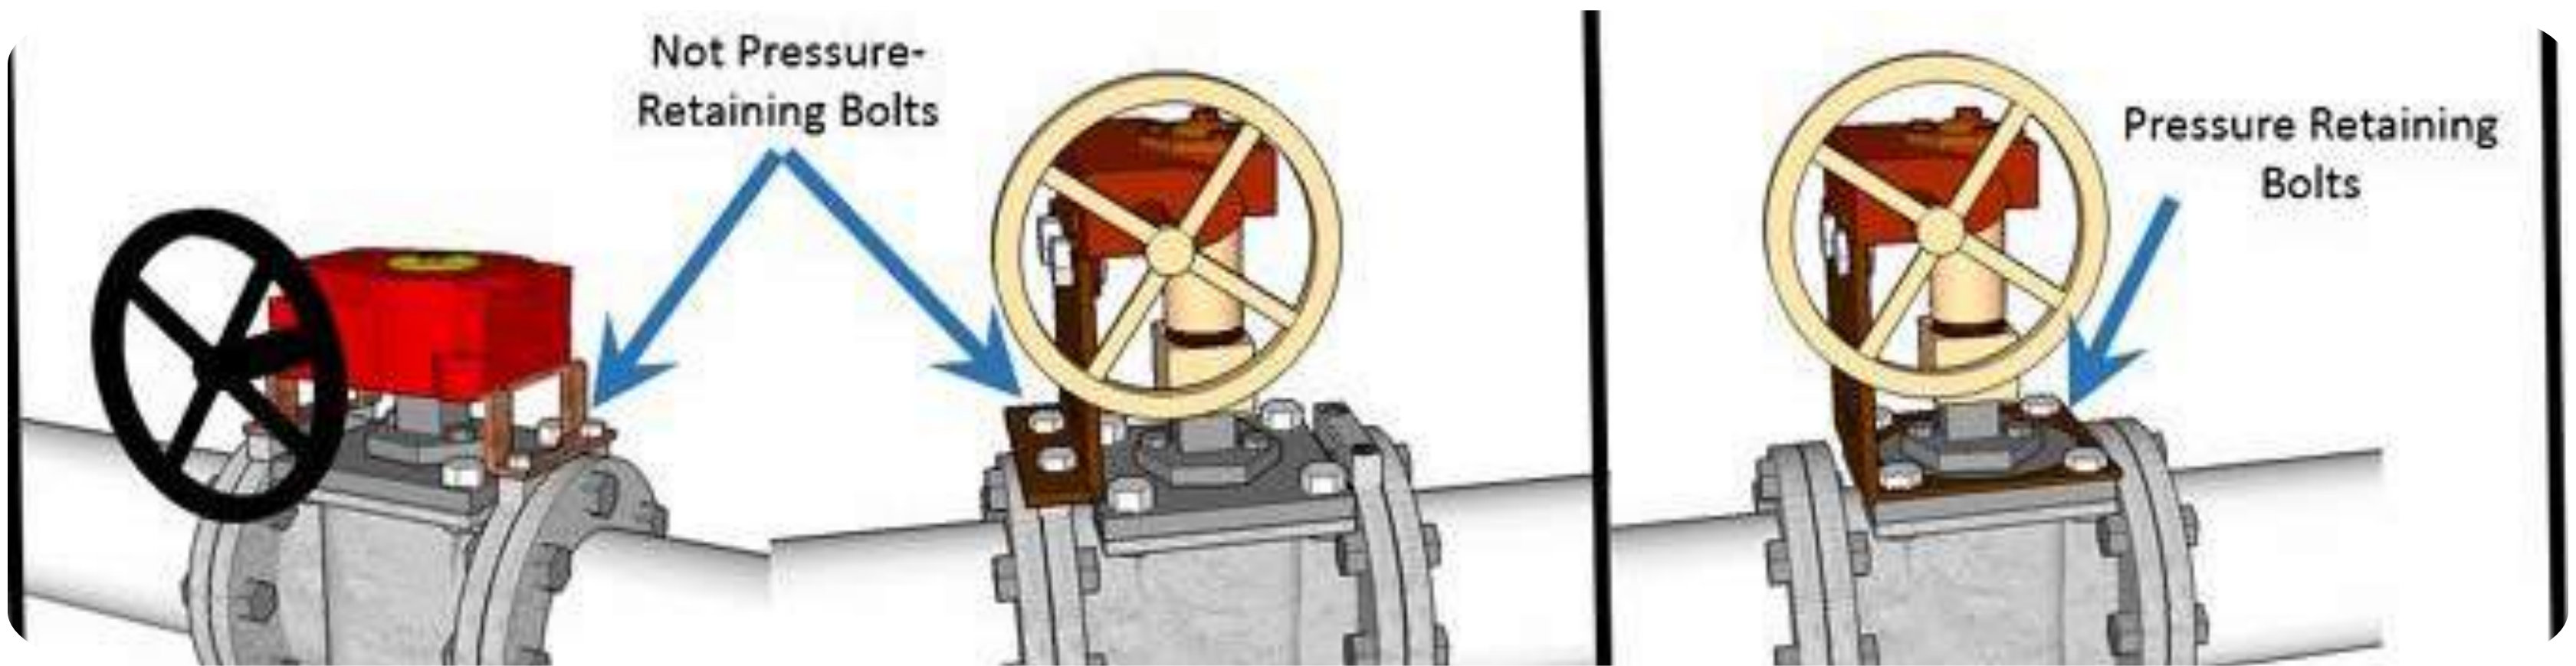
- **The plug valve manufacturer (Durco) updated the plug valve design in 1984 so that the gearbox support bracket could be attached to the valve using different bolt connections than those that secure the pressure-retaining top-cap to the valve body.**
- **Approximately 97 percent of the plug valves located in the Baton Rouge refinery's alkylation unit are the more recent Durco plug valve design, which secures the gearbox assembly to the valve body flanges.**
- **With this improved design, the gearbox support bracket is unlikely to connect to the pressure-retaining top-cap, which can help prevent future incidents.**

- The newer plug valve more broadly used in the alkylation unit is a better design. The redesign addressed the potential to have a chemical release when removing the gearbox assembly. The valve designers provided four additional connection points to secure the gearbox support brackets and these attachment locations are not pressure-retaining components. (Figure 9). With the newer and improved valve design, if a worker completely removes the gearbox and its support bracket(s), a chemical release cannot occur.

- The location of the bolts on the newer valve design may have also contributed to the operator removing pressure-retaining bolts. On the newer design, the bolts connecting the support bracket to the valve are vertical, and are usually removed in order to remove the gearbox and handwheel.

- For the less common, older valve design, the vertical bolts were the pressure-retaining bolts and should not be removed; instead, the horizontal bolts should be removed to disassemble the gearbox and handwheel safely. It could appear as though these critical vertical bolts had to be removed to take the inoperable gearbox off the valve. Although other bolts allowed for gearbox removal without touching the critical pressure-retaining bolts, this design can lead to potentially catastrophic consequences.
