3D4 Structural Analysis and Stability FTR

Louis Zeng (lz406)
Fitzwilliam College March 2021

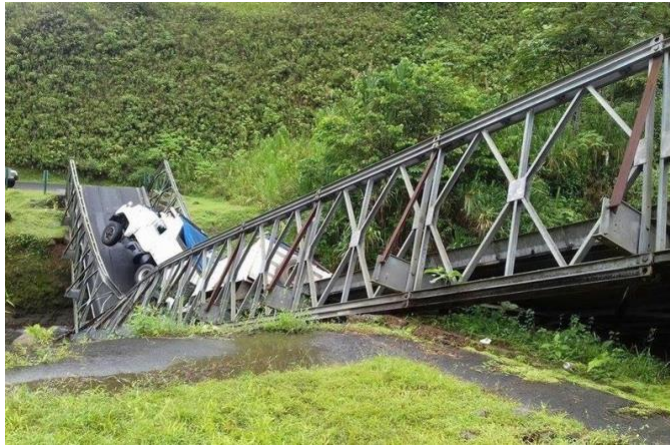
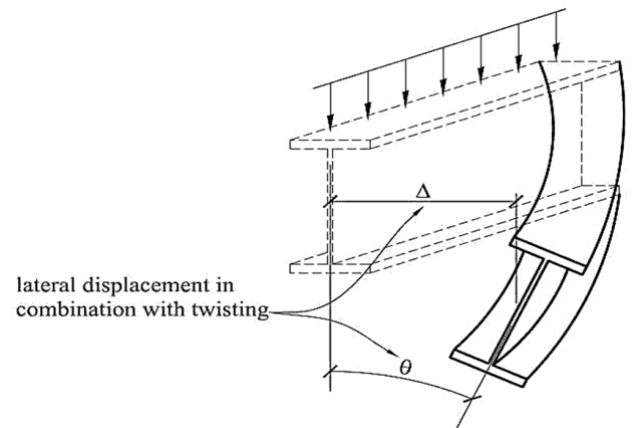
Post WW2, the use of Bailey bridges is dramatically diminished. As shown in the Figure 1. (right), vertical frames and transoms of a Bailey bridge (made of I beams) have their upper (compression) flanges free to displace laterally and rotate. And therefore, when an applied vertical load is large enough to cause both lateral displacement and twisting of a transom or chord, “lateral torsional buckling” occurs, which causes the Bailey bridge susceptible to buckling failure.

Figure 2. (Right) lateral torsional buckling of a I beam.
(Left) a collapsed Bailey bridge with its Bailey Panels and chord show buckling.

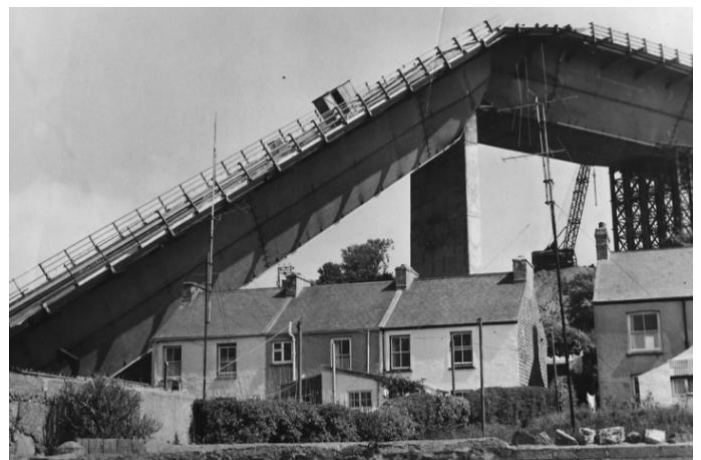
Figure 4. (Left) A sketch of the trapezoidal box-girder cross section of the Cleddau Bridge, and a perspective view of the cross-section in the numerical model. (Right) Failure of the Cleddau Bridge (Milford Haven). Notice the bottom flange is buckled.

According to the later Australian Royal Commission report, as the supporting diaphragm over Pier 6 buckled, the overall depth of the steel box girder was shortened, which caused the bottom flange more likely to buckle due to the shortening of the inter-flange distance. (i.e., as the moment was now carried by a reduced lever arm, greater compression was acted on the bottom flange until the weakened deck box can no longer sustain the bending moment, and the cantilevered section rotates about the now formed virtual hinge.)

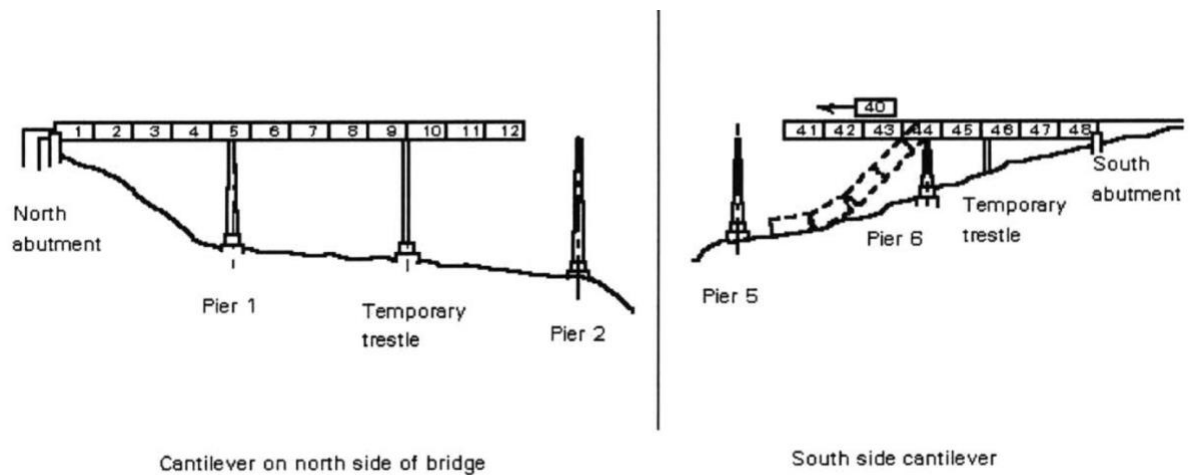
Figure 6. Schematic diagram of Cleddau Bridge construction and its failure.

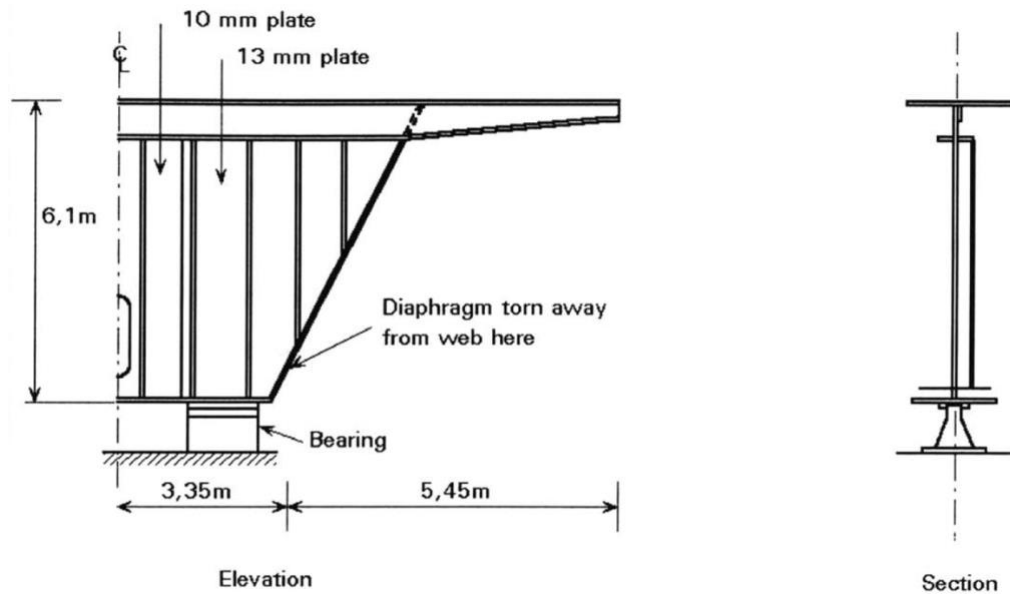
Figure 7. Drawings of the diaphragm over Pier 6.

- The Cleddau bridge consists of welded steel trapezoidal box-girder superstructure as shown in Figure 4. (Left).
- As shown in Figure 5. (Left), Figure 6. The construction method adopted for the Cleddau Bridge was to cantilever out pre-assembled deck sections from each side of the river. The bending moment and stresses on the deck is in general much greater in the cantilevered state than after erection.
- The collapse occurred when the last deck section (40) between pier 5 & 6 was moving out along the cantilever.
- It was pointed out by the Merrison Committee of Inquiry that the buckling of the support diaphragm at the root of the erected cantilever initiated the failure, as shown in Figure 4. (Right). After the diaphragm was torn away from the bottom part of the web, bottom flange and the web were allowed to buckle. (shown in Figure.7)

- Most apparently, a hogging bending moment and a large vertical shear force were applied to the diaphragm due to the weight of cantilevered section.
- Diffusion of the point load from the supporting bearings below, in addition to the out-of-plane bending effect due to bearing's eccentricity.
- The sloping/inclination of the webs results in additional horizontal compression on the diaphragm.

- The buckled support diaphragm which initiated the failure is likely have been as much as $\frac{3}{4}$ inch out of flat, which makes it susceptible to local buckling.
- The bearings in between the pier 6 and the box-girder superstructure were out of line with diaphragm's neutral axis and could have induced bending moment.
- Some bolts which were used to connect longitudinal stiffeners to the bottom flange were tightly installed in their corresponding oversized holes, instead of the designed loose installation. And under load movement, the bolts could have torn off the longitudinal stiffeners from the bottom flange, causing more instabilities under compression.
