**6-8 Bishopsgate / 150 Leadenhall Street –
Structural ‘Lessons Learned / Observations’**

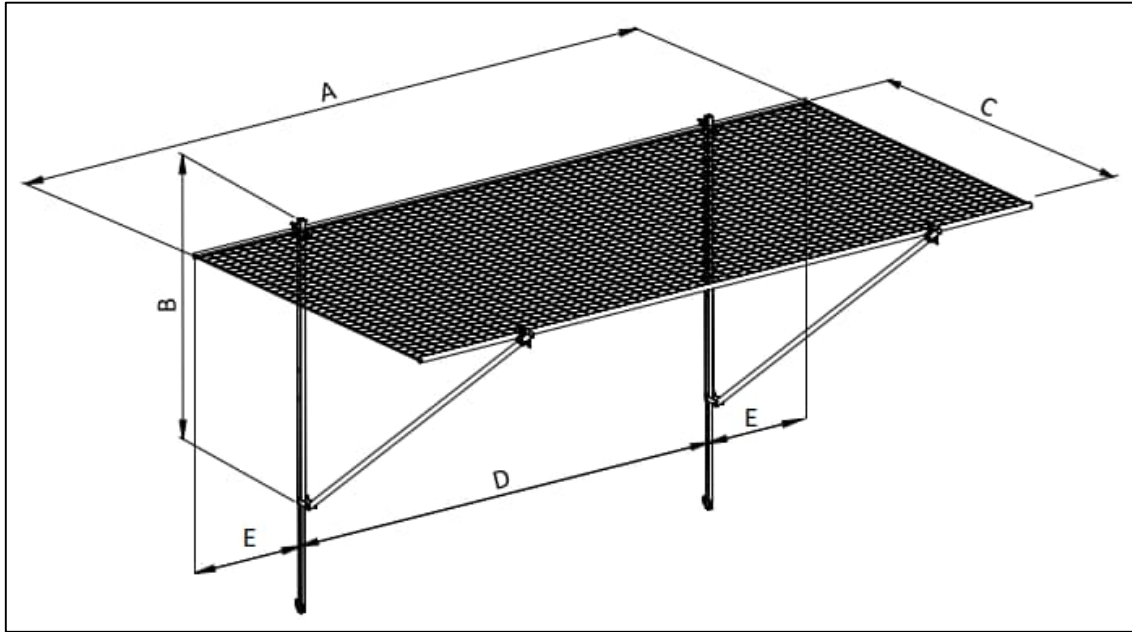
During November 2021, the Project experienced adverse weather. Specifically, there were high winds which resulted in damaged Vertemax fans. On further review, the Construction Manager discovered that the fans did not have a suitable base design, incorrect bolts were installed on a significant number of arms (one bolt had no nut which we can only assume fell into either the Pit Lane or Bishopsgate) and there was not a designed restraint mechanism for the top of the fans. It took well into December 2021 before the design and practical issues around the fans were fully resolved.

The design of the Vertemax fans is based on a simply supported system. Where the fan rests on the upper metal deck and relies on the “leg” pushing against the beam underneath to provide support, when the fans are deployed / erected. However, this design was only suitable for wind speeds up to 30mph, which was stated on William Hare's own documentation. The Project was experiencing wind speeds significantly more than 30mph which highlighted issues with the design. Additionally, William Hare had no strategy and/or methodology to overcome this. To overcome this, William Hare and Lendlease co-ordinated, to design a system whereby the fans could be fixed onto a bracket at deck level, to ensure that they remained in position during high winds, with the top of the fans tied back to the studs.

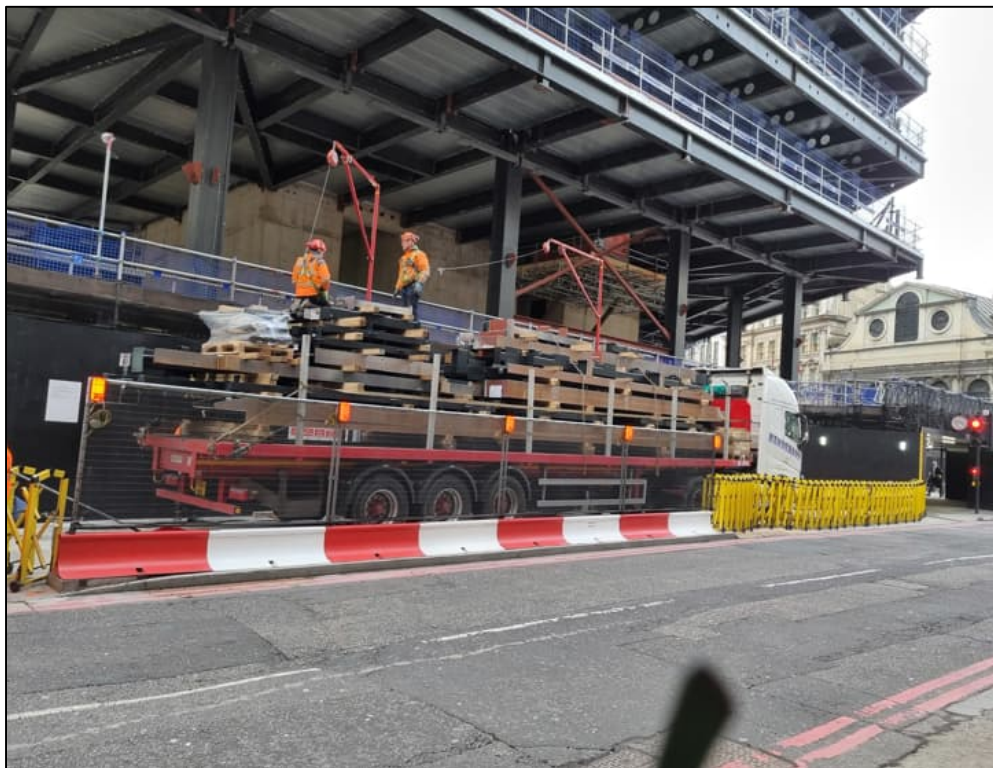
The below photograph of offloading operations at 1 Leadenhall Street (Brookfield Multiplex) shows how William Hare had intended to offload material from the outset of the Project.

- Steel could become destabilised and ‘*topple*’ over the side of the HGV due to the loading of the steel being stacked higher than the steel king posts.
- There are no handrails to prevent the operatives from falling.

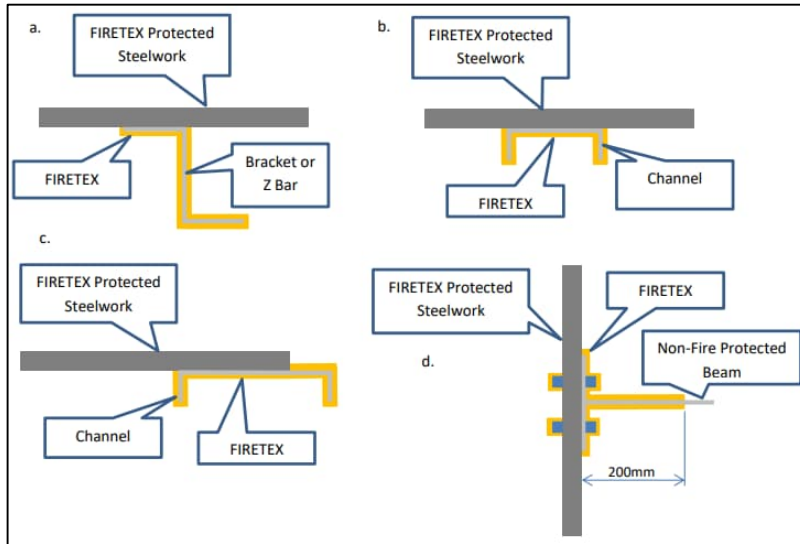
William Hare’s ‘Behaviour of Intumescent Steelwork’ (260906-WHL-XX-XX-TS-X-0001) document explained, from Sherwin William’s (FIRETEX) perspective, how the treatment of attachments to primary steel should be designed.

The below illustration from the ‘Behaviour of Intumescent Steelwork’ (260906-WHL-XX-XX-TS-X-0001) document provides examples of how secondary attachment could be treated.

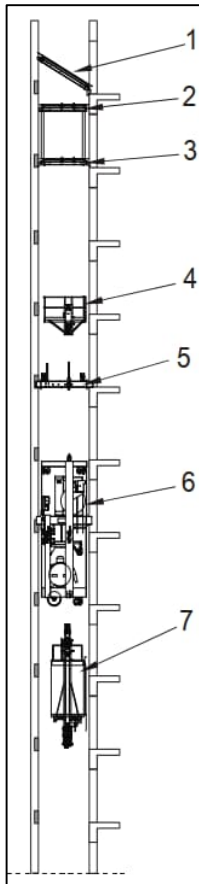
- 6) Kone's JumpLift required weather protection to protect activities taking place below from water ingress. Keltbray Structures Limited failed to properly weatherproof the Working / Protection Decks.

In Lift Shafts with the JumpLift, only the Crash / Weather Deck would be required as the JumpLift system provides the Working Deck.

1. Deflection Deck (provided by Construction Manager via Keltbray Structures). It should be noted that Kone recommend in their JumpLift '*Installation Instruction*' that the Deflection Deck is attached to the core form.
2. Waterproof Crash Deck (provided by Construction Manager via Keltbray Structures)
3. Crash Deck (provided by Construction Manager via Keltbray Structures)
4. Installation 'Time' Platform (provided by Kone)
5. Cathead Hoisting Beam (provided by Kone)
6. Cathead (provided by Kone)
7. Car (provided by Kone)

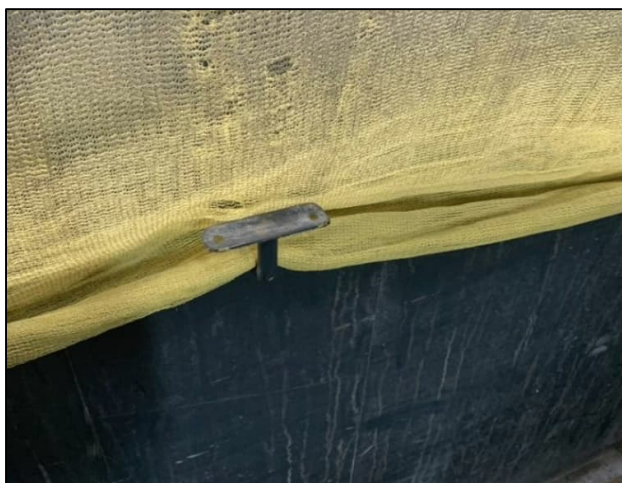
- 4) The Scope of Work should have been clearer regarding the responsibility of who was to provide fixings for the handrail to the stairs.

During the construction phase, Keltbray Structures argued that the “stem” bracket which allowed for the external balustrade to be fixed onto, did not form part of their Trade Contract. The Scope of Work was not entirely clear on this element of scoping.

The Scope of Work’s wording could be amended to, “... Metal Stairs on the Project shall include the flights, landings, half-landings, and internal permanent handrails, and associated fixtures and fittings. The Metal Stairs should be (factory) finished to base and first coats only. Final finishes and the associated external permanent handrails fixed to concrete will be completed by follow-on trades.
