Best Practice Sharing Award

ชื่อโครงการ : **COMPABLOC REPAIR TECHNICAL**

บริษัท : **PTTGC**

No.	Title	Details
1	Project Name*	(English*) Compabloc Repair Technical (Thai) เทคนิคการซ่อม Compabloc
2	Objective*	To find the repair and testing technical for several leakage of Compabloc.
3	Executive Summary*	To get the guideline and technical for repair Compabloc in PTTGC group (The first time for repair Compabloc in our group). We can identify and evaluate the leakage localization to select the proper technical for repair. In the next repair, we can fix the leakage by ourselves and then the cost saving and benefit will be 1.98 MB/time (no procurement for external service).

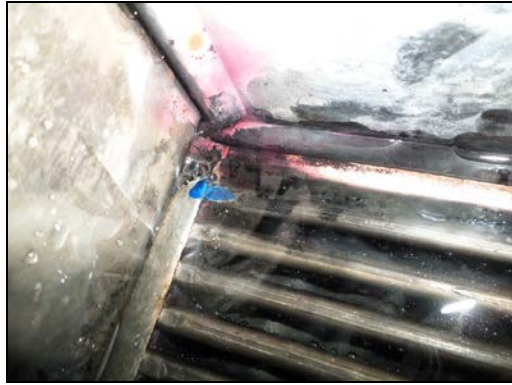
Leak location on the top left of Aa side (at the first channel)

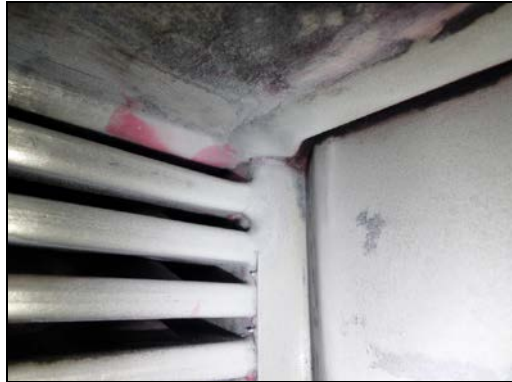
Completed weld repair on the other side. No bubbles show during air-bubble test.

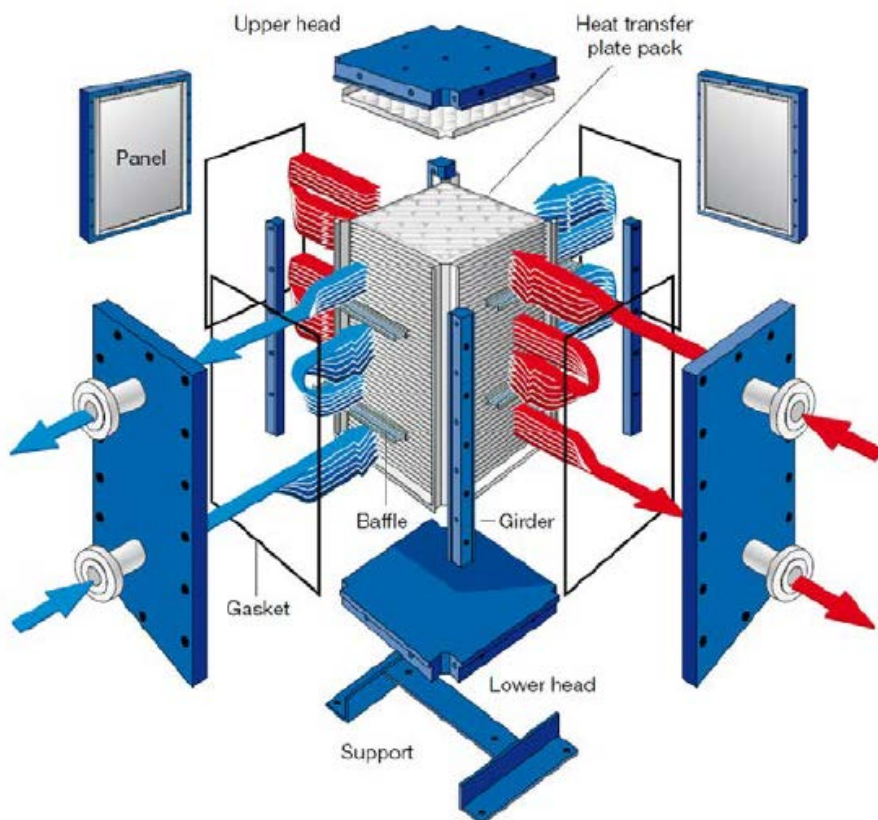
CPI Step 1: Compabloc, which is a welded plate heat exchanger, was cleaned since Mar 2016 and then found internal leakage at Aa side (hot side) during hydrostatics test. The leakage need to be fixed by special technical. The repairable achievement is no leak to be observed.

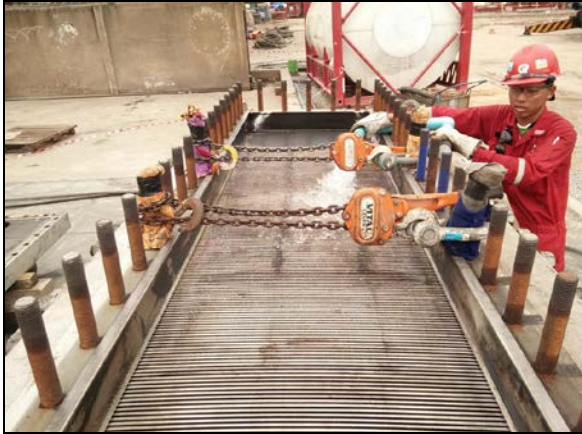
3.5 Perform air-bubble test and identify leak location. (need to fix a dimension change by using chain pulley)

Chain pulleys were pulling the Compabloc frame

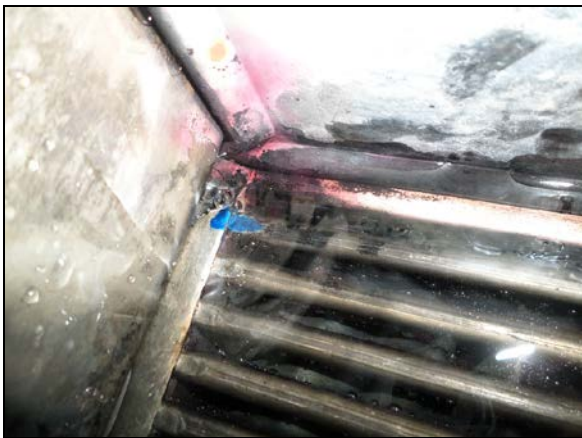
The bubble was appearing at blue mark below which is a leak point.

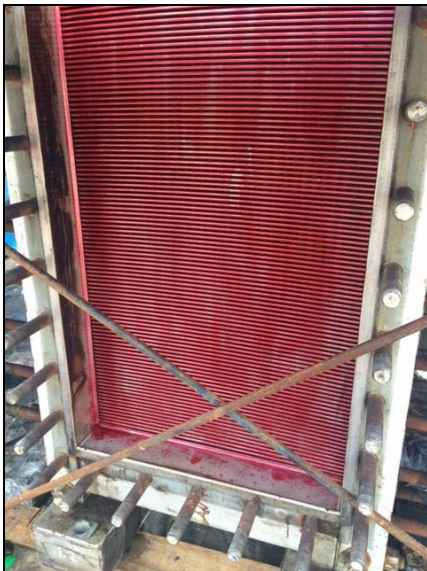
3.7 PT check on all plate pack surfaces to detect the discontinuity

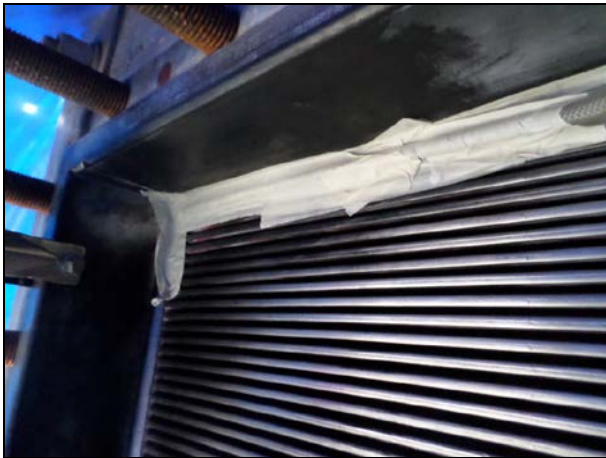
3.9 Repair a crack by GTAW with special backing procedure (avoid burn through and oxidation on back side)

Sealing for argon backing

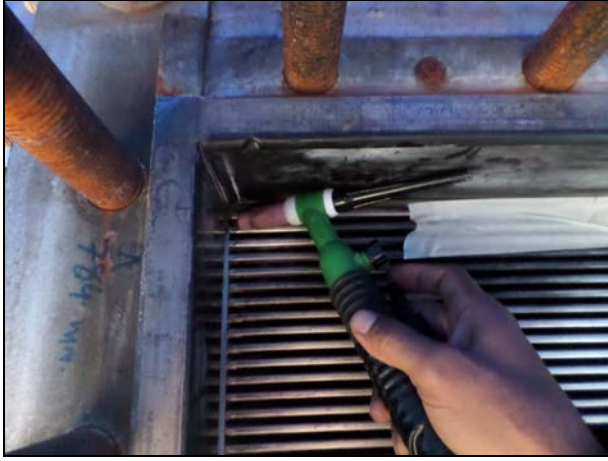
Electrode holder was not able to access at Aa side for welding

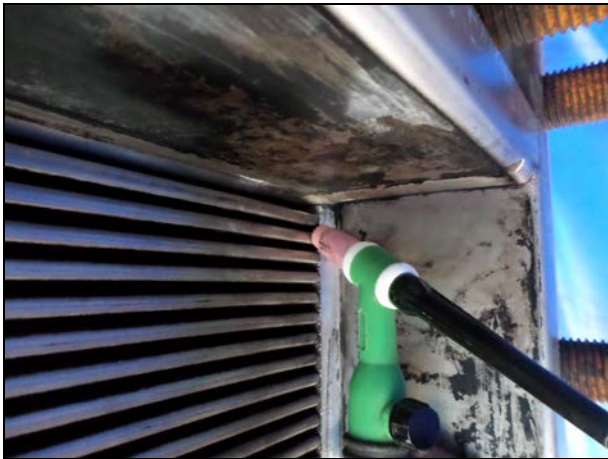
According to Aa side leakage point could not be reached properly, it will be repaired on Bb side (at the same point on Aa side leakage).

5.6 Corner weld which occurs at top left of Aa side cannot repair because Aa side leakage point could not be reached properly, it need to be repaired on Bb side (at the same point on Aa side leakage).

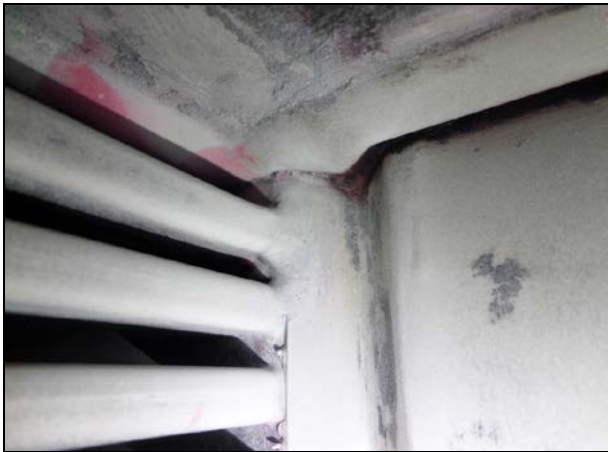
3.10 Weld testing at Bb side by PT

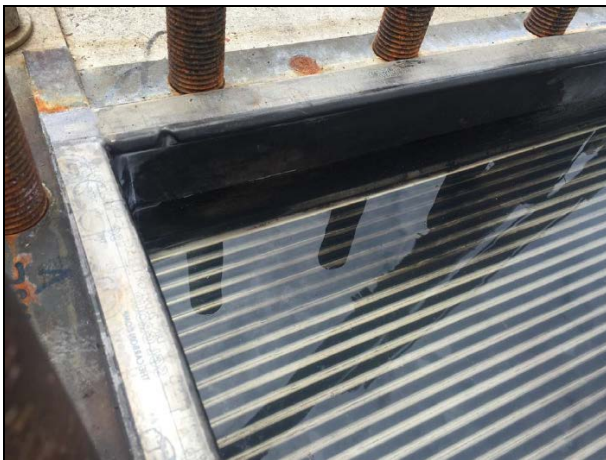
3.12 Perform 2nd air-bubble test

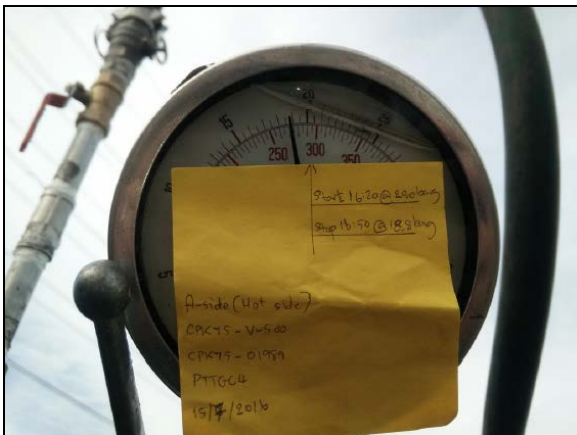
3.14 Unbalanced hydrostatic test at 19.8 barg on both side.

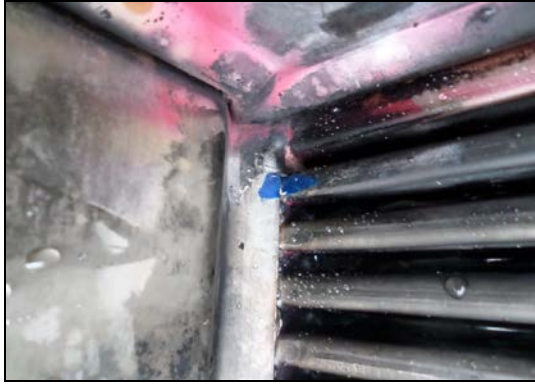
Before repair

CPI Step 4: Repair result, recover equipment integrity with weld quality

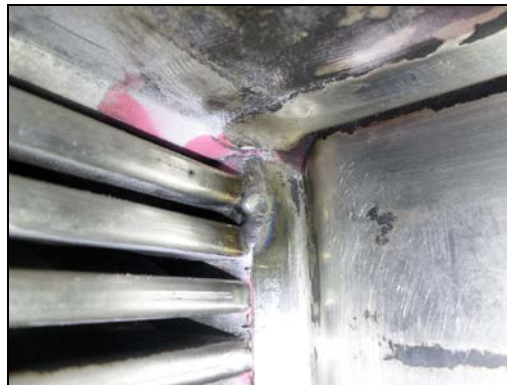
- 5.1 The way to identify and localize a leak is to do an air-bubble test. The Compabloc must place horizontally on the floor, with the top panel removed and that circuit is filled with water.
- 5.2 Chain pulley should be used to maintain the plate pack dimension during filled water for air-bubble test.
- 5.3 Need PT check on all plate pack surface.
- 5.4 There are three types of Compabloc leak as following corner weld leaks, cross leaks over the plate and plate-weld leaks,
 - 5.4.1 Corner weld leaks, repair by GTAW with or without filler metal

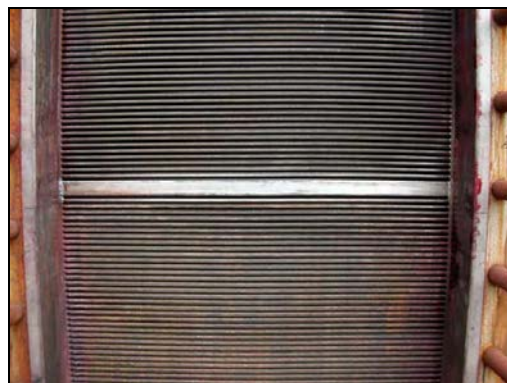
- 5.4.2 Cross leaks over the plate, sealed with a metal-strip at four sides by GTAW

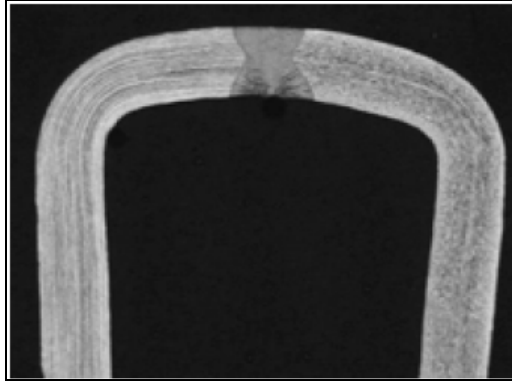
- 5.4.3 Plate-weld leaks, this type of leak is uncommon because of the high quality of laser welding.

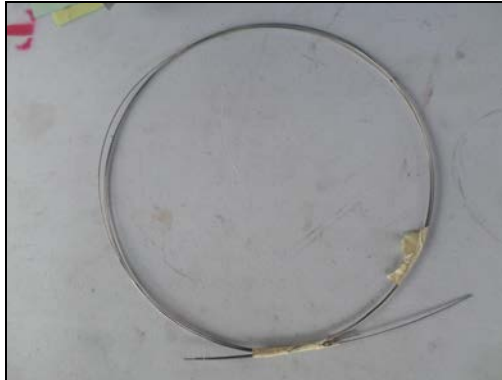
5.5 Filler rod diameter is 0.8 mm for repair only. More diameters will effect to burn through.
