# Flare inspection by Unmanned Aerial Vehicle (UAV) at GC7

Wutthinan Petchpeng  
Senior Plant Reliability Engineer  
U-TM-RM

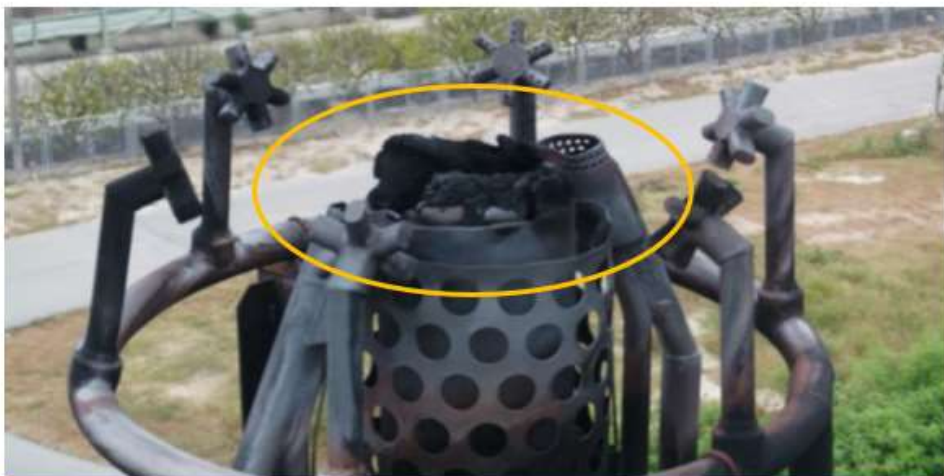
Found some ashes on flare gas tip

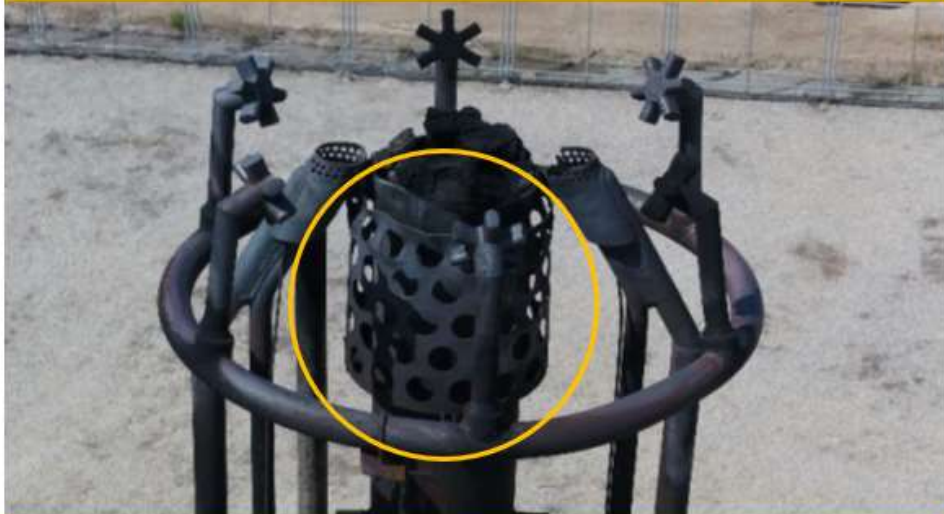
Pilot burner metal case is broken

General corrosion on flare stack body, the steam injection system and molecular seal

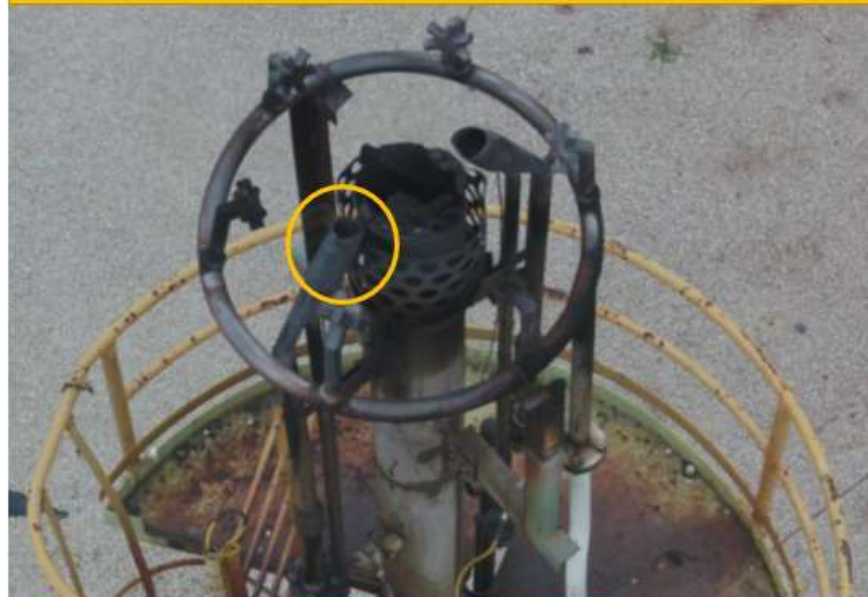
Minor distortion on flare gas tip metal case

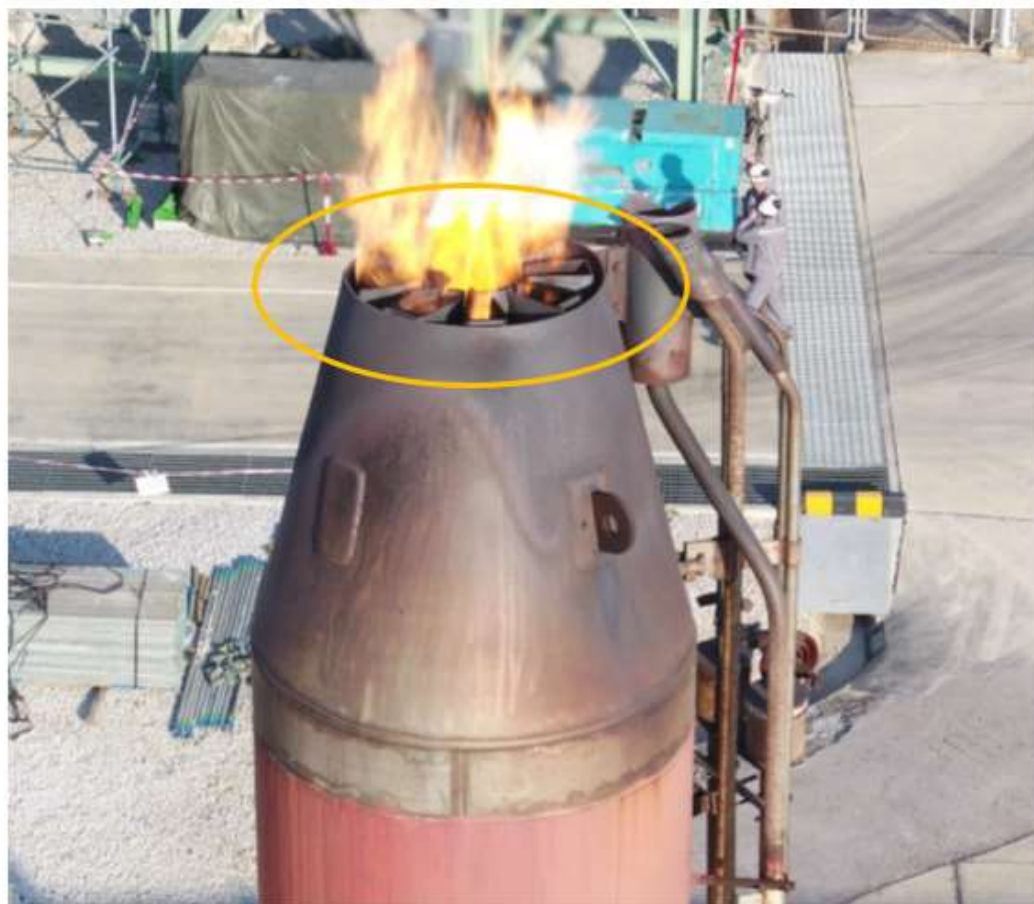
Minor distortion and metal tearing on flare gas tip

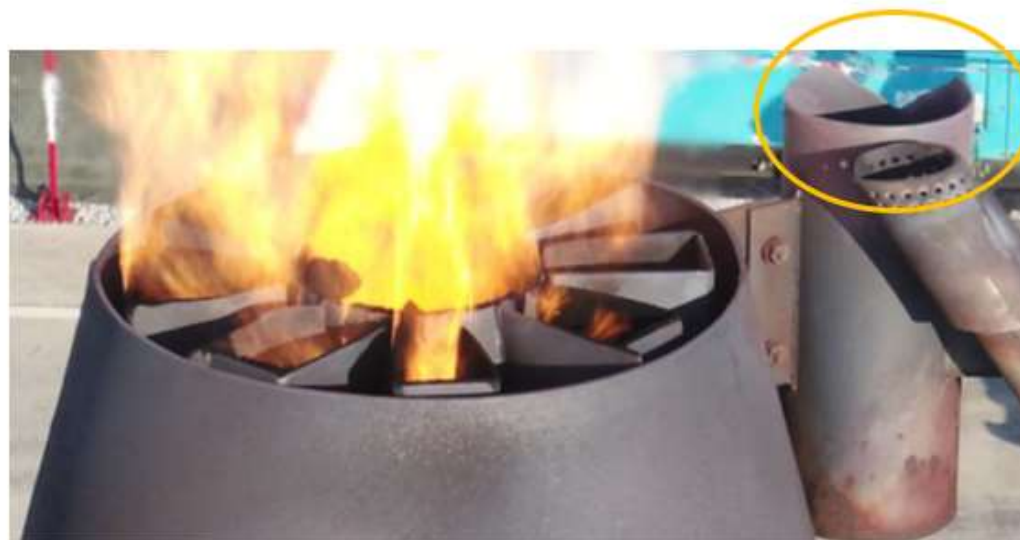
Metal tearing on pilot burner

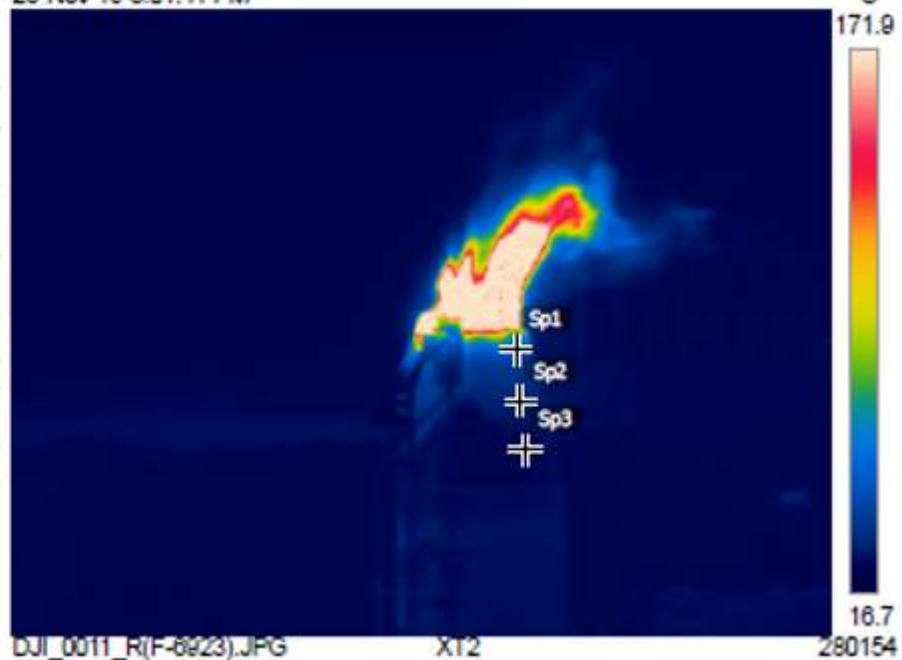
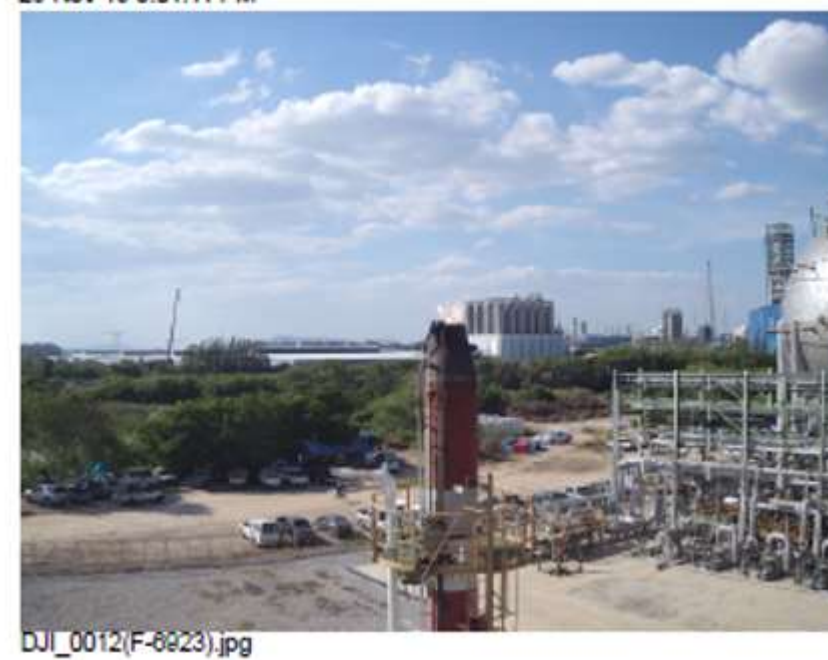
Sp1	58.1 °C
Sp2	37.7 °C
Sp3	27.5 °C

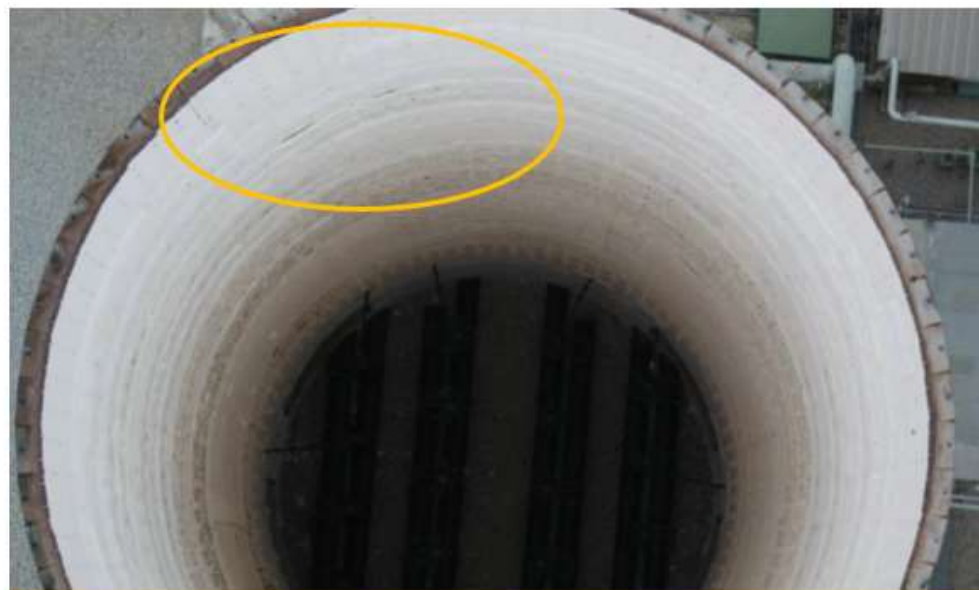
Minor incomplete Insulation

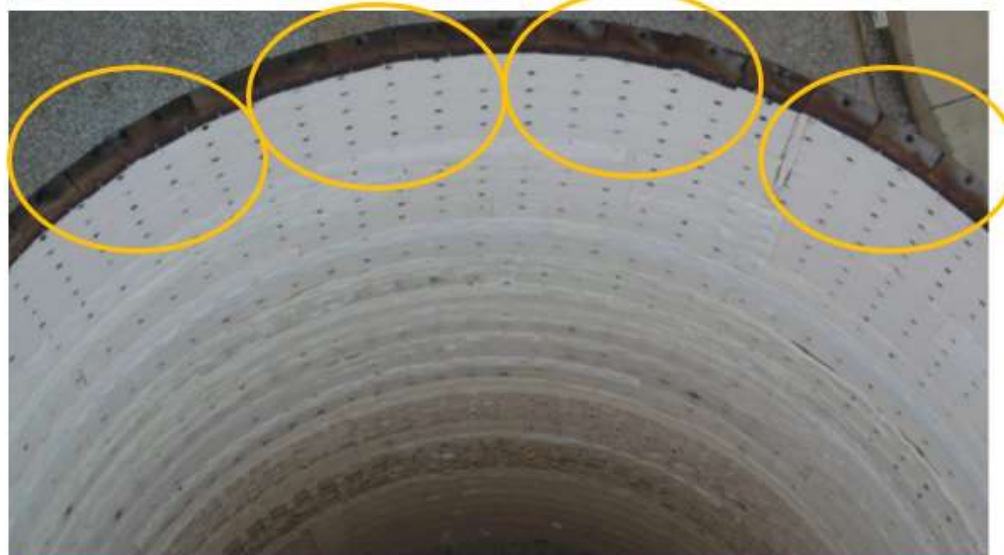
General corrosion
