ISEC2076 ASSIGNMENT #1

Physical Security Assessment

Steylen, Lucas

Facility Name	Munden's Moving
Location	45 Lovett Lake Ct, Halifax, NS B3S 1B8
Business Opened	June 1 st 1984
Company Contact	Phone: +1 877-289-9120 Local Phone: 902-450-1323 Email: mundens@mundensmoving.com
Owner	Robert J Munden
Office Manager	Justin Munden
Vice President	Sheila Mont

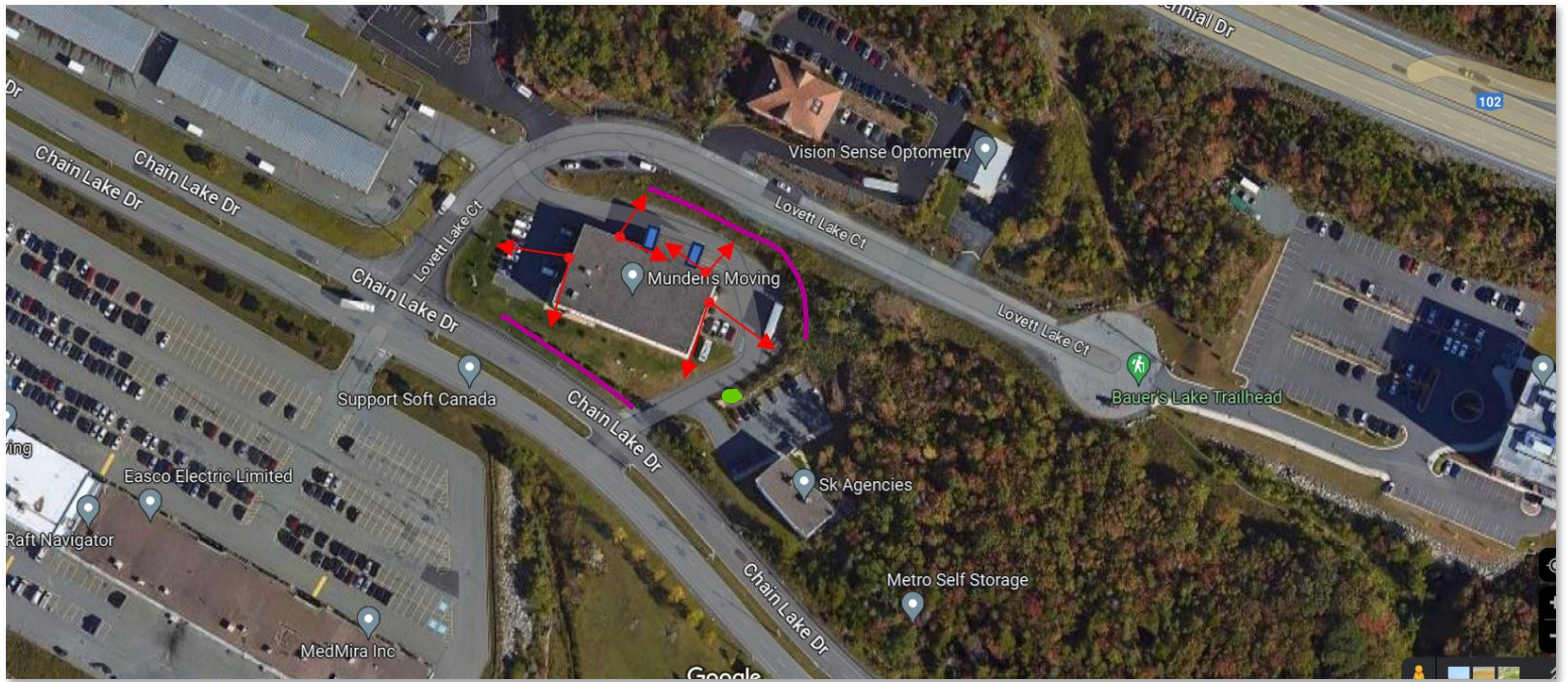
Figure 7 (Google, 2023)

As seen in Figure 7, the red dots and arrows show security cameras and their estimated range and view. They clearly seem to have been placed at points of interest with the blue rectangles marking the loading and unloading zones. With one of the other two cameras viewing the private driveway to the back park lot and loading zone and the other one viewing the front door. The purple line indicates steep natural barriers, with the front one indicating a steep but small incline from the main road up to the property. And the back one indicates a steep cliff like drop off from the back road down to the loading area. The green dot indicates a “No Parking” and “Private Property” sign.

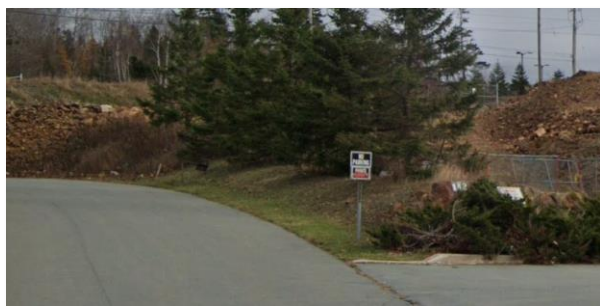
Figure 9

Vulnerability: while there are decent natural barriers especially along the backside of the building as well as a no parking and private property sign on the rear driveway shown in Figure 9. There is a lack of secure fencing around the perimeter to control access to the front parking lot and more importantly the back parking lot and loading area. There is nothing stopping vehicles from accessing the rear parking lot from the front or pedestrians from the rear.

Solutions: **Perimeter Fencing**

Security fence lining the property from the surrounding roads. This will mean that the closest neighboring building will have to have a new driveway put in indicated by the grey rectangle. To be in accordance with CPTED the fence should stand at 8 feet tall and contain 3 strands of barbed wire along the top. These suggestions are drawn out in Figure 8

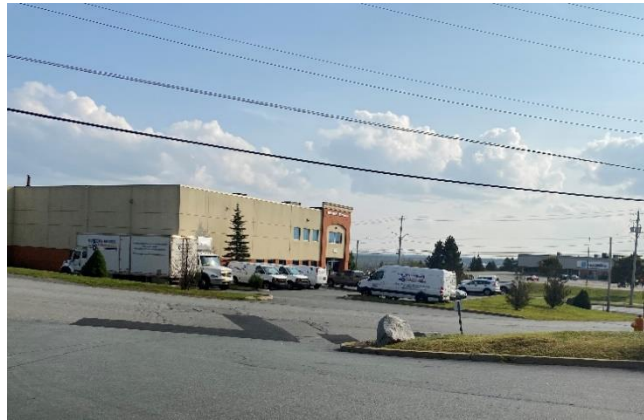
Figure 11

The building has decent natural barriers, especially from the rear of the building. As you can see in Figure 13 and 14 there is a steep almost cliff like drop off from the road to the back parking lot/loading area. The vegetation is quite unkept and messy, this ideally should be cleaned out and replaced by a hedge trimmed to 36 inches to adhere to CPTED Landscaping recommendations. There is also a very small but steep incline from the sidewalk up to the front door and parking lot with a line of trees where the incline levels out to enforce a natural property line as seen in Figure 10. The property has very good and clear visibility for the front and the sides of the building seen in Figure 11. With no unnecessary nooks or crannies or shrubbery that blocks visibility.

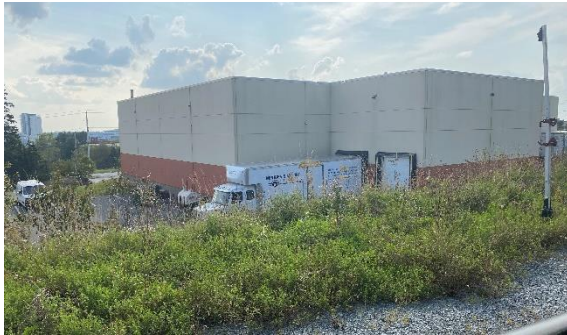
Figure 13

Vulnerability: lack of clear vegetation barrier to the rear of the building. This is not super necessary because this step is mainly to reinforce the subconscious natural barrier and this already exists with the steep drop off from the upper street but should still be considered.

Solution: A hedge should be planted around the rear and the west side of the building and should be trimmed and maintained at 36 inches from the ground. If the step is taken to implement the outer fence mentioned above, then this step will not be necessary. The business should however have a vegetation/landscape planting and maintenance program.

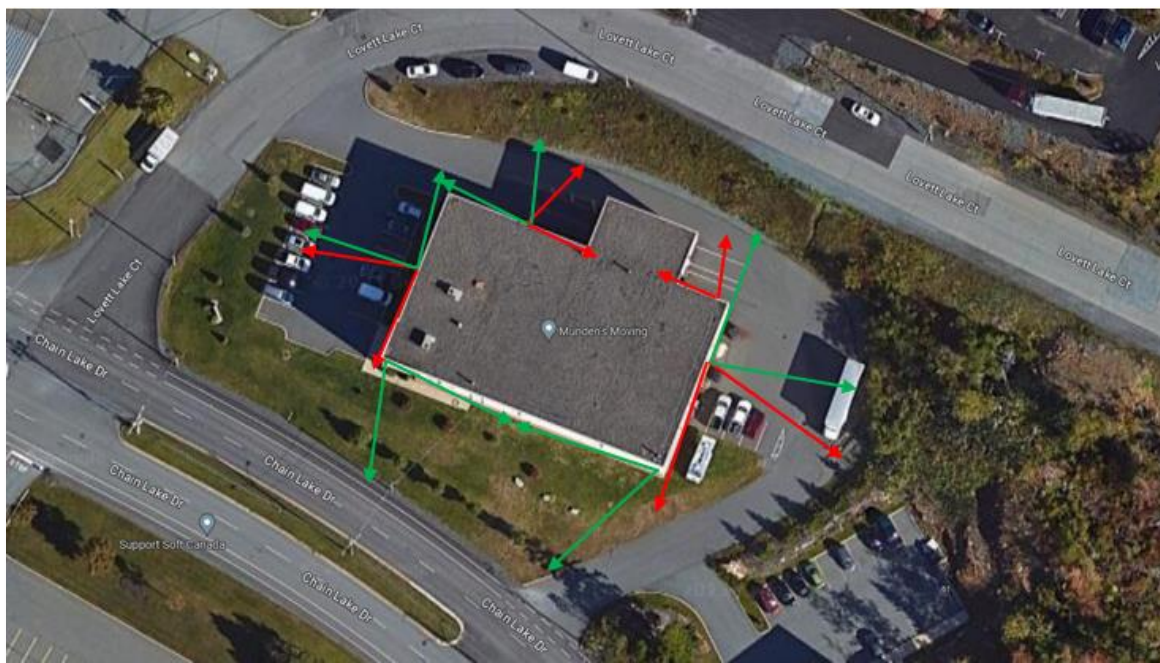
Figure 15
(Google, 2023)

Vulnerability: while the site does have decent surveillance, there are many blind spots. The entire front side of the building facing the main street is completely out of view of any camera. In Figure 15 above, the red lines show the estimated field of view of the existing cameras.

Solution: to increase the visibility of the security system, suggestions for new camera placement have been added to Figure 15 above. The green arrows show the estimated field of view for the new cameras. Signs should be added throughout the property to notify potential intruders and increase the perception of risk. For all cameras to maintain effectiveness during the night there must be proper lighting in each area under surveillance. The CCTV footage should be regularly monitored to ensure all cameras are working properly, the lighting is still proper, and footage is being saved and archived and is able to be retrieved if necessary.

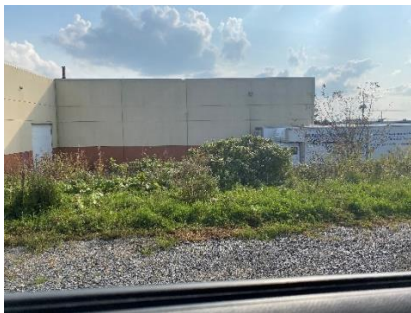
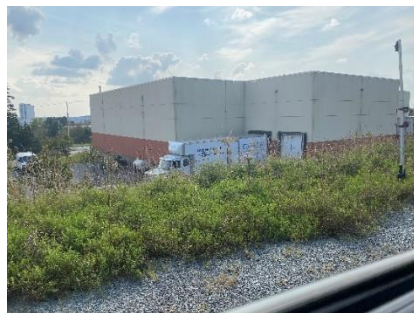
The front southwest corner of the building has upper and lower-level reflective windows, which is good to increase the perception of risk that someone might be watching from inside the building. However, as you can see in Figure 16 and 17 above, there are no windows at all on the right (west) side or the rear (north) side of the building.

Vulnerability: No passive security opportunities on the right and rear side of the building due to a lack of windows.

Solution: install reflective windows on the rear and right side of the building or add some sort of casual surveillance opportunities to increase passive surveillance and to increase the preserved risk for a potential intruder.

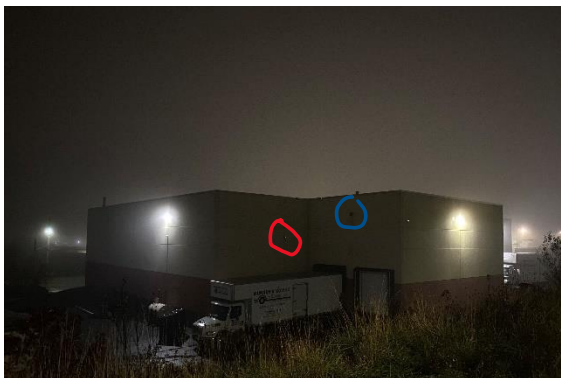
circle is one of the security cameras and the blue circle is the burnt-out light directly above the loading dock. Other than the obvious burnt-out light, the only part of the building lacking good lighting is the South-East corner, pictured in Figure 22 above. This corner also contains the private driveway to the loading dock. Some lighting could also be added to increase the light levels in the north half of the front parking lot.

Vulnerability: the south-east corner of the building, the private driveway to the back of the building and the north half of the front parking lot are all not adequately lit for the suggested security cameras.

Solution: new lights should be added to the property/building to light the highlighted areas in Figure 27 below, that are currently not lit adequately. In addition, all current lighting should be replaced with more powerful flood lights, as the current lighting is not as strong as it could be.

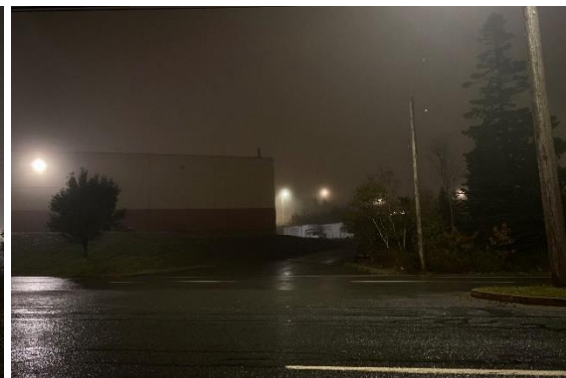
Overall, the property is well lit, and three of the four existing cameras have adequate lighting, at the front of the building, the east side and the unloading dock as seen in Figure 19, 20 and 21 above. However, I would suggest that the existing lighting be updated to more powerful flood lights. Also, in Figure 21 the red

Vulnerability: Above the loading dock at the rear of the building there is a camera that is inadequately lit due to a burnt-out light positioned elevated and adjacent to the camera. This is shown in Figure 21.

Solution: the light should be replaced and to ensure that this doesn't happen again the camera should be monitored daily to ensure that lighting remains adequate.

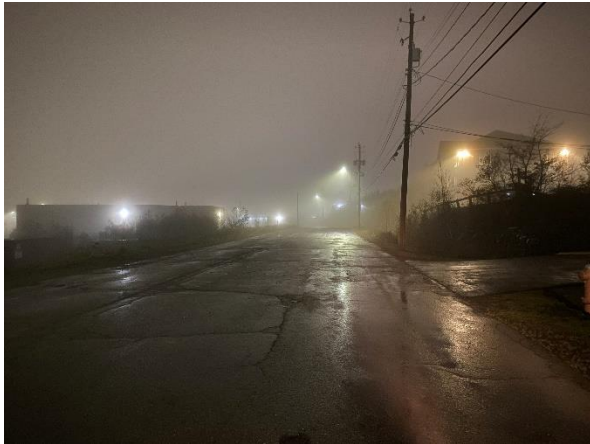
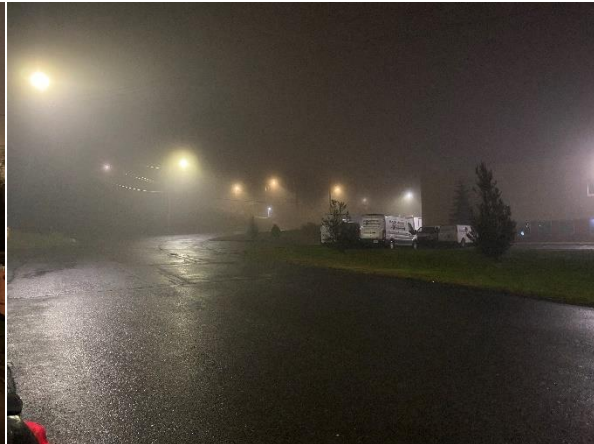
As shown in Figure 23 and Figure 24 above, the side road that runs up and behind the building has decent street lighting at the start of the road but the lighting stops once the road goes past the building and doesn't start again until the road hits another business about 250 meters down the road. The main road
