Date	PC APP software:	BOB Firmware:	Donlight Firmware:	Github hash
07/07/2022	1.3.2 +Gerderland detup	+1.00.06	2.0.0	9c5dd7e6e79d4a42567d73da661bcd3da96c2c06

**13000003500\_rev01\_BOB\_V01\_00\_05\_hazarddelaytoleranceUpto11ms** is build on top of v01\_00\_04 with increased tolerance to delay in turning signals.

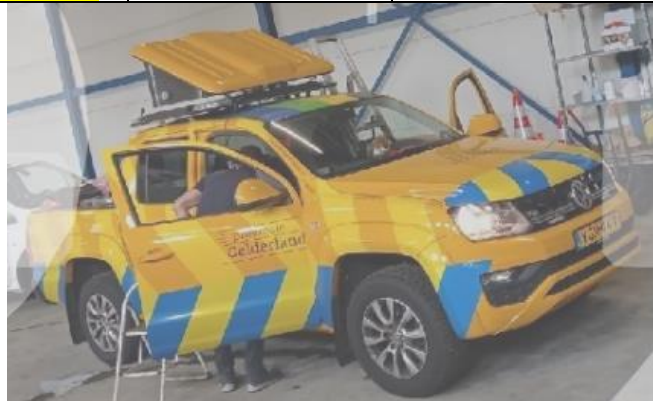
After spending 3hours with Richard at Gerderland and connecting the turning signals from the vehicle to an oscilloscope, we noticed this vehicle had a delay between turning signals of 9ms. As the BOB was set to tolerate delays up to 5ms between received turning signals the lights were glitching when the hazard was on.

Also , **Setup for gerderland vehicles** was created.

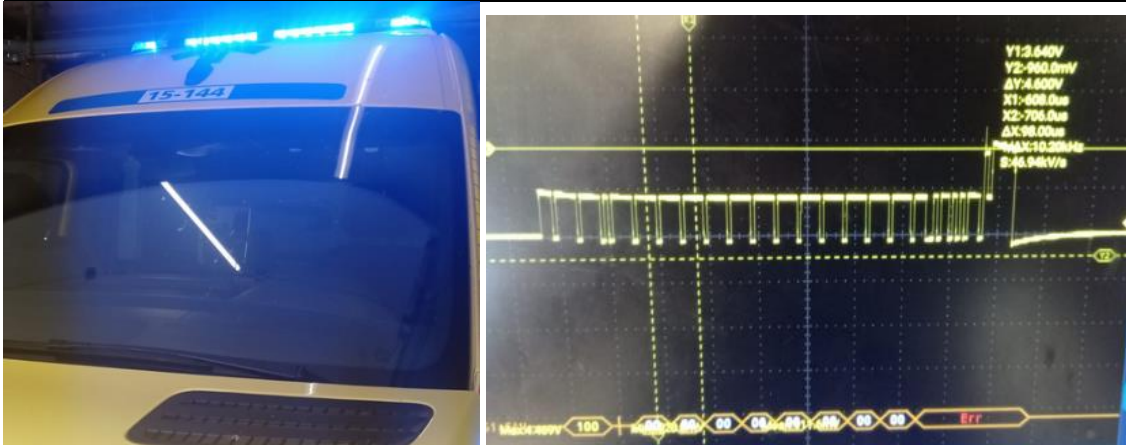
After two weeks at Marelko debugging Ambulances we made the following changes:

- Created BOB 1.00.04 firmware, improvements in the clock were made reverting the bug present in 1.00.03 firmware.
- Updated all Batch3,batch4,batch5 firmwares, they don't turn off when the sync canbus is not received, this way even if the BOB fails they will continue functioning (not synchronised and unable to switch off), they also reset its canbus if they feel something is wrong.

This setup was tested at Marelko and didn't show any error 13h uninterrupted.

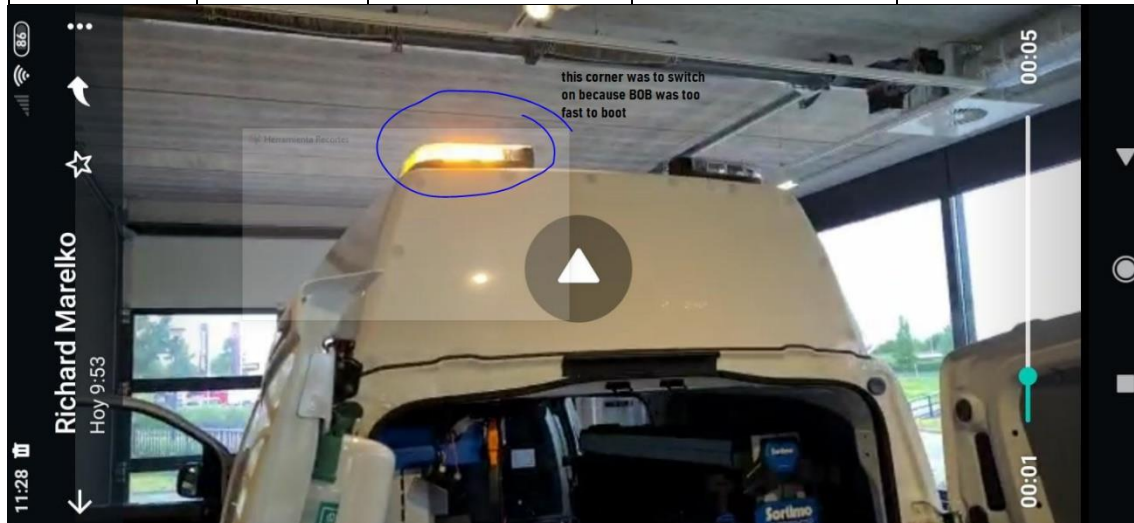
After a morning call with Richard, one ambulance's rear left corner was not switching on, this was caused by the BOB booting too fast.

This issue appeared with 1.00.04, as we improved the clock the booting process was finished faster.

I created the BOB firmware **v1\_00\_06** which is built on top of v1\_00\_05 with 300ms delay instead of 250, the issue was reported fixed after Richard tested it during 6 minutes with no problem.
