## Donlight Changelog 16/03/2023

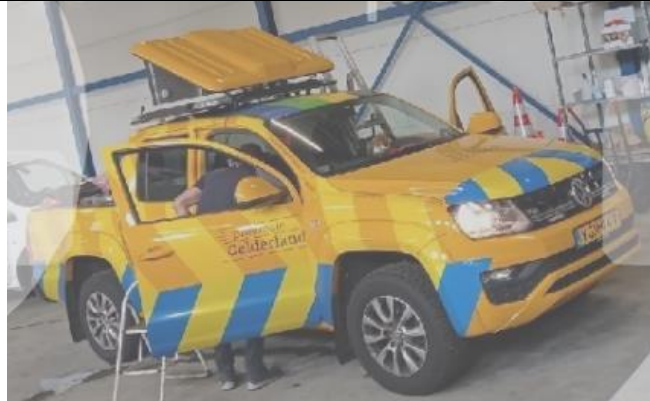
After spending 3hours with Richard at Gerderland and connecting the turning signals from the vehicle to an oscilloscope, we noticed this vehicle had a delay between turning signals of 9ms. As the BOB was set to tolerate delays up to 5ms between received turning signals the lights were glitching when the hazard was on.

**13000003500\_rev01\_BOB\_V01\_00\_05\_hazarddelaytoleranceUpto11ms** is build on top of v01\_00\_04 with increased tolerance to delay in turning signals.

Also , **Setup for gerderland vehicles** was created.

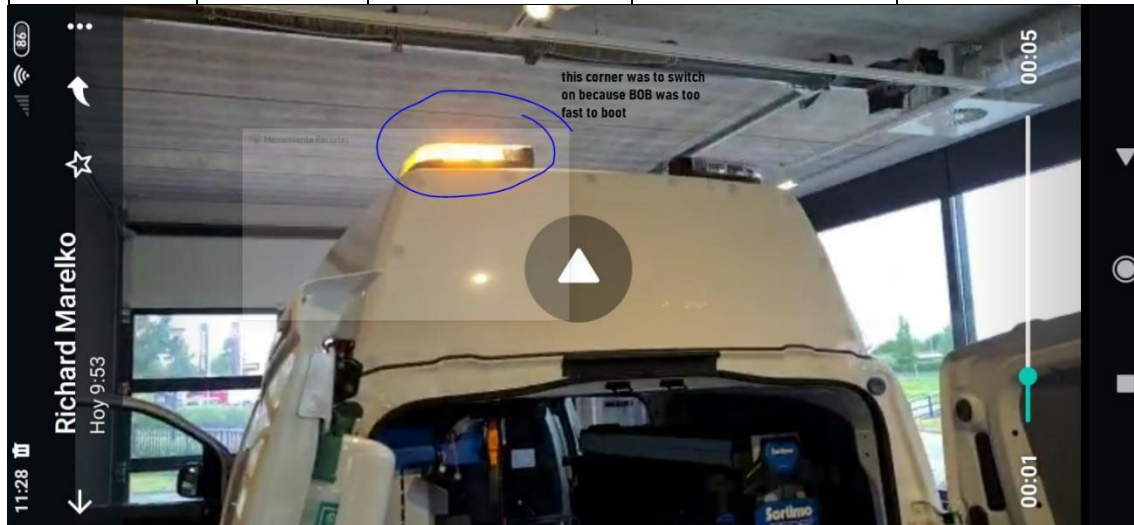
After a morning call with Richard, one ambulance's rear left corner was not switching on, this was caused by the BOB booting too fast.

This issue appeared with 1.00.04, as we improved the clock the booting process was finished faster.

I created the BOB firmware **v1\_00\_06** which is built on top of v1\_00\_05 with 300ms delay instead of 250, the issue was reported fixed after Richard tested it during 6 minutes with no problem.

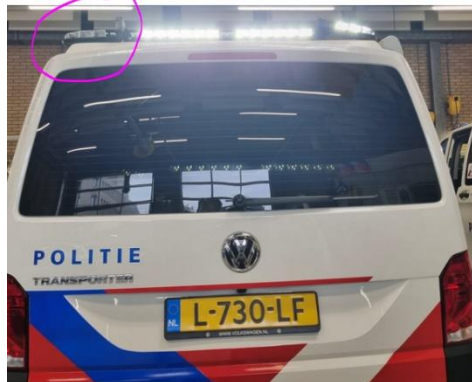
After reviewing one by one this are the specific configs fixed that were deaf to polaris commands.

- Box-body MB Sprinter
  - BLcorner
- sprinter6
  - BLcorner
  - FL55blue
  - FR55blue
- sprinter6\_fixedcolours
  - BLcorner
  - FL55blue
  - FR55Blue
- sprinter6\_fixedcolours\_blue\_white\_fronts
  - BLcorner
  - FL55Blue
  - FR55Blue
- sprinter6RearWithArrow
  - BLcorner
- sprinter8\_fixedcolours
  - BLcorner
  - BLstraight
- sprinter9
  - FrontLeft
  - FrontRight

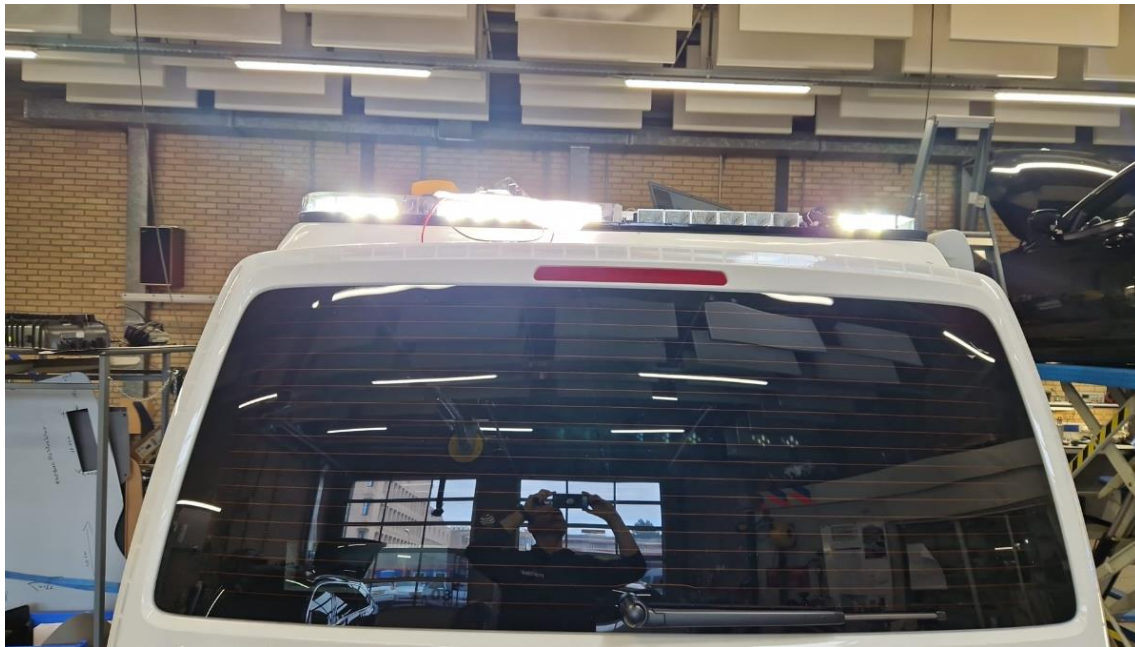
Richard spotted an issue with a straight module not responding to Polaris commands.

It turns out the issue i thought fixed 10/10/2022, was still present in the configuration BRstraight.bin from the setup sprinter8.
