Date	PC APP software:	BOB Firmware:	Donlight Firmware:	Github hash
07/07/2022	1.3.2 +Gerderland detup	+1.00.06	2.0.0	9c5dd7e6e79d4a42567d73da661bcd3da96c2c06

Donlight Changelog 12/12/2022

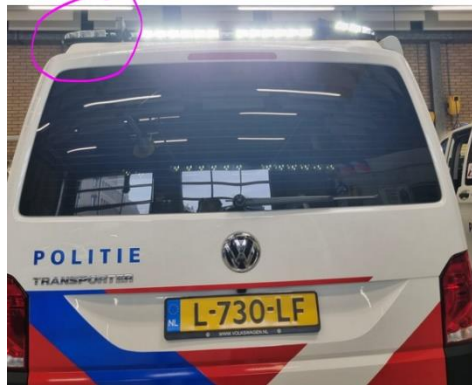
After reviewing one by one this are the specific configs fixed that were deaf to polaris commands.

- Box-body MB Sprinter
 - BLcorner
- sprinter6
 - BLcorner
 - FL55blue
 - FR55blue
- sprinter6_fixedcolours
 - BLcorner
 - FL55blue
 - FR55Blue
- sprinter6_fixedcolours_blue_white_fronts
 - BLcorner
 - FL55Blue
 - FR55Blue
- sprinter6RearWithArrow
 - BLcorner
- sprinter8_fixedcolours
 - BLcorner
 - BLstraight
- sprinter9
 - FrontLeft
 - FrontRight
