Date	PC APP software:	BOB Firmware:	Donlight Firmware:	Github hash
07/07/2022	1.3.2 +Gerderland detup	+1.00.06	2.0.0	9c5dd7e6e79d4a42567d73da661bcd3da96c2c06

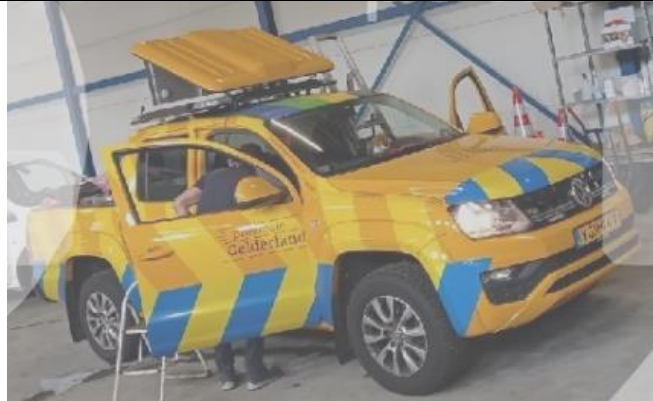
After spending 3hours with Richard at Gerderland and connecting the turning signals from the vehicle to an oscilloscope, we noticed this vehicle had a delay between turning signals of 9ms. As the BOB was set to tolerate delays up to 5ms between received turning signals the lights were glitching when the hazard was on.

13000003500\_rev01\_BOB\_V01\_00\_05\_hazarddelaytoleranceUpto11ms is build on top of v01\_00\_04 with increased tolerance to delay in turning signals.
