Residensi Vista Harmoni

APPLICATION FOR SPECIAL RATING (FIRE TARIFF)

SECTION A: FIRE & ALLIED PERILS INSPECTION FORM

INSURED : Residensi Vista Harmoni

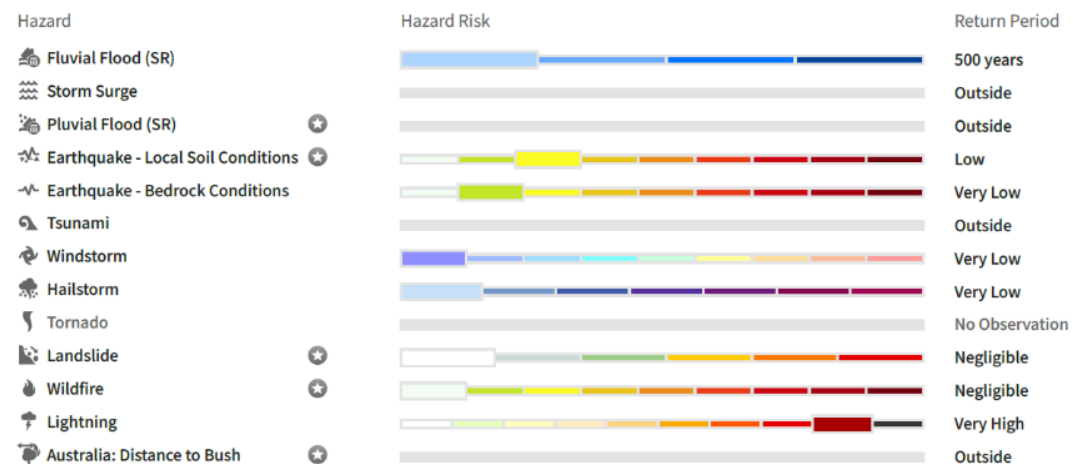
The risk is protected with adequate drainage systems. Nearest waterbody is Klang River. Based on Swiss Re Catnet as shown below, fluvial flood is considered High with 500 years return period. No history of flood claim.

The exposure to special perils is considered as low except flood. According to Swiss Re Catnet, the risk is located within 500 years return flood zone area where it is considered high. Exposure towards other perils and exposure from the surrounding neighbours are regards as low.

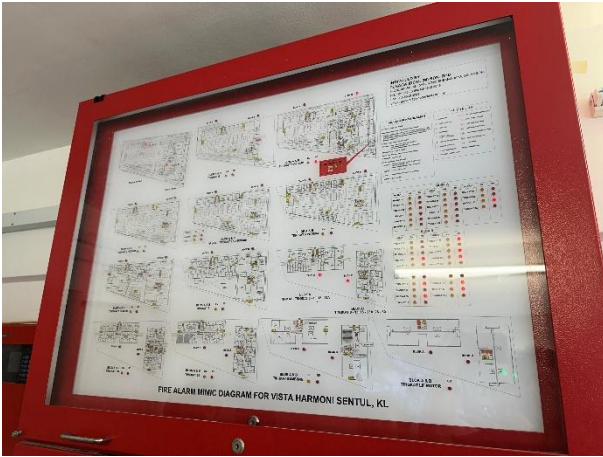
Fire Alarm Panel

3.9.3 Are the detectors, alarms and fire control panel in working condition **and** switched on?
☒ Yes ☐ No

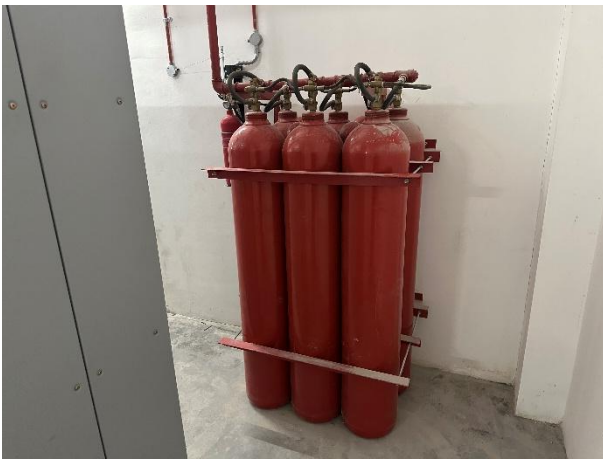
CO2 Tank

Location	Type	Total flooding or local application	Condition of system (<i>Working condition and switched on</i>)
MSB & Genset room	Carbon Dioxide	Total flooding	Appears good and switched on

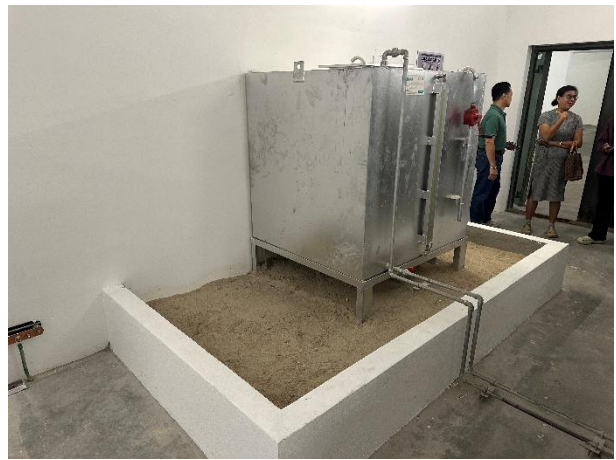
Diesel Tank

The diesels are solely for the generator set and kept inside the generator room which is off limit to public. A bund wall surrounds the diesel tank. There is also CO2 flooding system in the genset room with CO2 type portable fire extinguisher.

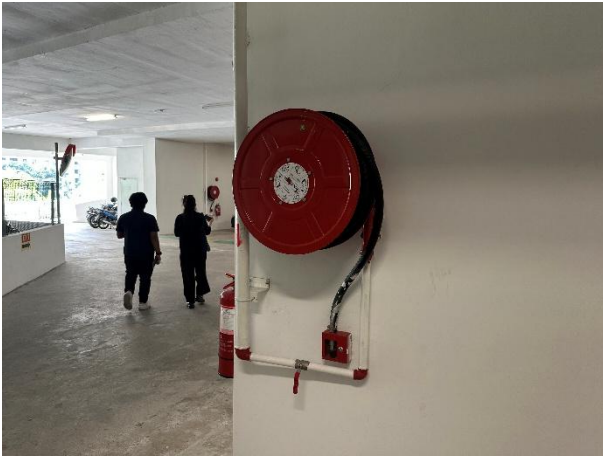
Hose Reel

3.5.1 Does the water throw of the most remote hose reel point achieve 6 metres (20 feet) or more?
[x] Yes [] No

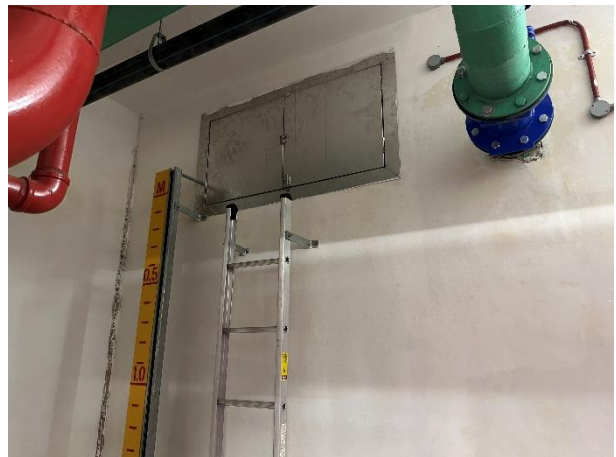
Wet Riser Concrete Water Tank

Type: Reinforced concrete tank
Maximum capacity of water supply: Info not available
Amount of water during inspection: 5ft out of 6ft

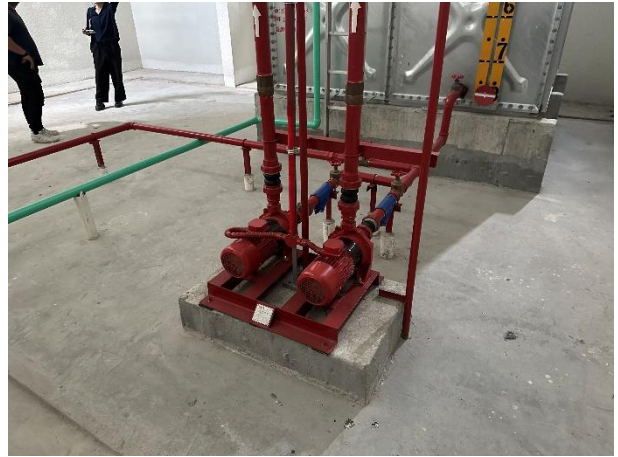
Hose Reel Pump (Block A)

3.5.7 Physical condition of pumpsets: Good condition

3.5.8 Working condition of pumpsets: Testing not conducted
(Verify by testing)

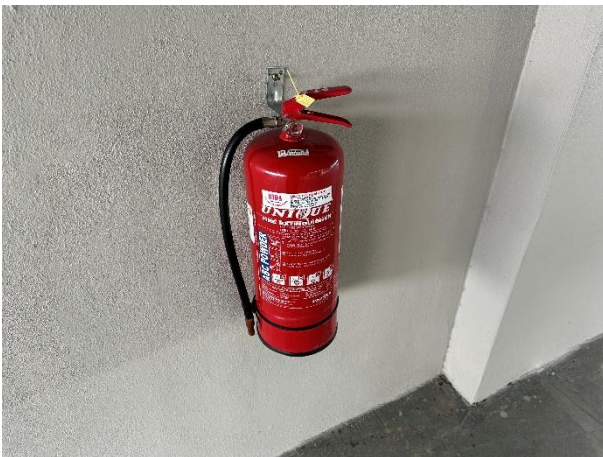
Portable Fire Extinguisher

3.4.1	Type	No. of units & Fire Rating (MS1539 - Red)	No. of units & capacity (Old model)	Condition
	a) Dry powder	209 units x 27A		Satisfactory
	b) Carbon dioxide	73 units x 21B		Satisfactory
	c) Foam			
	d) Water			
	e) Others

3.4.2 Have all the portable fire extinguishers been serviced in the last 12 months and attached with valid Fire Department certificates? [x] Yes [] No
